# Vault Light Removal

60 West 22<sup>nd</sup> Street

New York, NY 10010

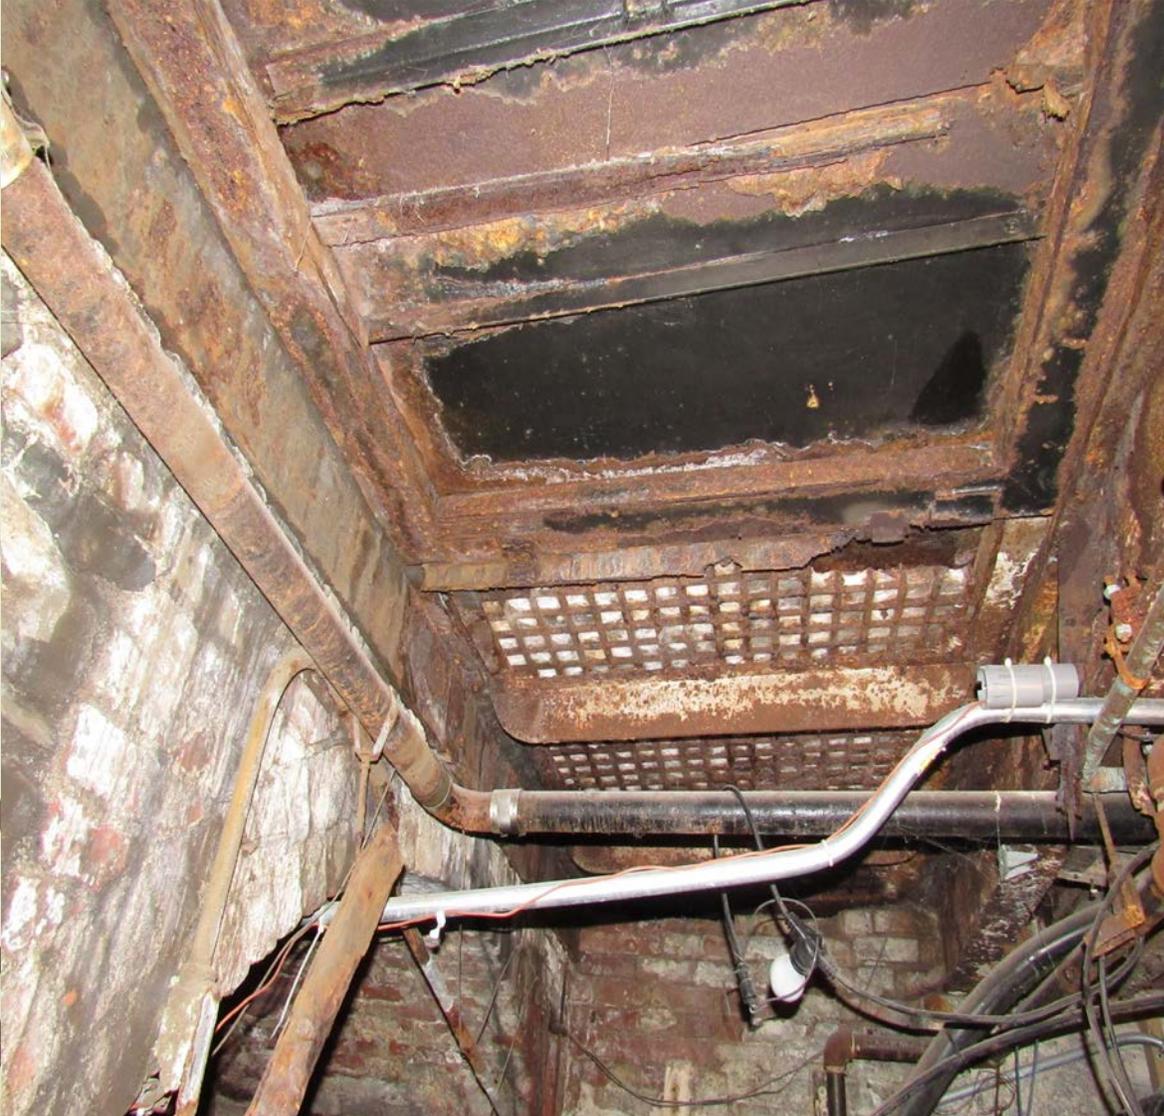
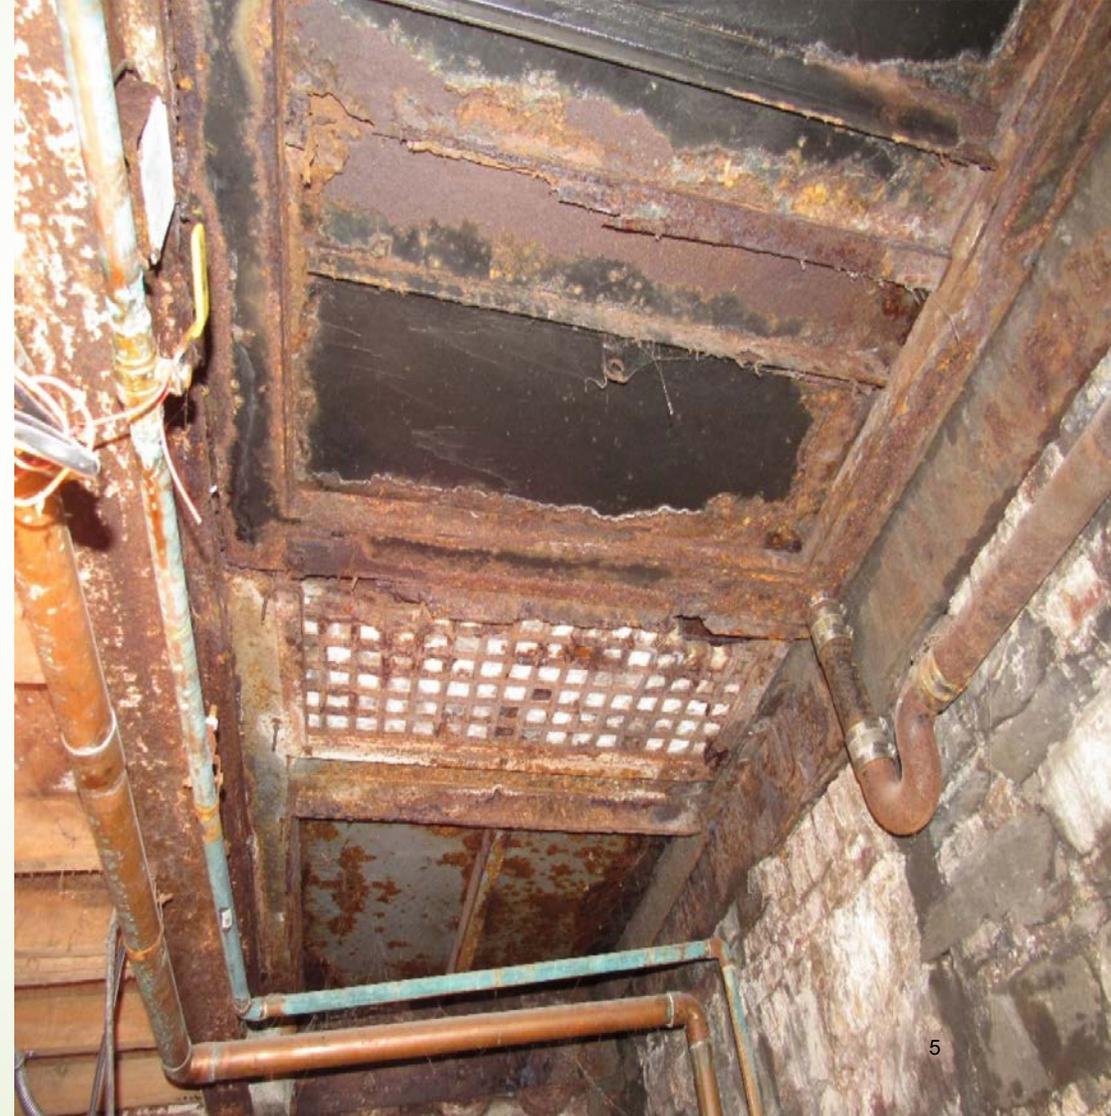
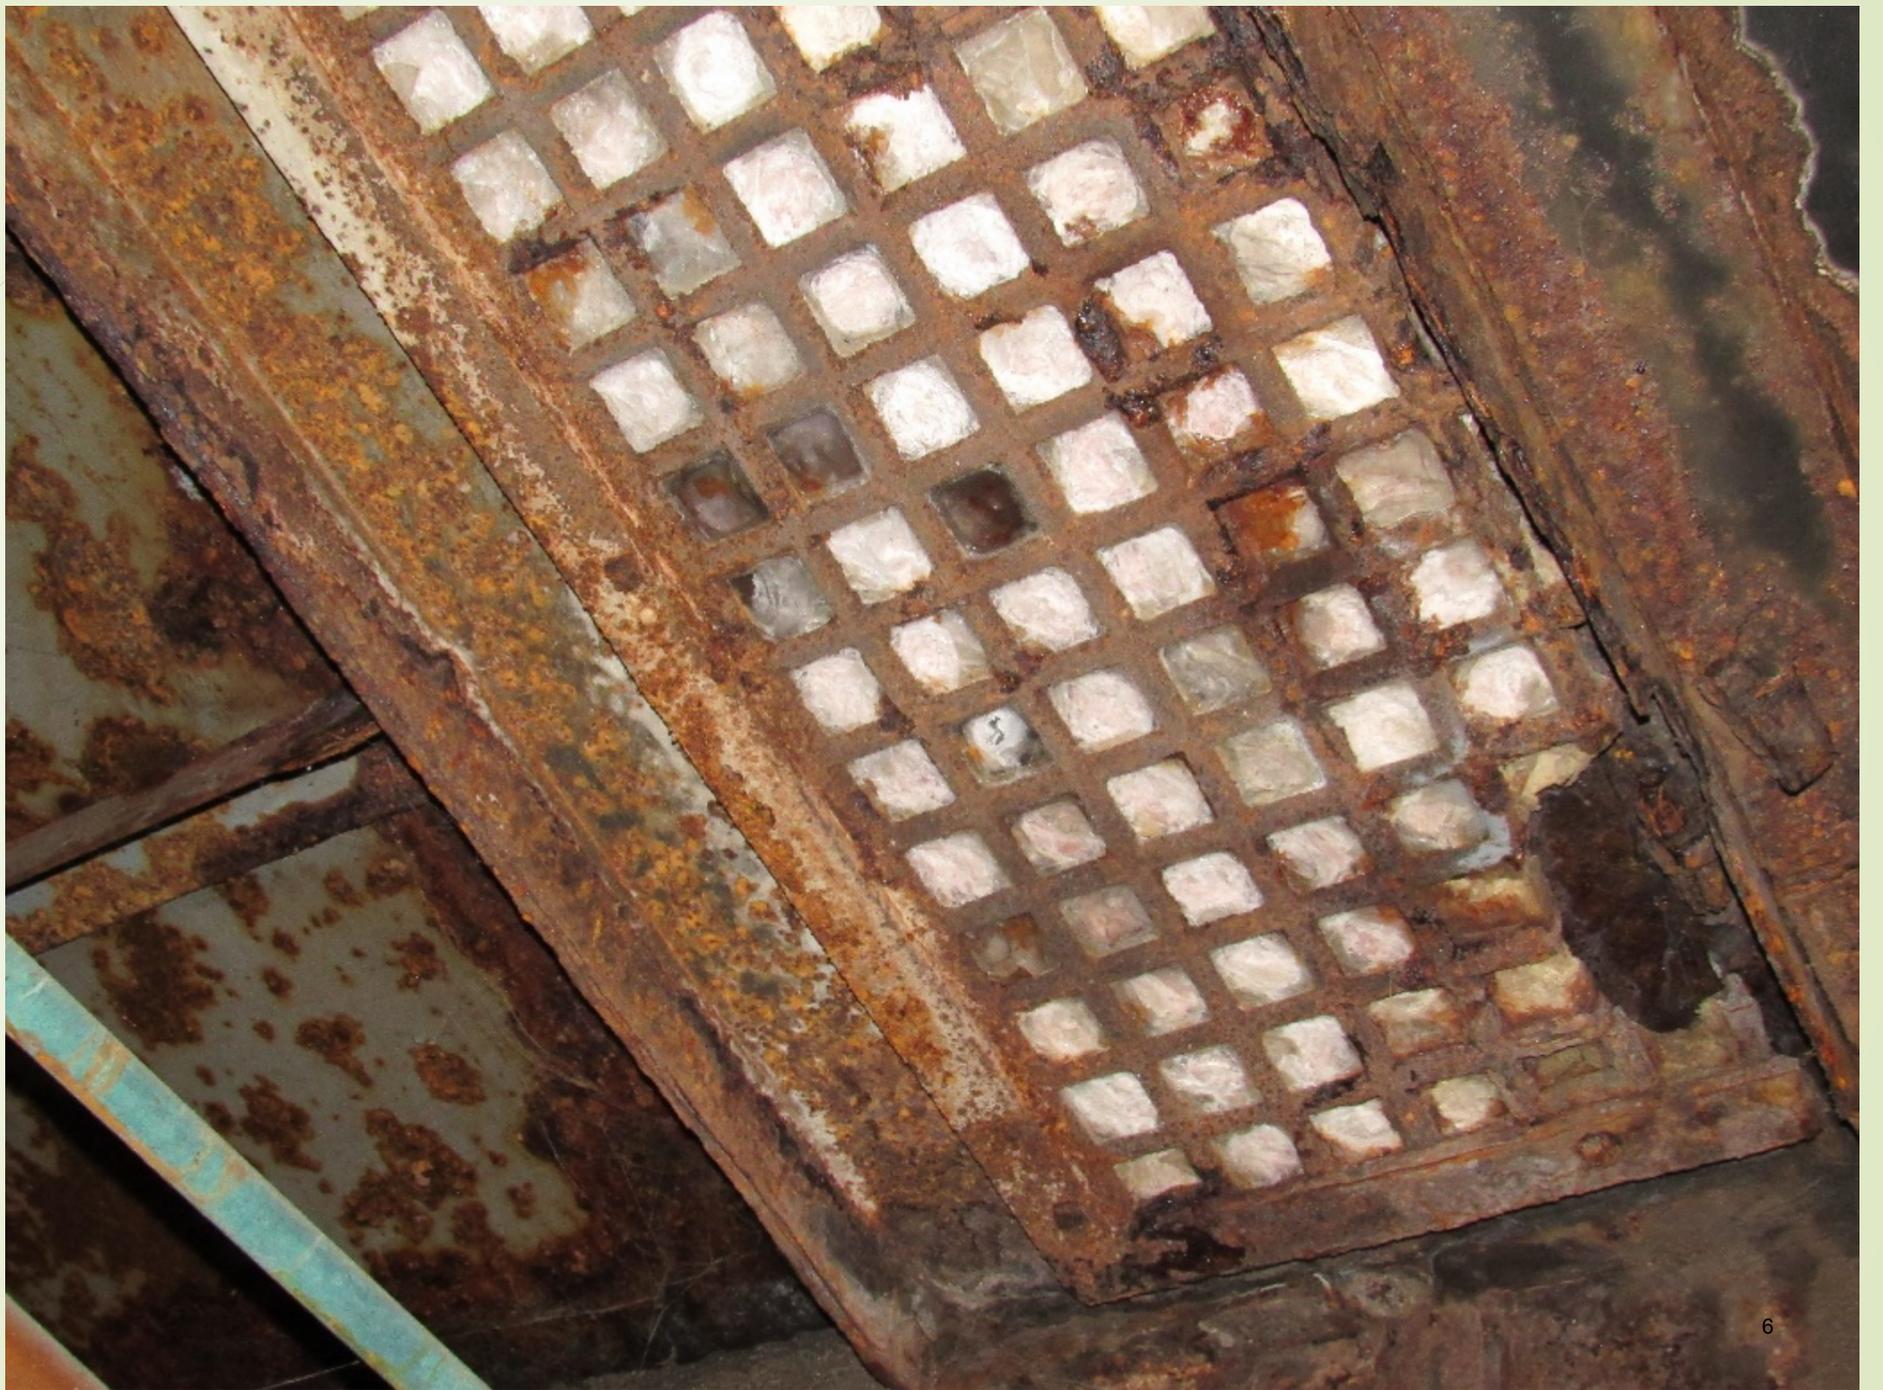
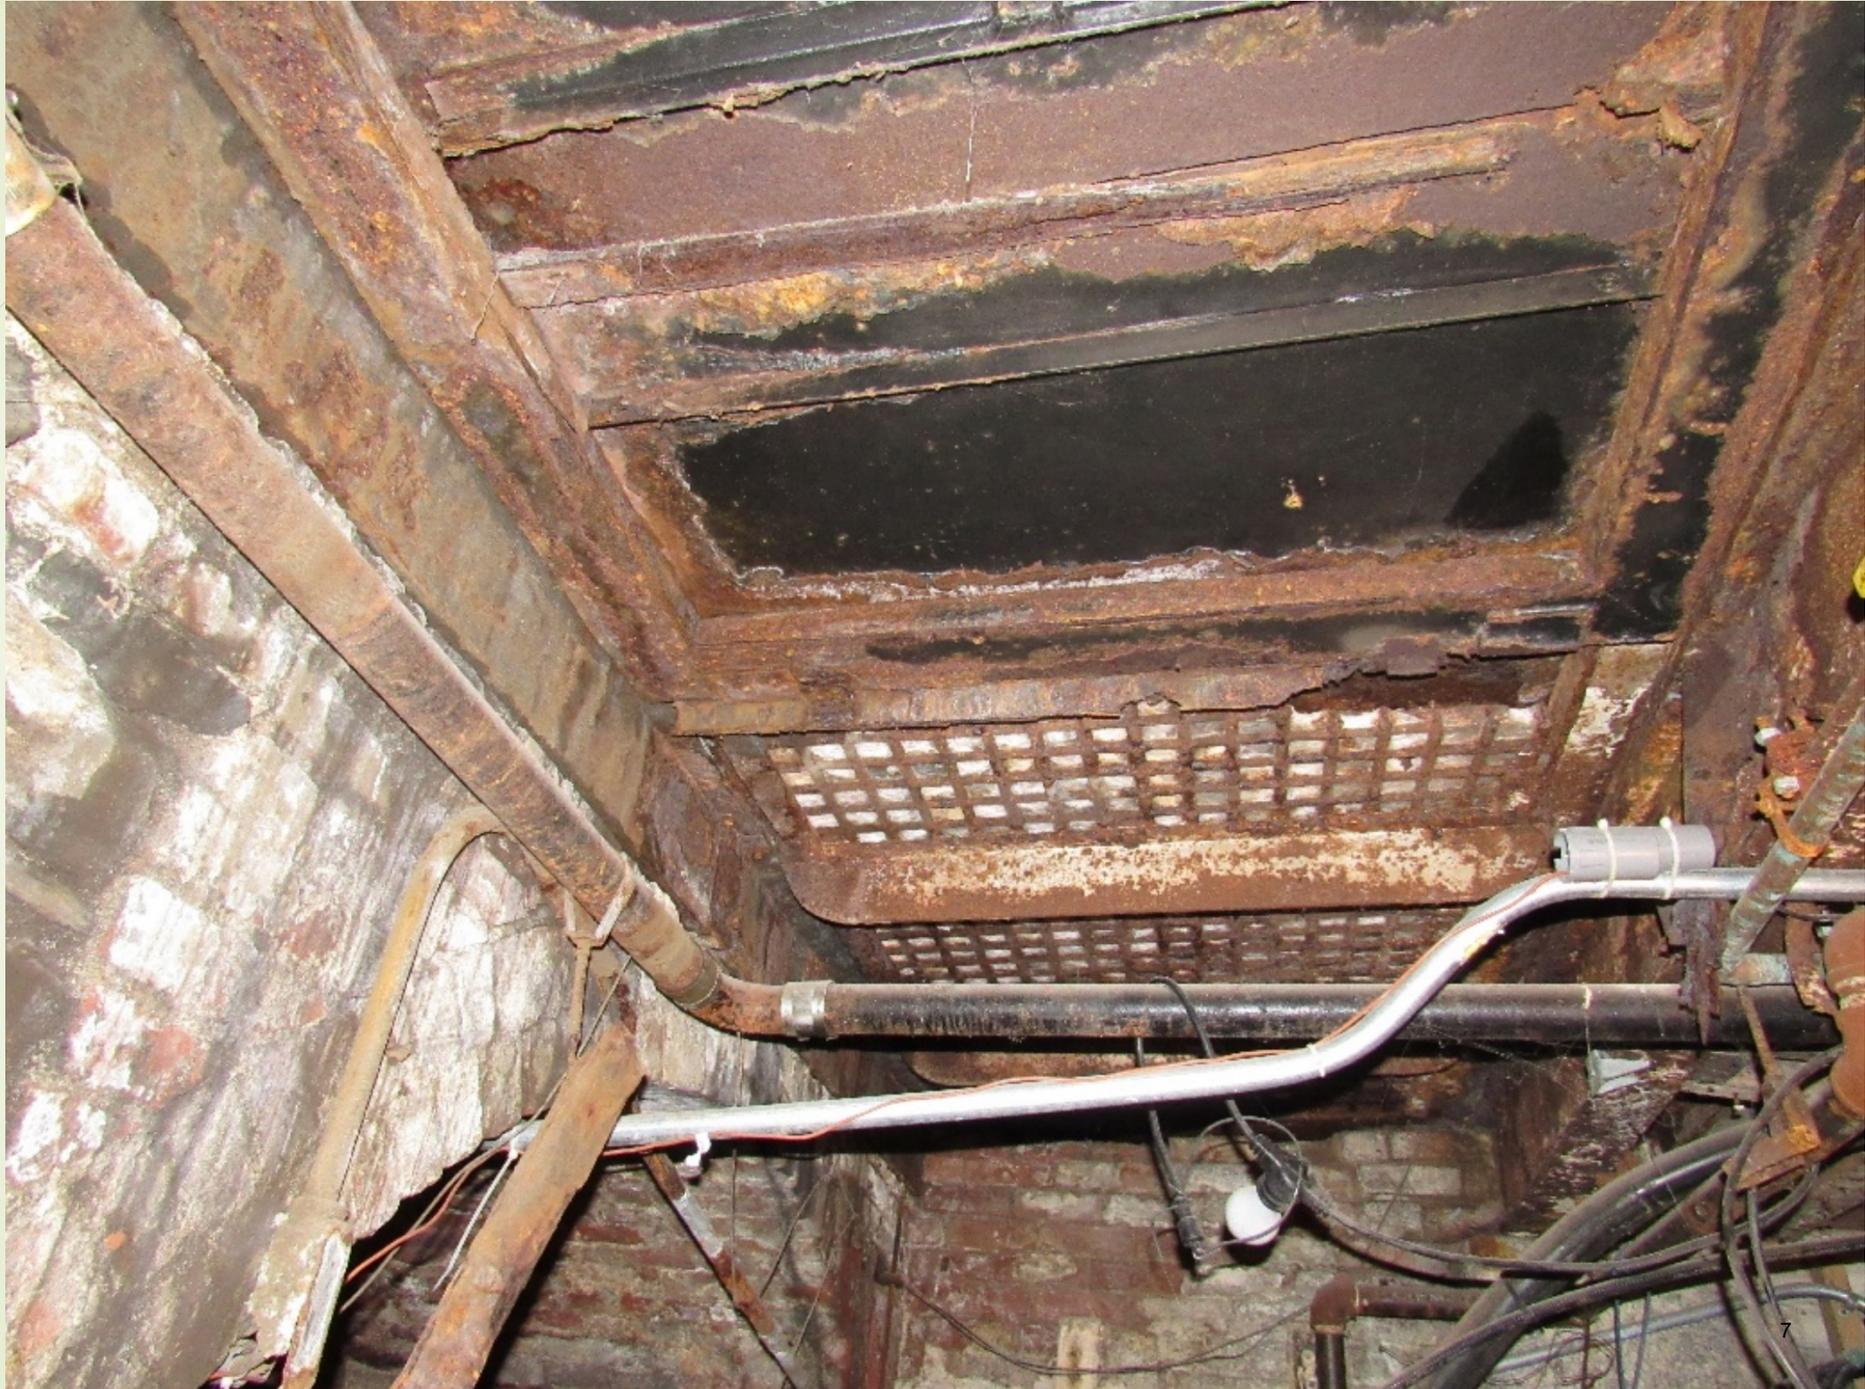
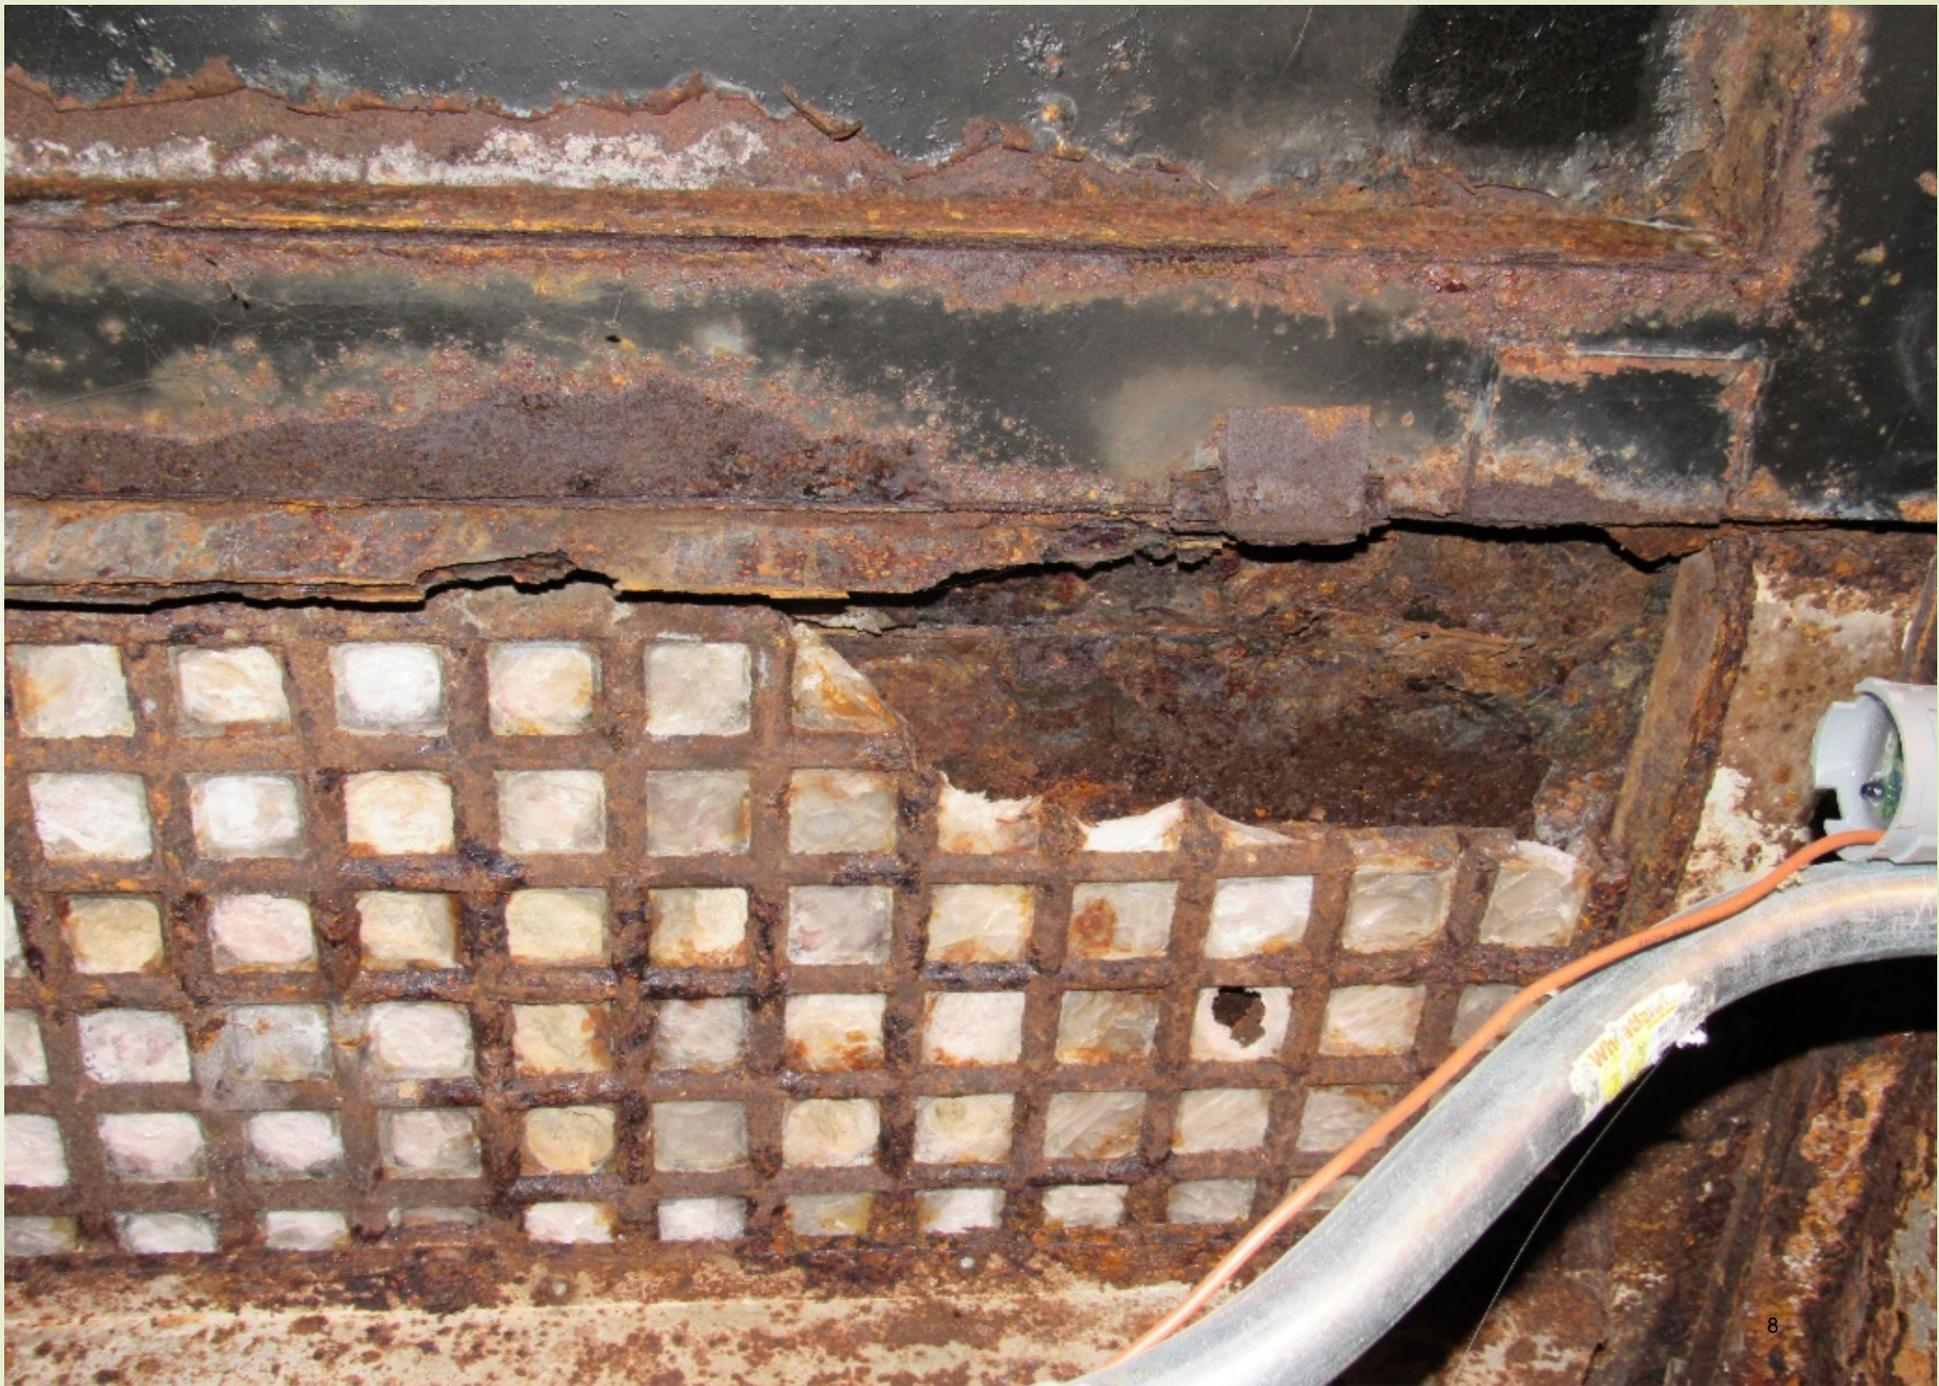
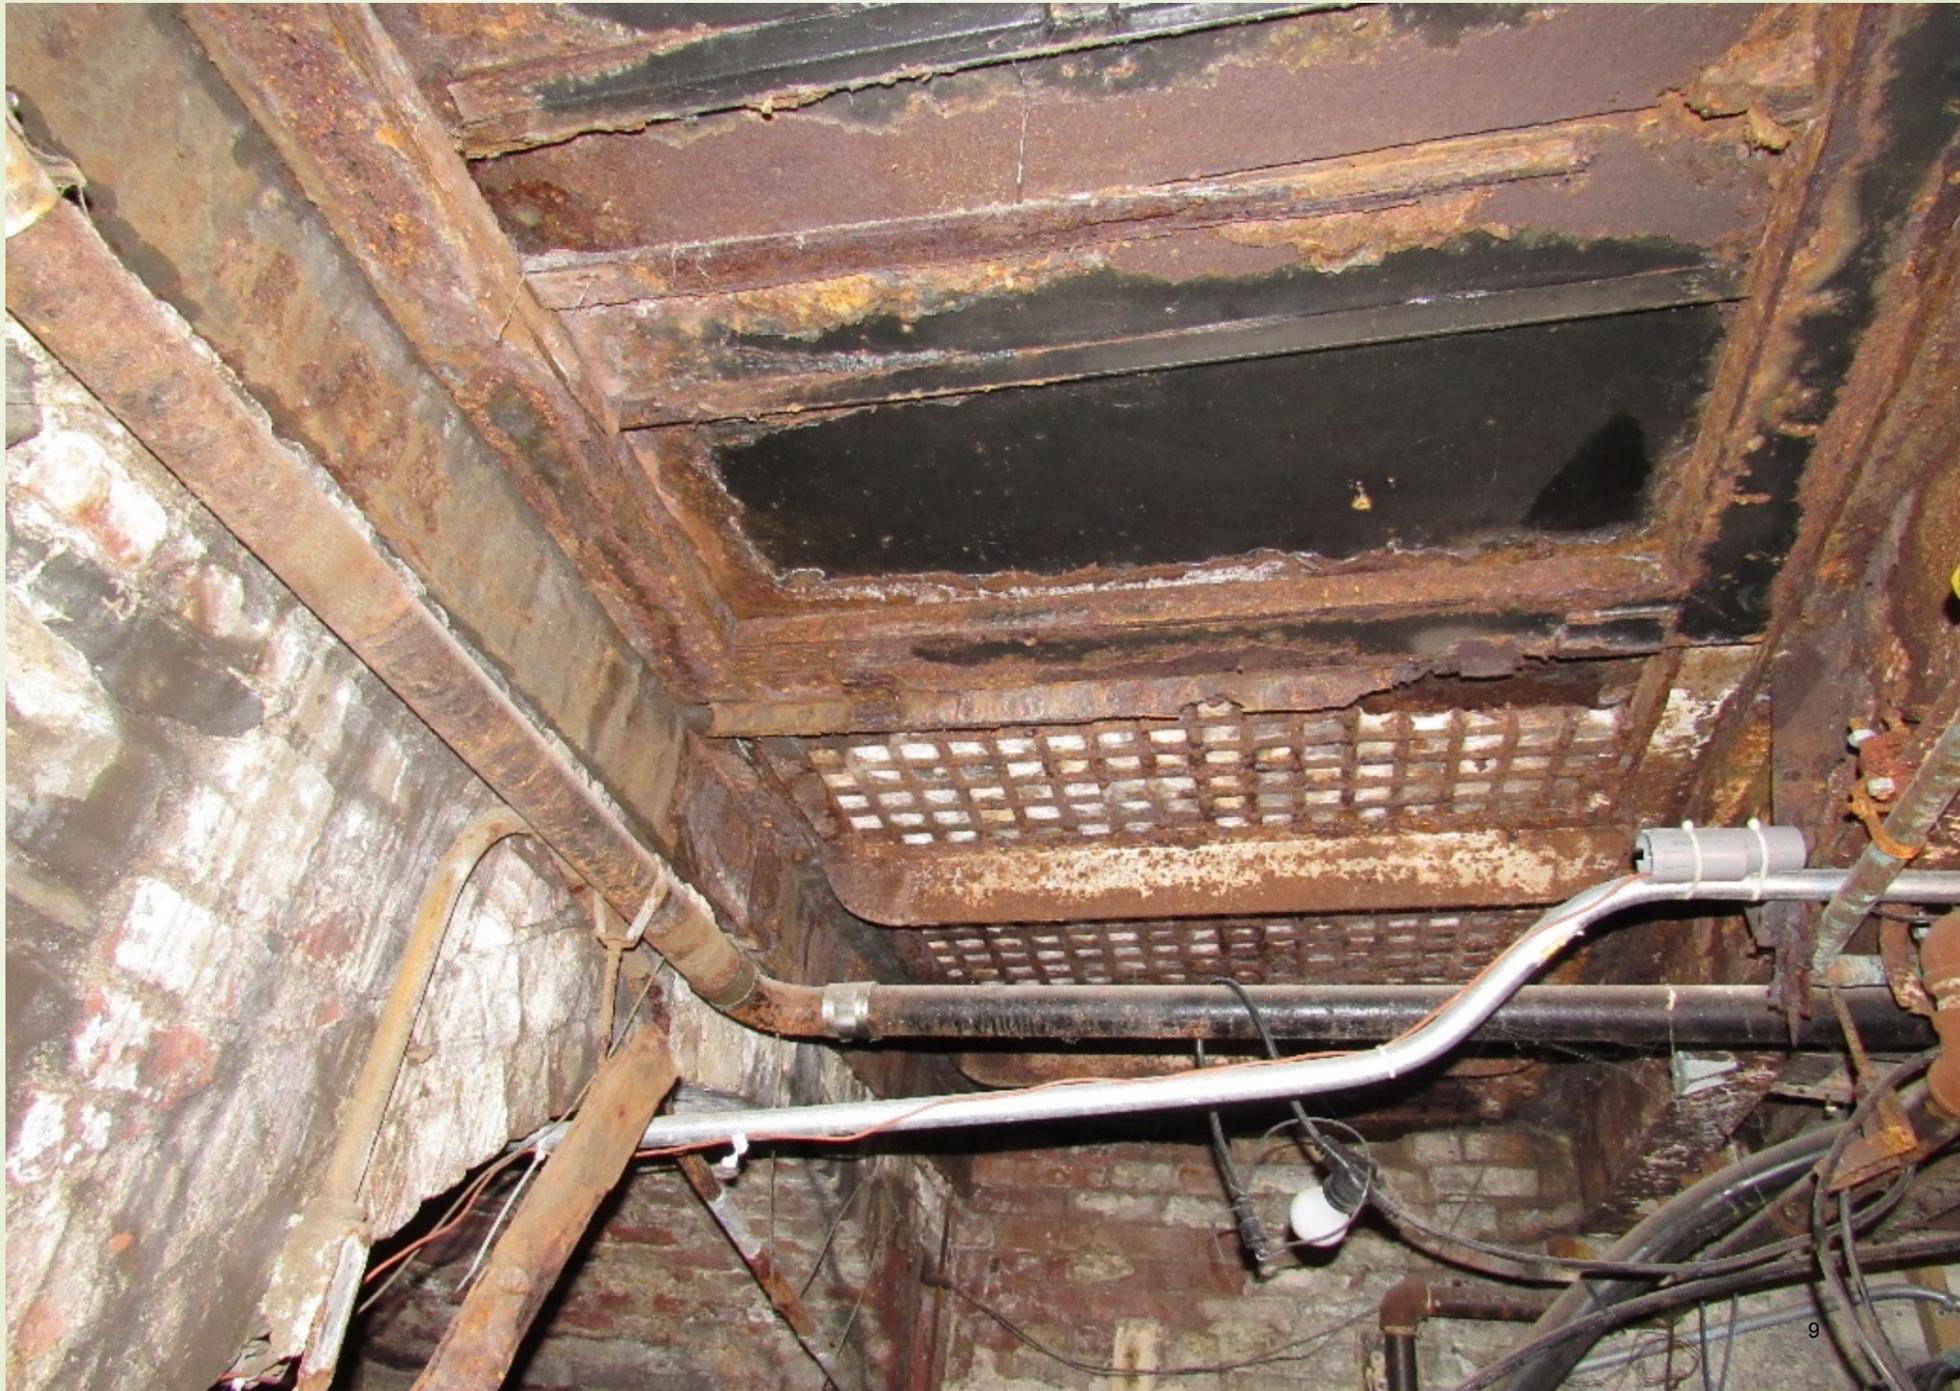
## Condition of Vault Lights

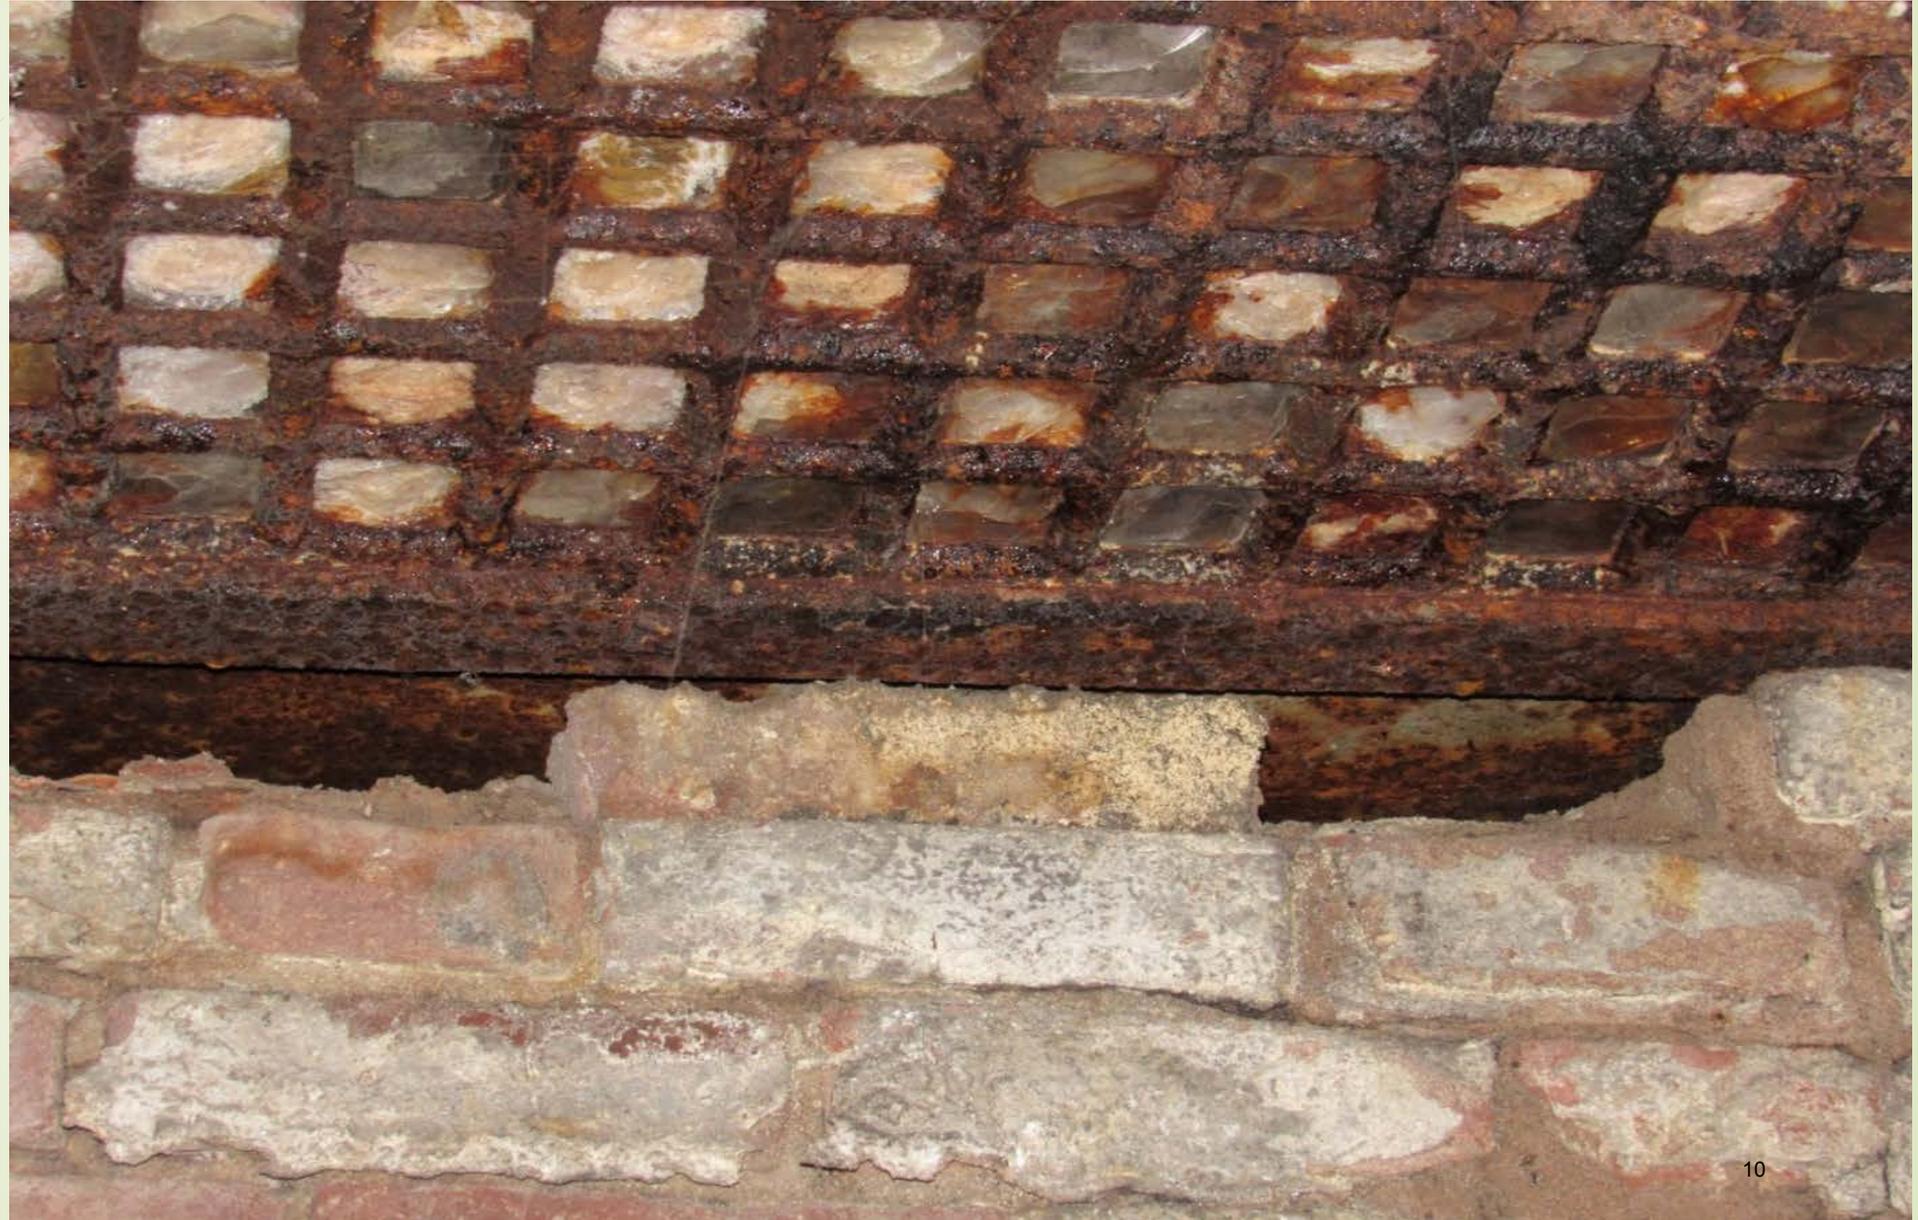
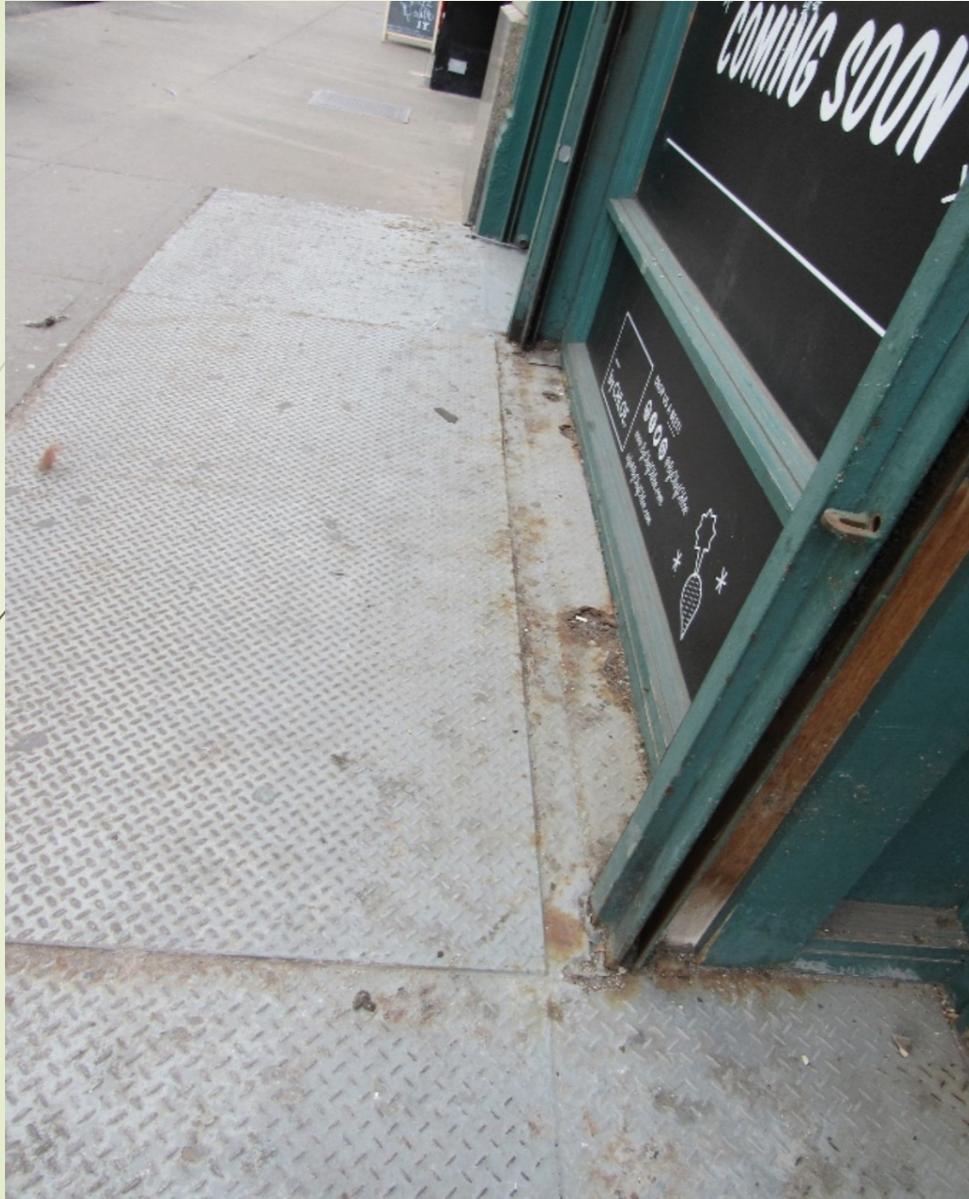
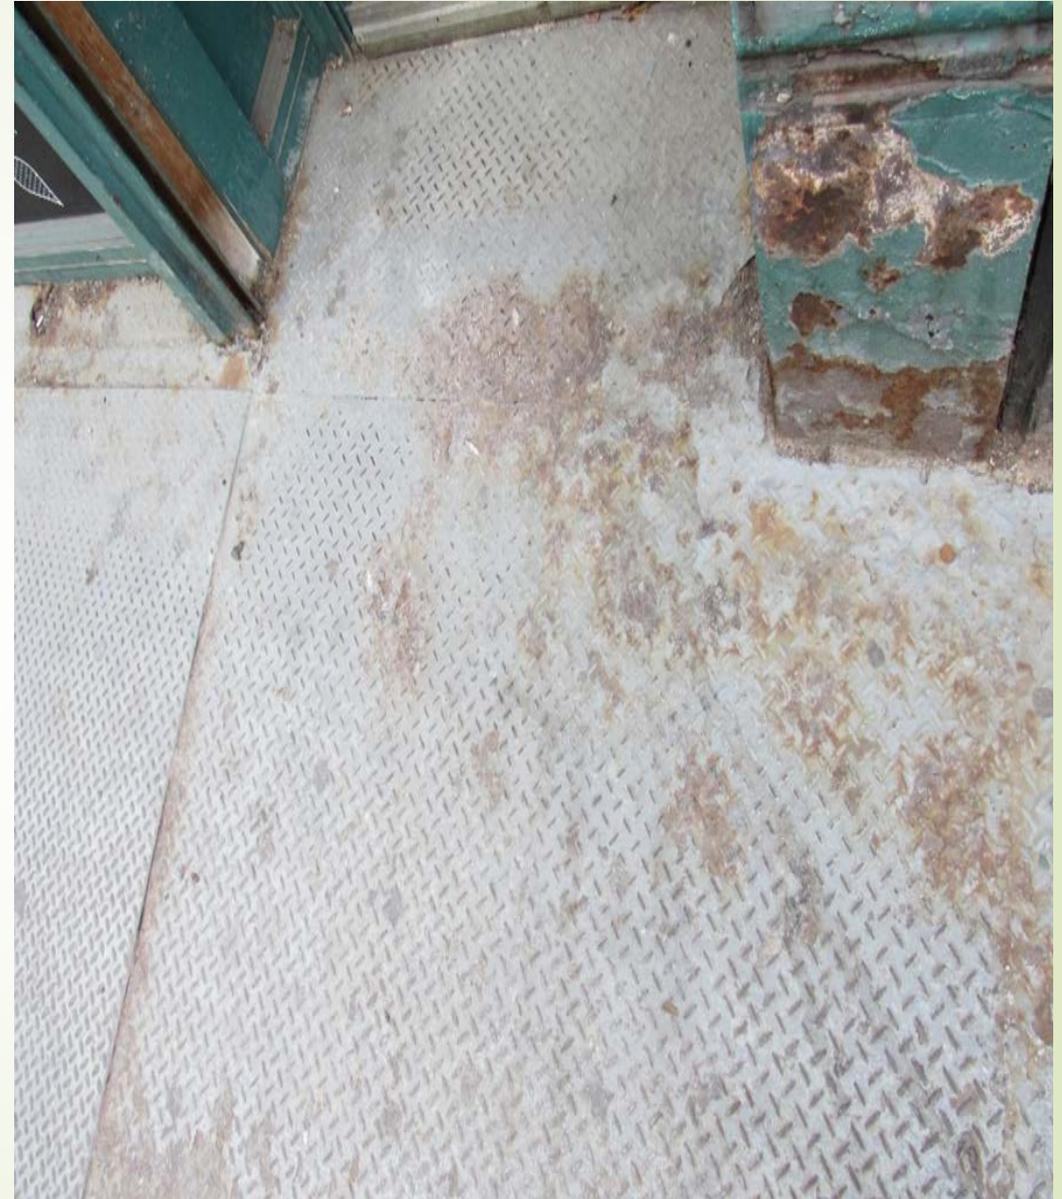
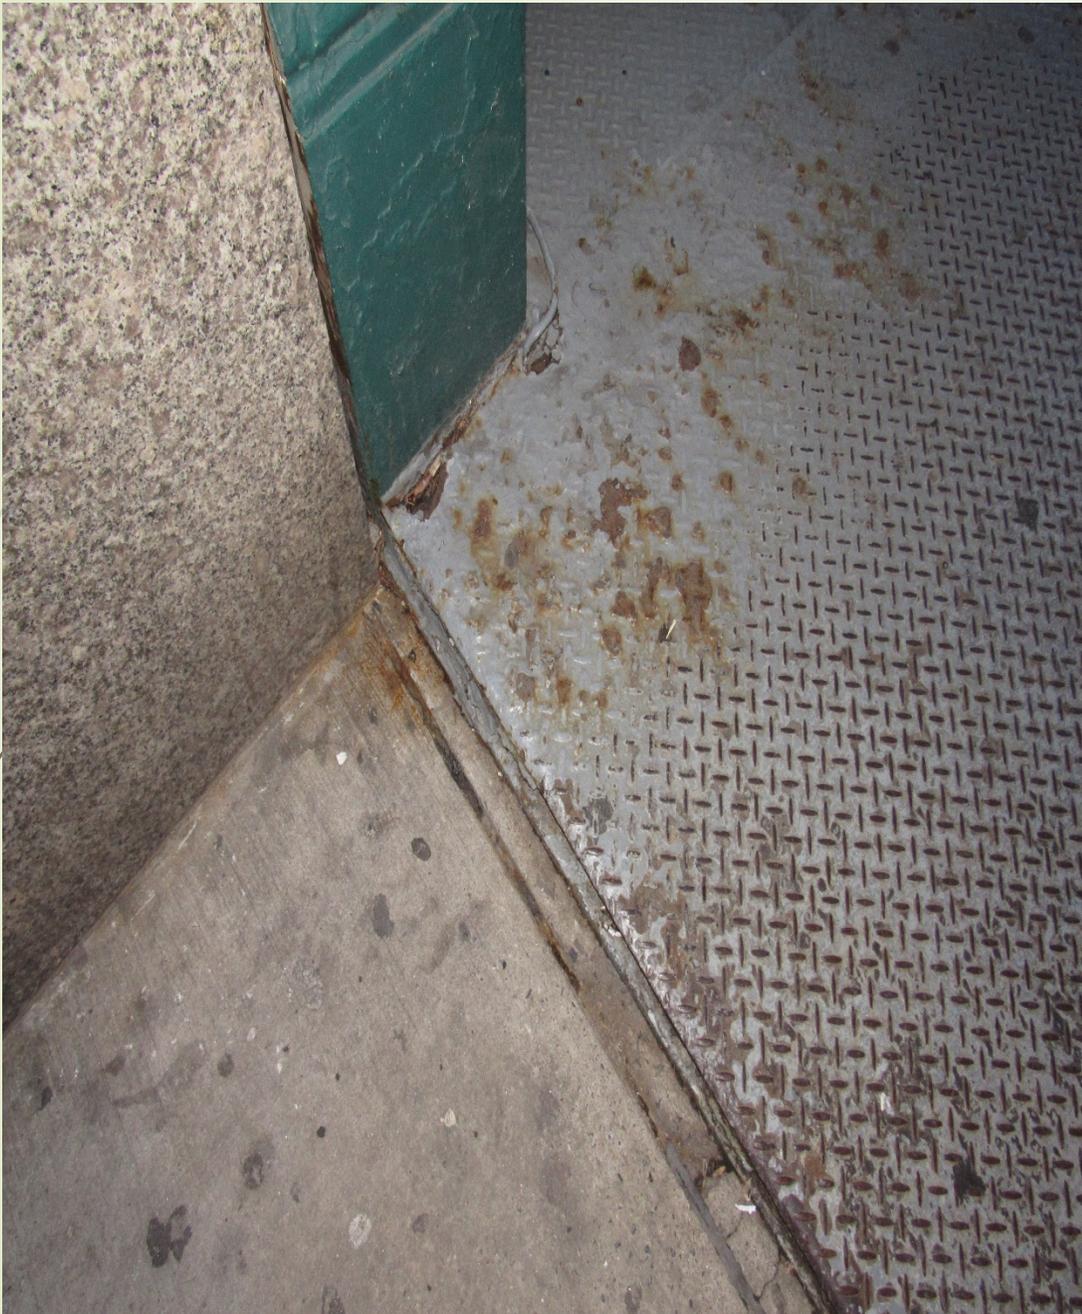
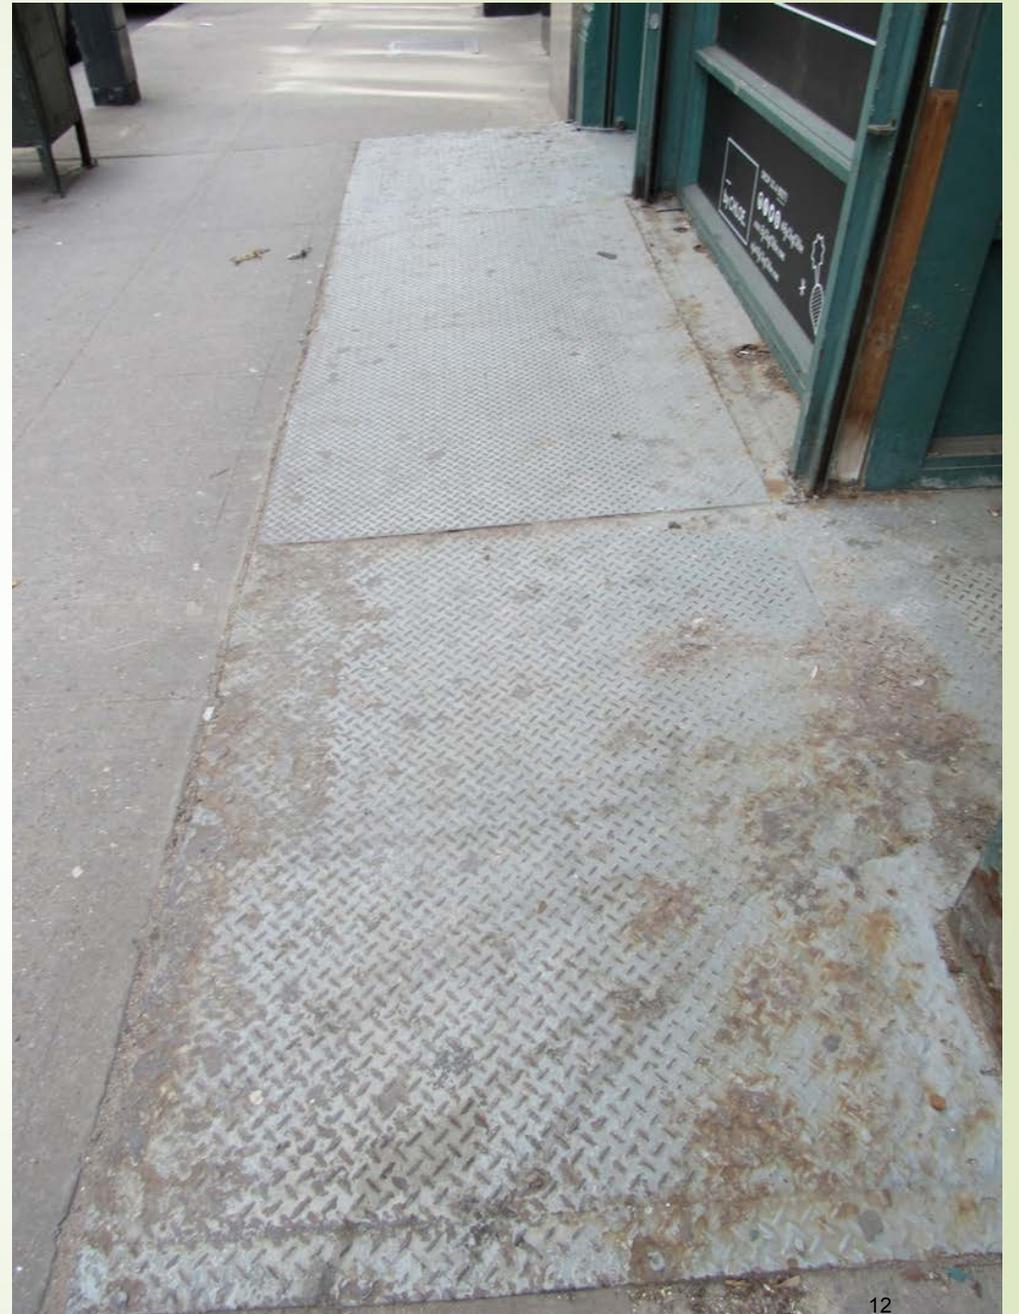
# Water Penetration
