# Vault Light Removal

60 West 22<sup>nd</sup> Street

New York, NY 10010

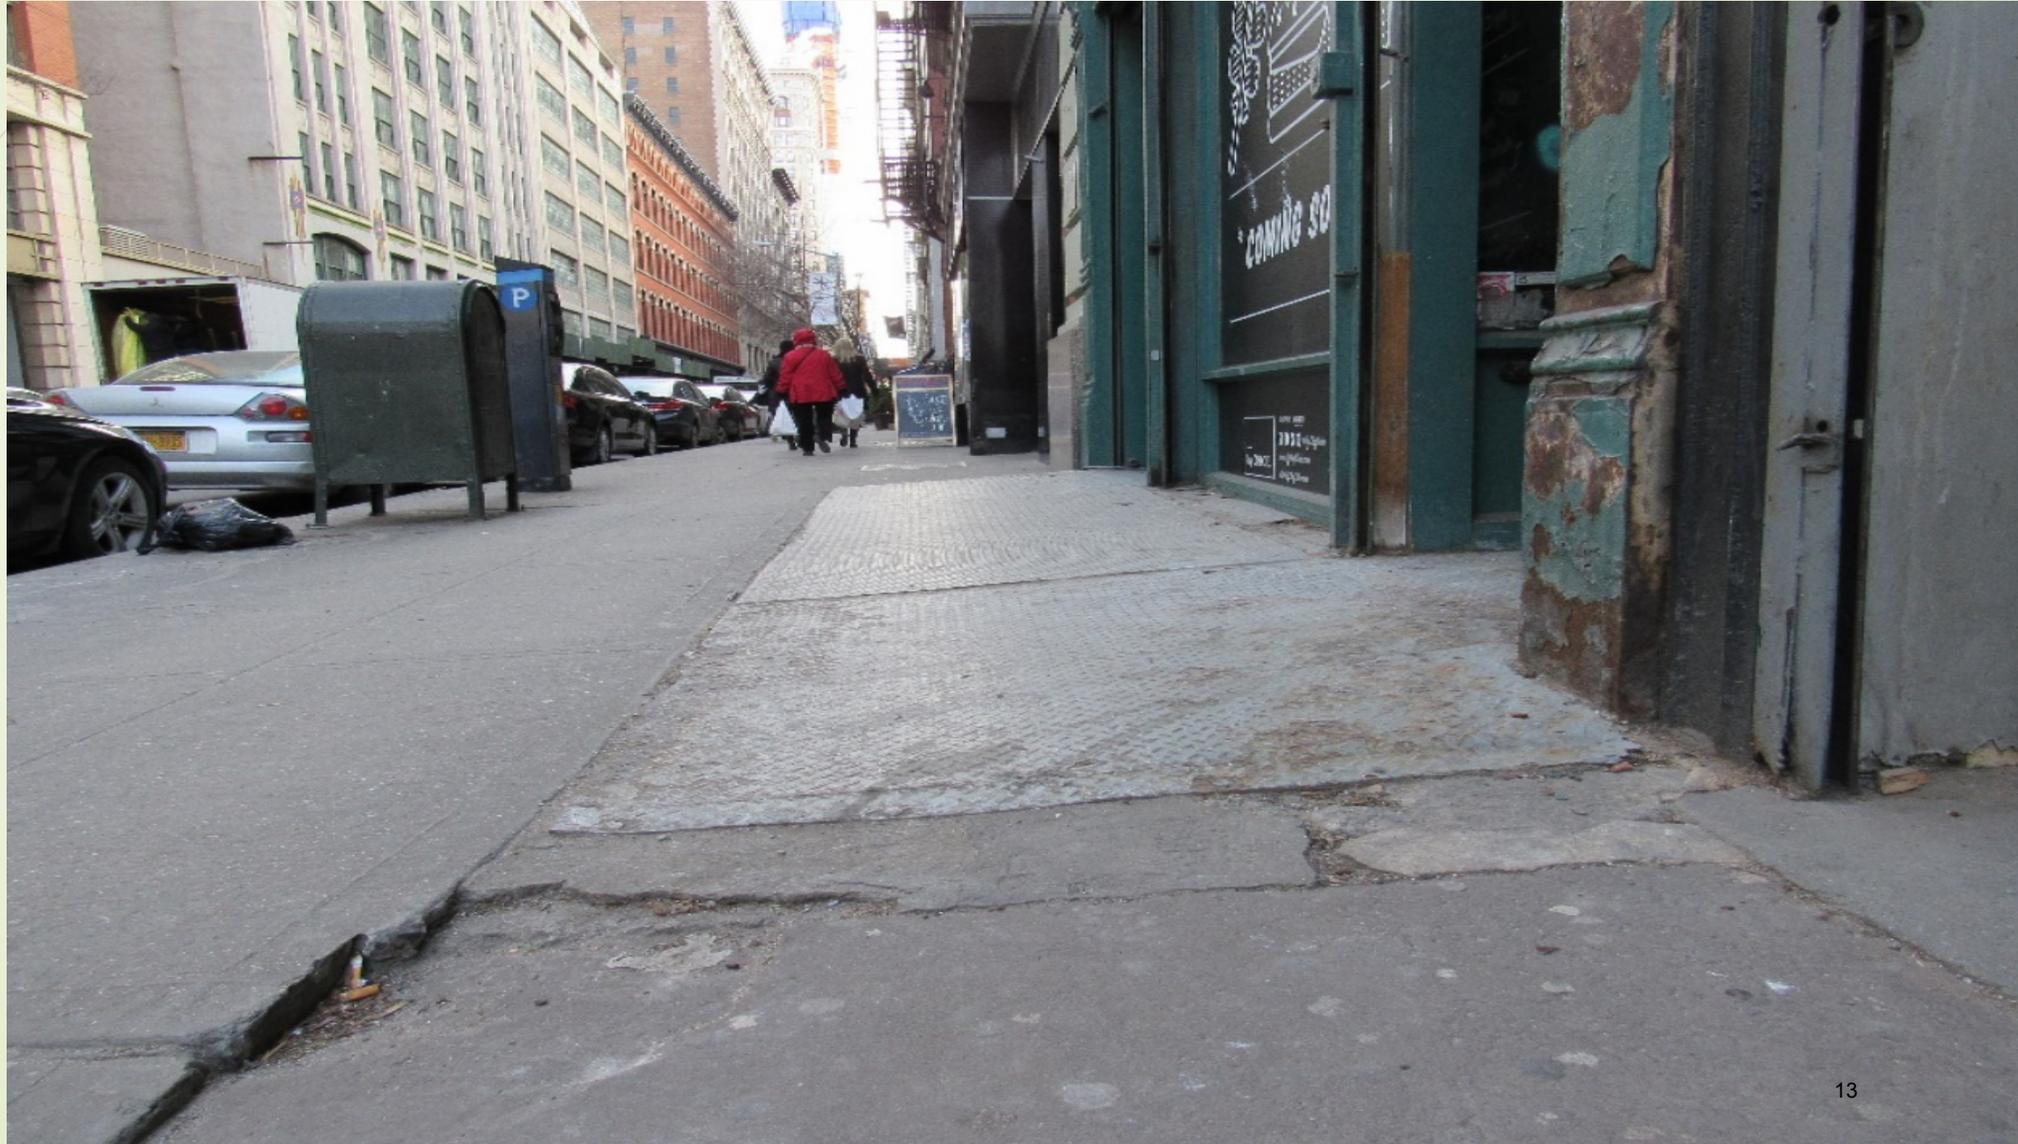
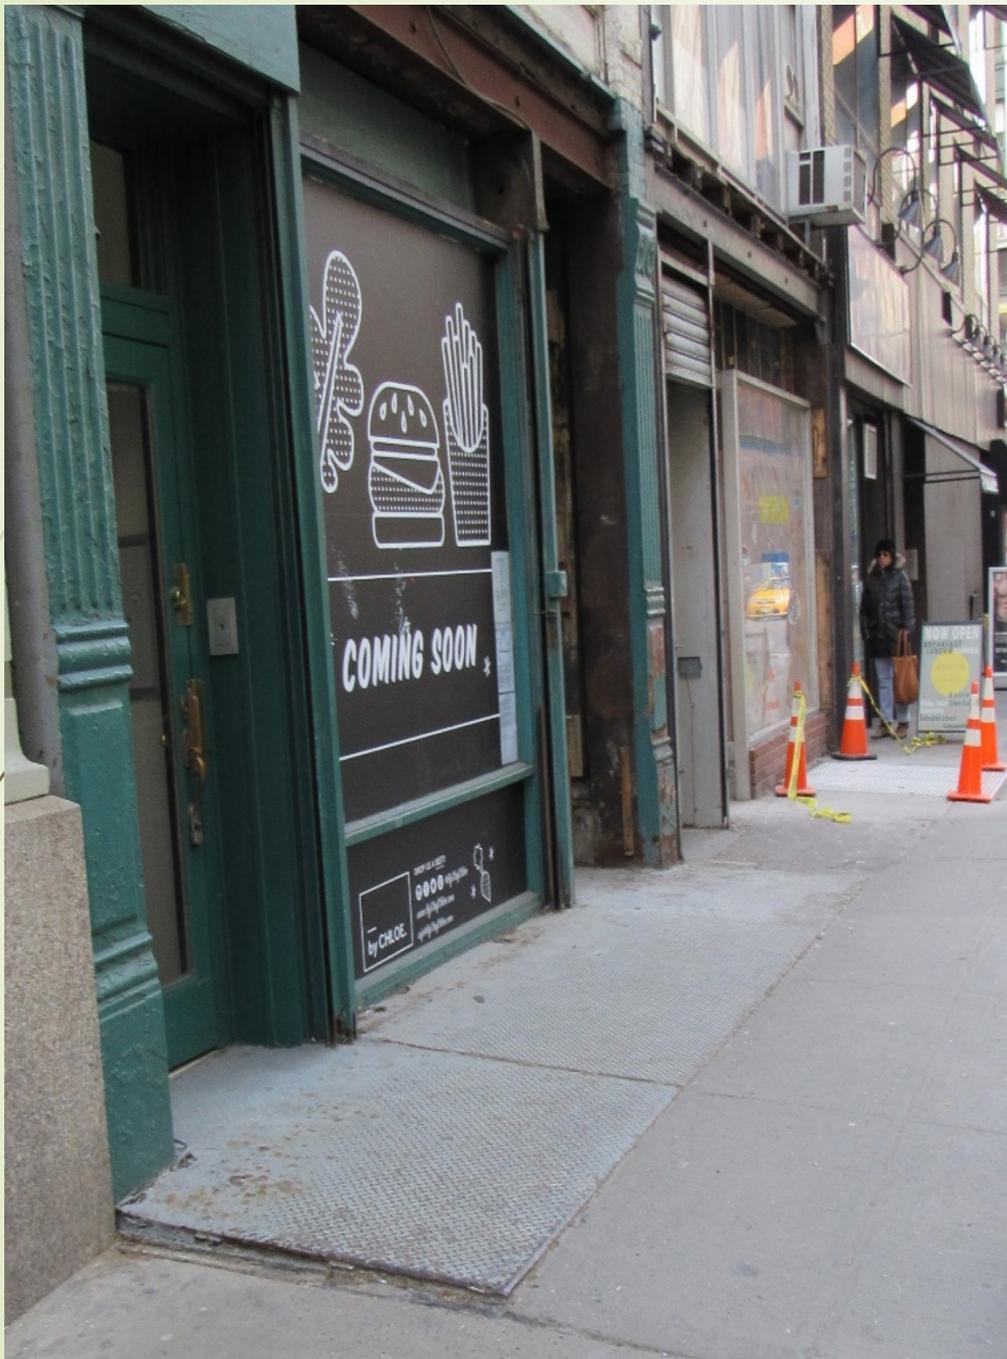
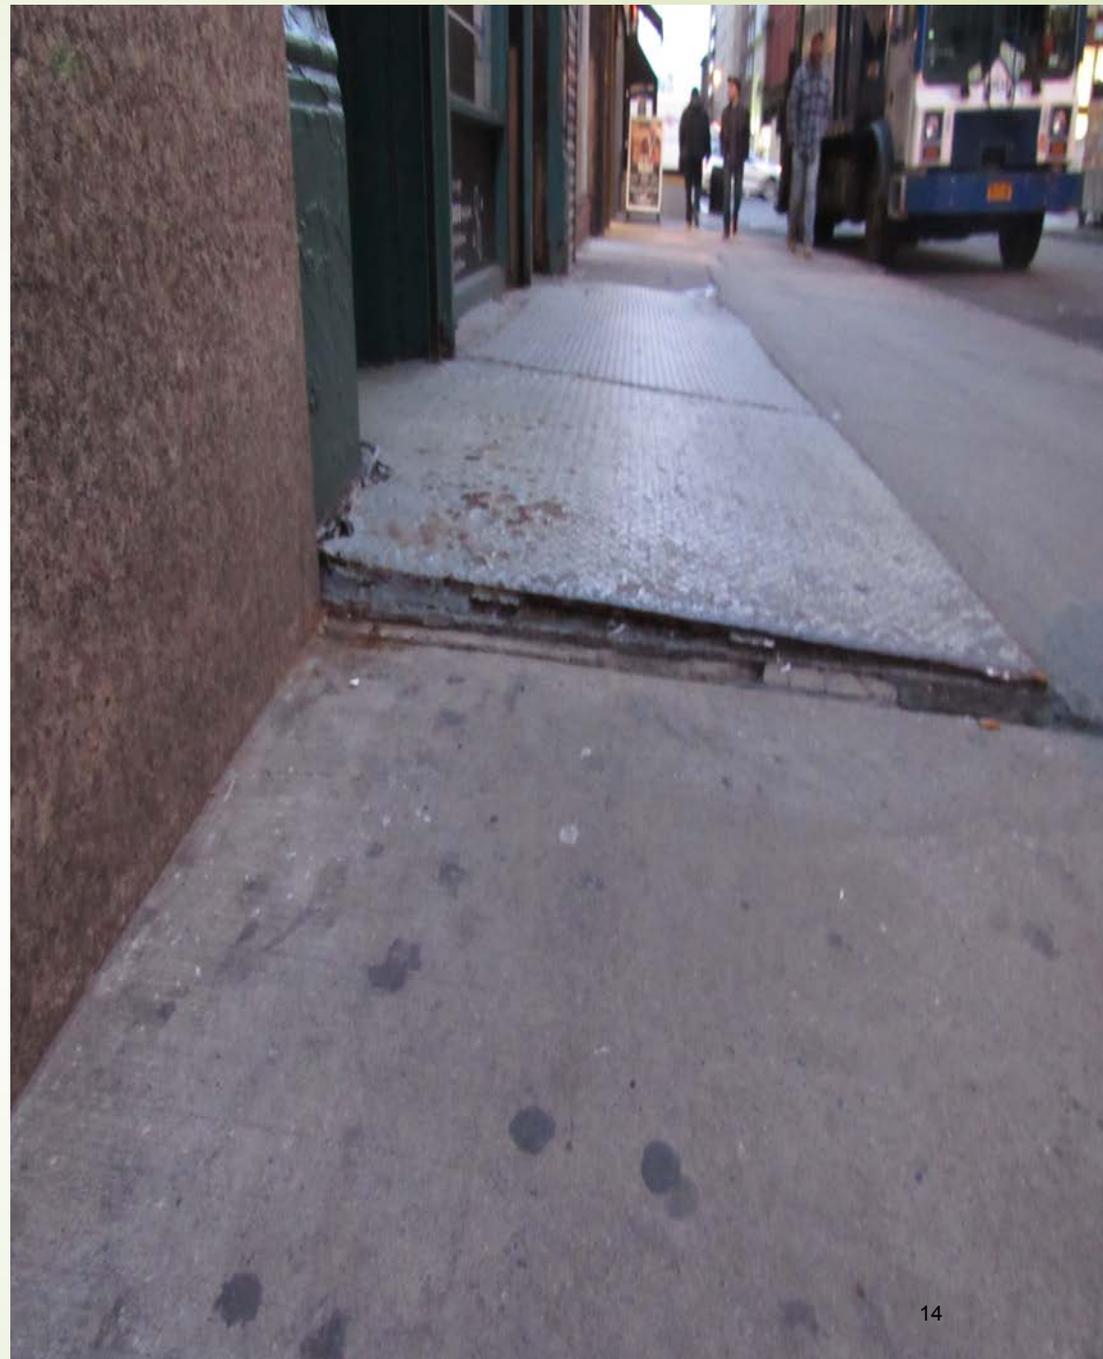
# Constant Trip Hazard
