Massachusetts Water Resources Authority

We're Very Much Alike:

The Boston Metro Area and NYC

The Future of Engineering and Water Quality into the Next Century
October 20, 2005

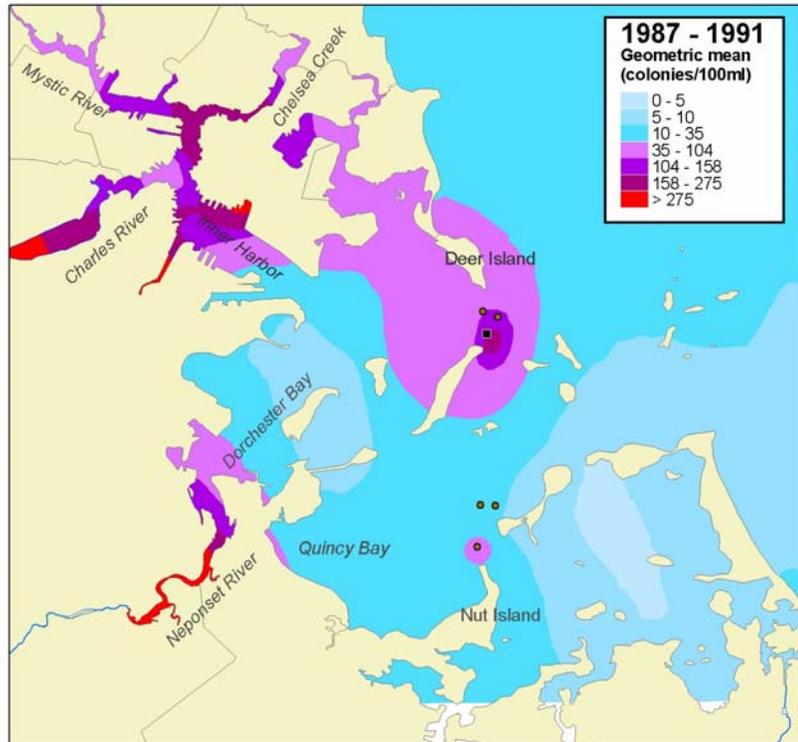
1987-1998 (Before Secondary Treatment and South System transfer)

Elevated bacteria around outfalls, rivers, Inner Harbor, shoreline

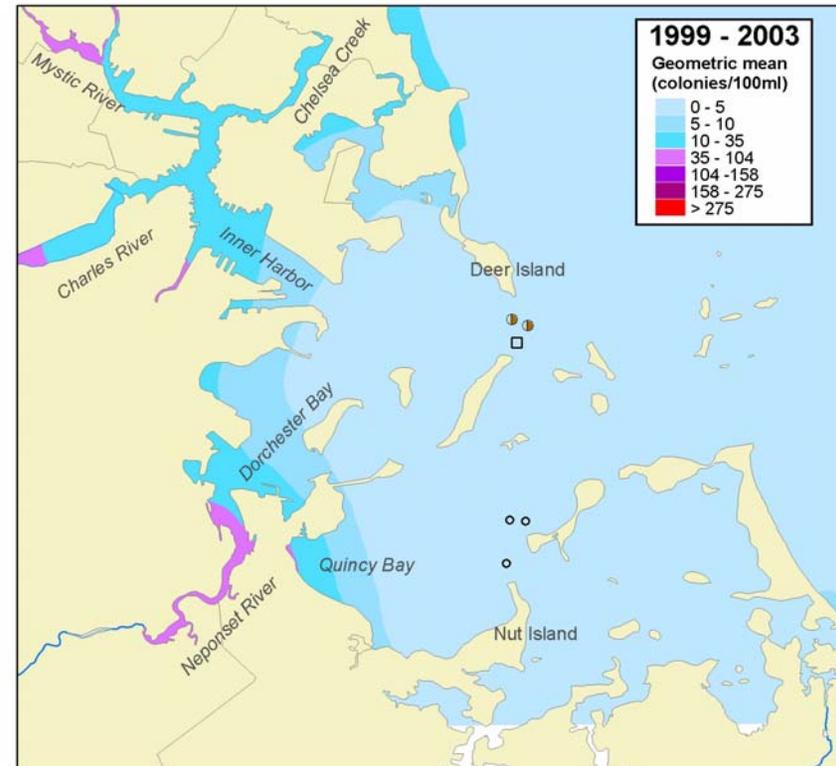
1999 - 2003 (After Secondary Treatment and New Outfall)

Most of Harbor well within swimming criteria, most remaining problems in rivers

Average *Enterococcus* counts in Boston Harbor

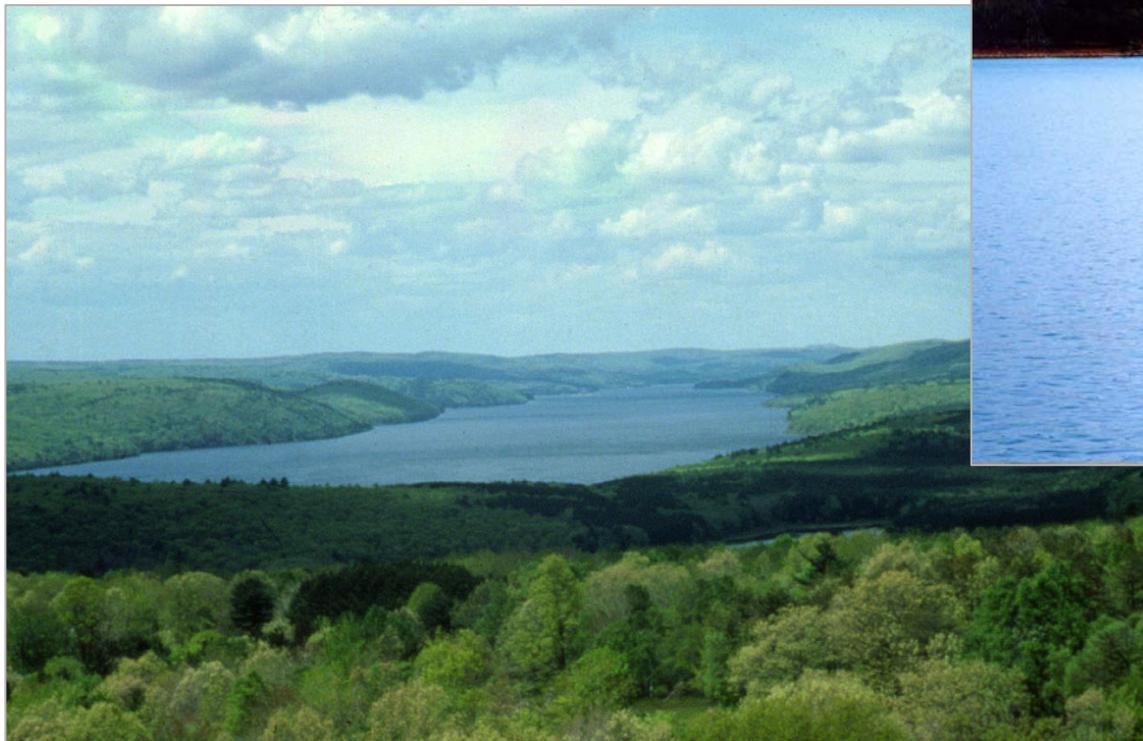
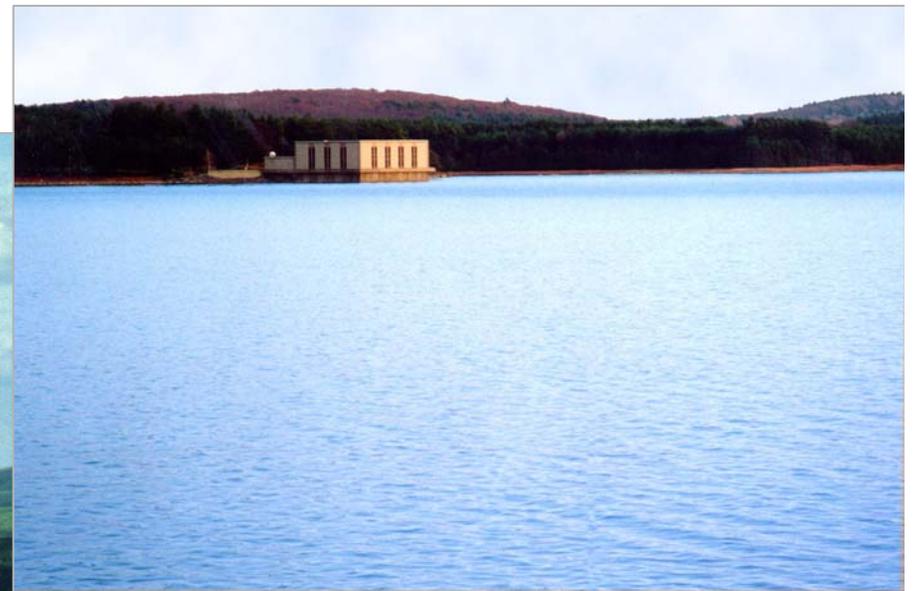
Watershed Protection

- Quabbin Watershed – 187 sq miles – 75% protected lands
- Ware River Watershed – 96 sq miles – 57% protected lands
- Wachusett Watershed – 117 sq miles – 56% protected lands

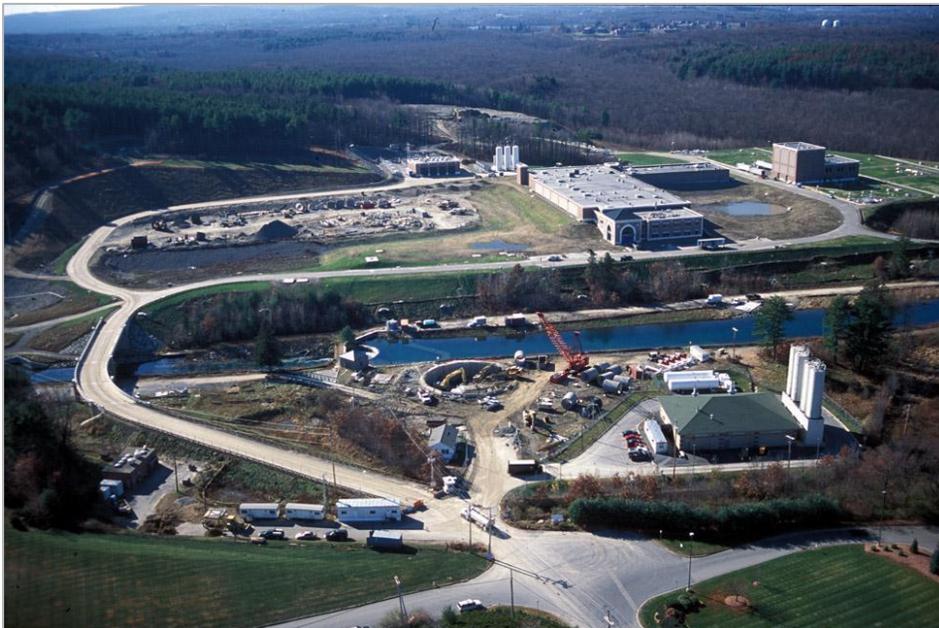
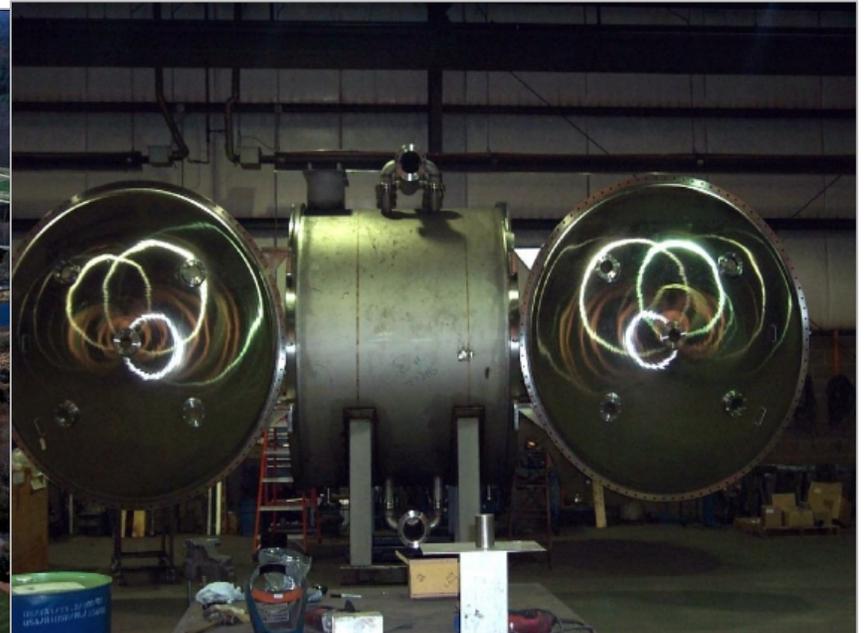
Modern Treatment – The Plant

- 405 MGD John J Carroll WTP in service July 27, 2005
- Chlorine Replaced by Ozone as primary disinfectant
- Treatment Consolidated From 3 to 1 locations
- Chloramines for Residual Disinfection
- Corrosion Control and Fluoridation

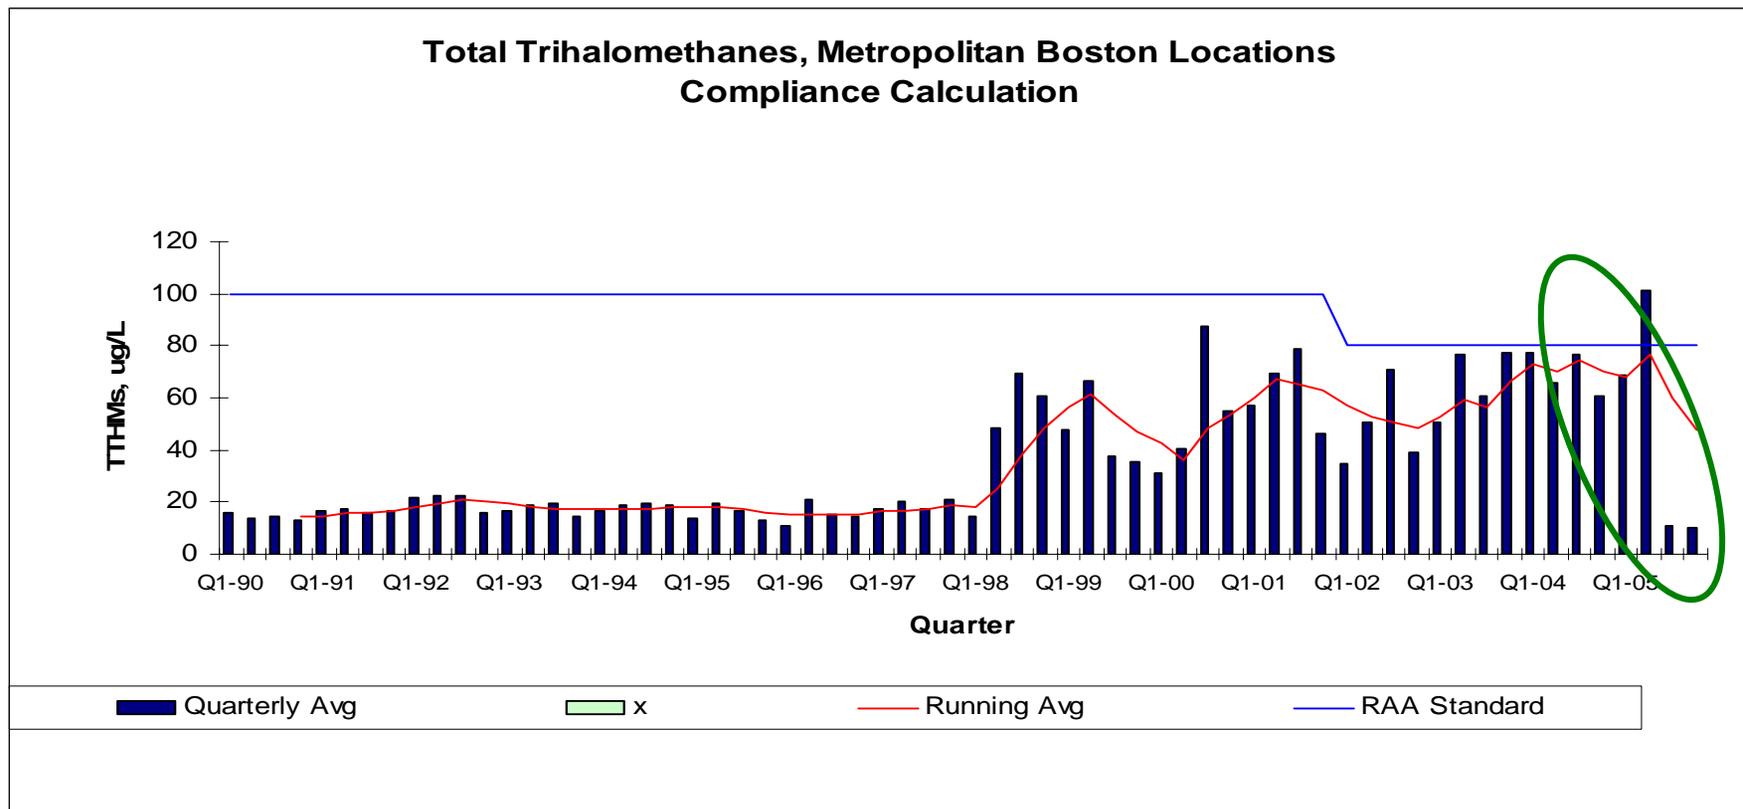
Modern Treatment – The Results

- 2-log *Cryptosporidium* Inactivation Target
- 90% Reduction in THMs
- Better Taste and Odor Control

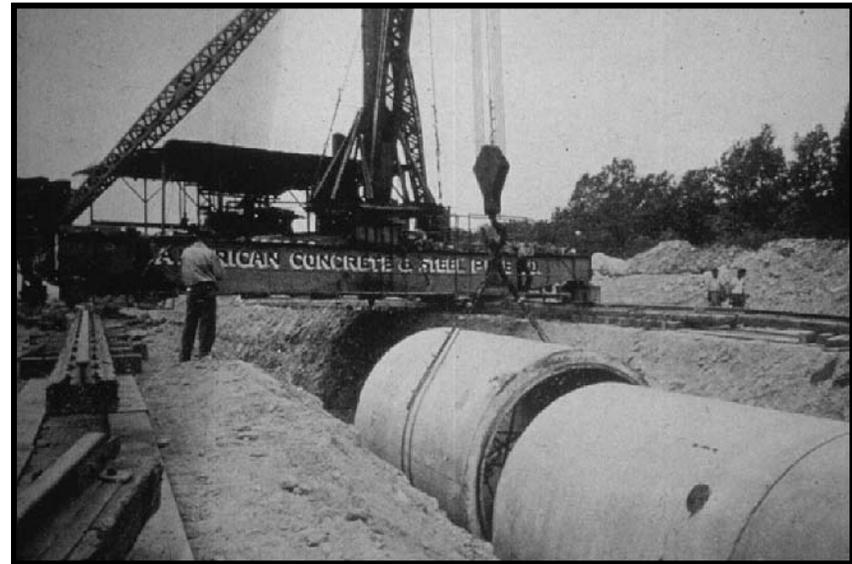
Inadequate Transmission System

- In 1936, the Legislature approved the construction of a two barreled high-pressure aqueduct to deliver water to the greater Boston area
- One barrel of the aqueduct system - the Hultman Aqueduct - was completed
- But work on the second barrel did not resume after World War II
- Since then, 85% of Boston's water supply was provided without redundancy

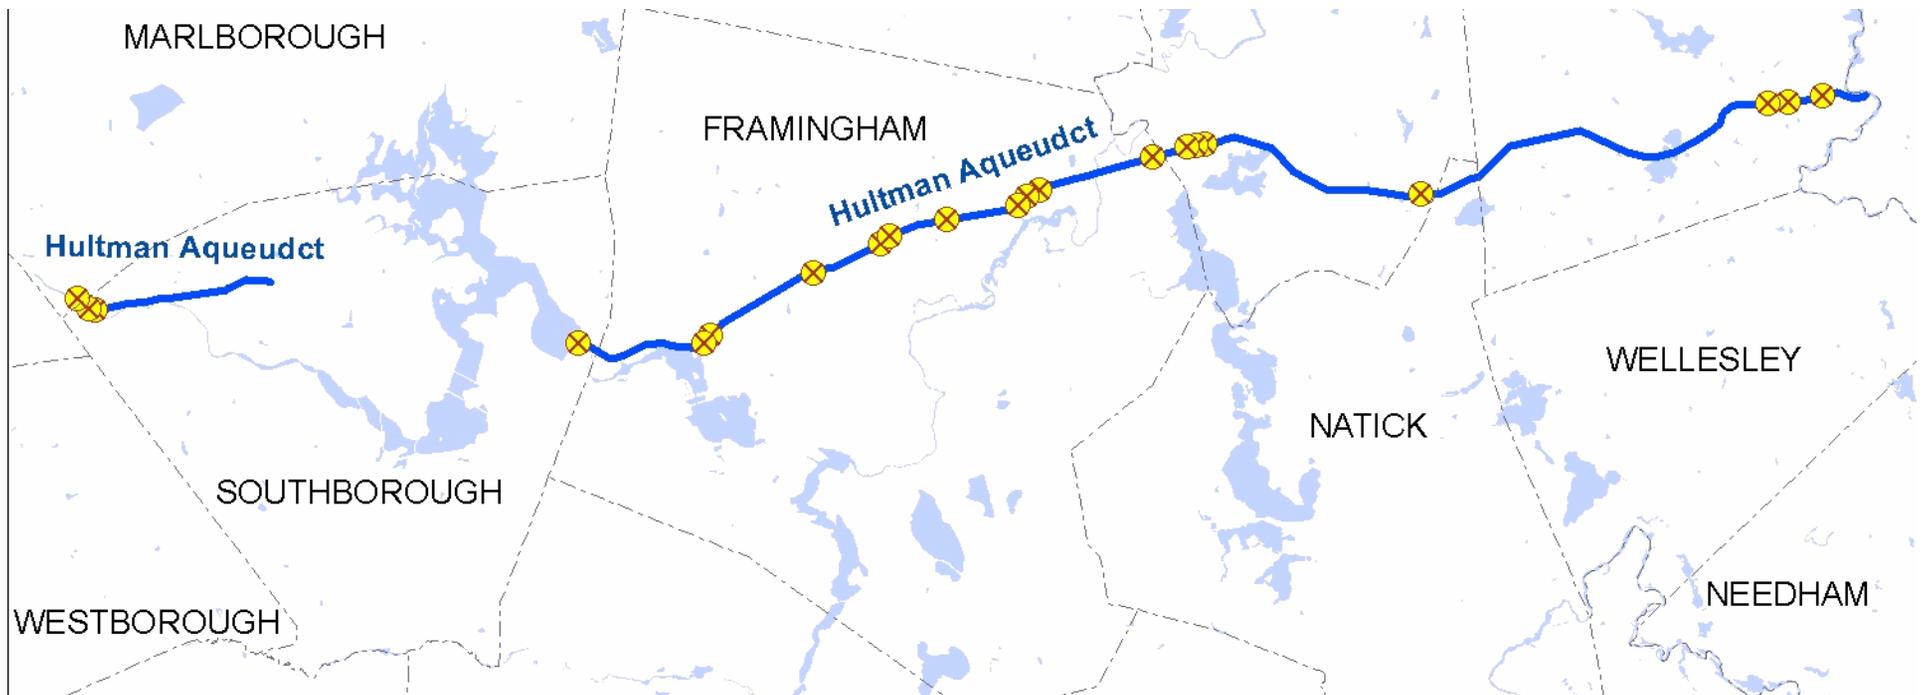
Hultman Aqueduct Leaked as Well

- 18 Significant Leaks Along the 19 mile Length
- Could Not be Taken Out of Service for Inspection or Repairs
- Appurtenant Facilities in Poor Condition
- Fear of Undermining and Catastrophic Failure

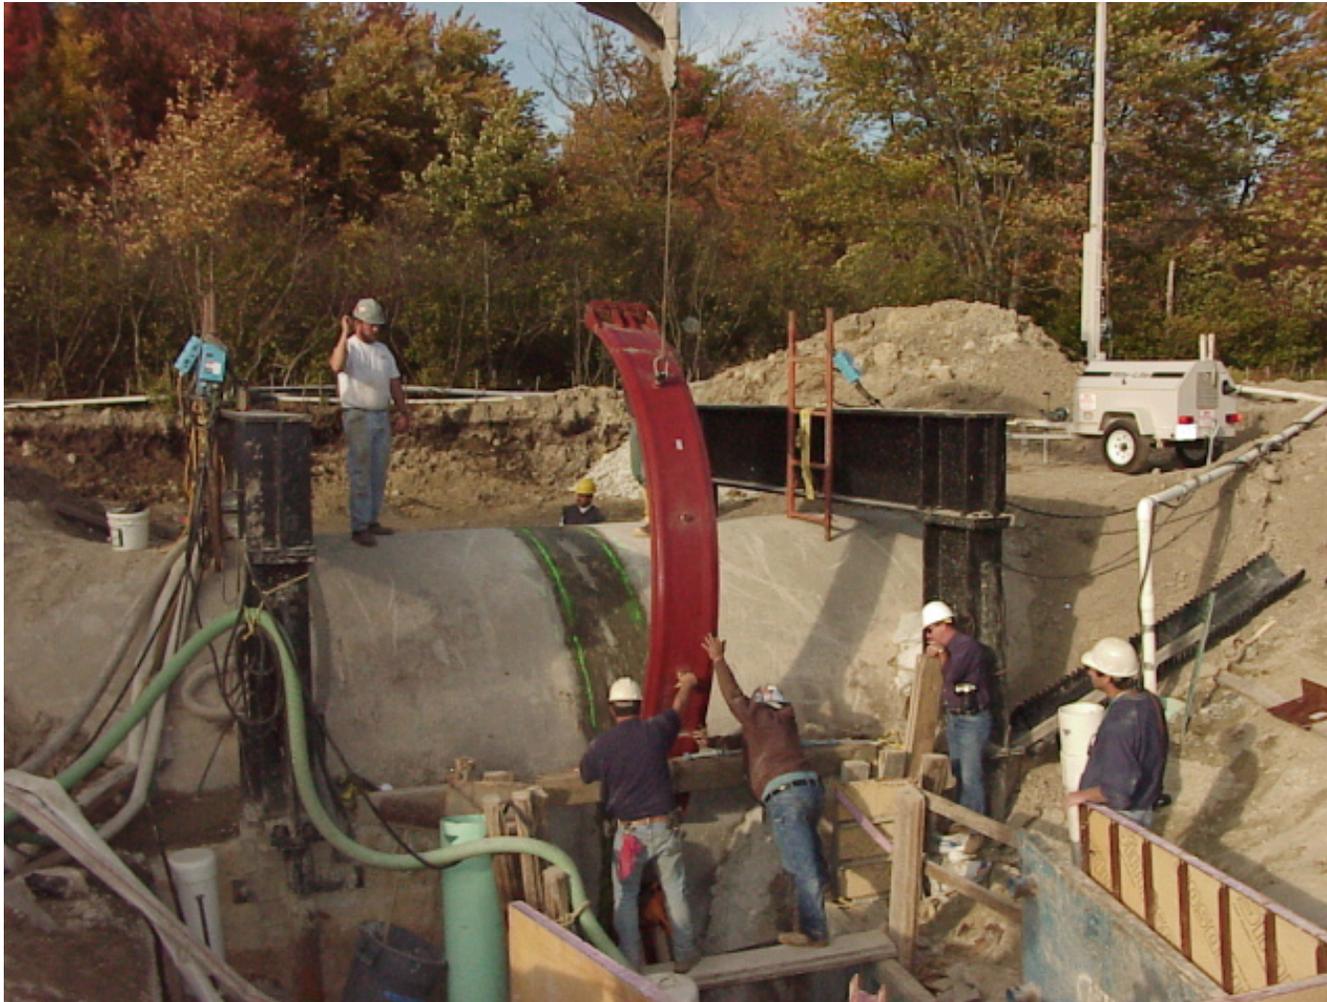
Repairs to the Worst Leak Gingerly Undertaken

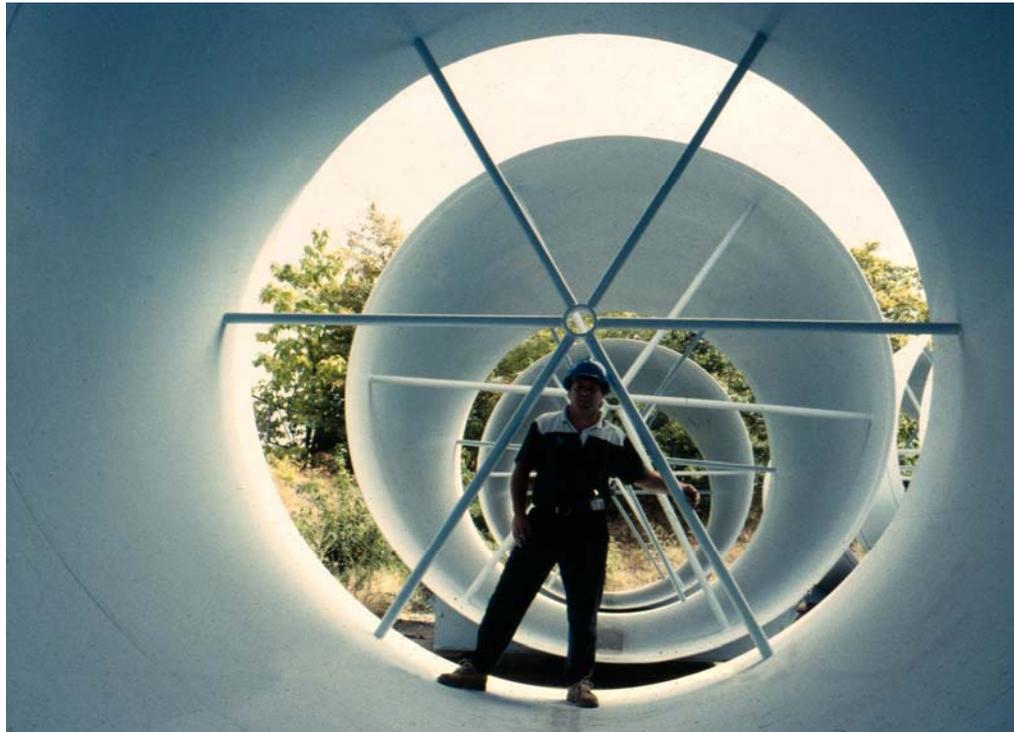
Contingency Planning for Catastrophe

- Detailed Response Plans Developed
- Drills Conducted - Table Top and Full Field Exercises
- Closure Pieces and Enough Pipe to Start Repairs Pre-Purchased
- Still Not Nearly Enough for Peace of Mind

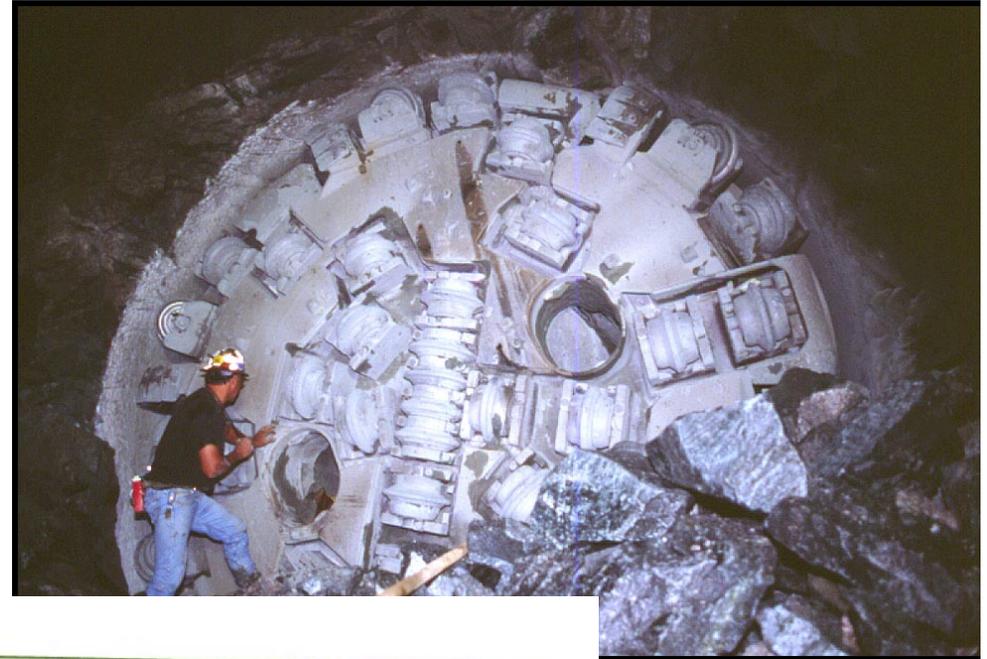
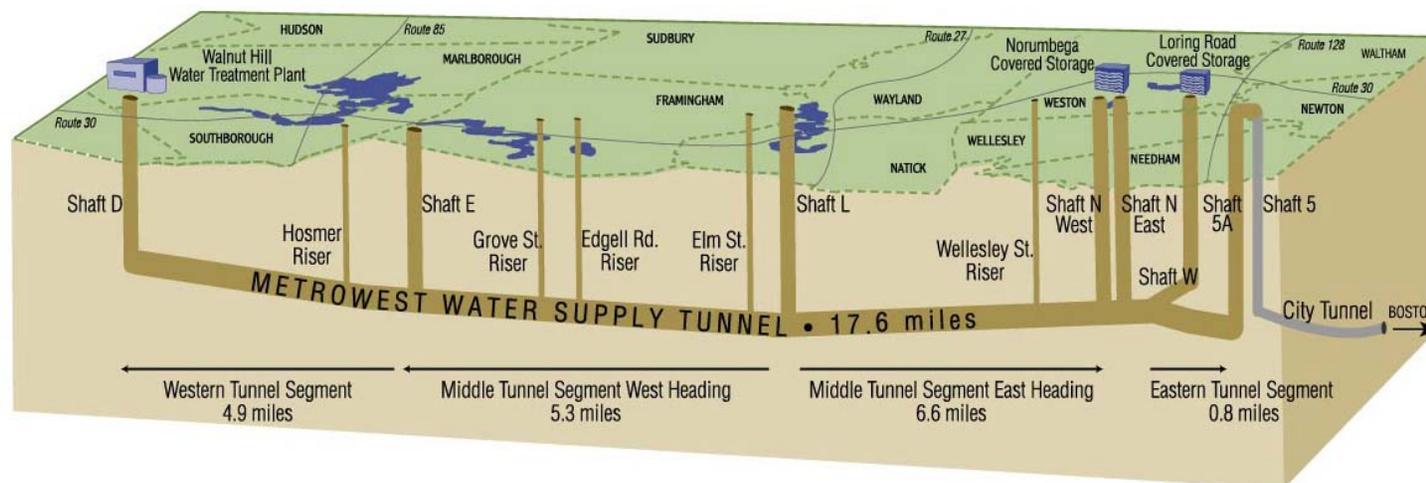
MetroWest Water Supply Tunnel

- 17.3 miles long
- Constructed 1995 to 2003
- Cost \$680 million
- Connects new WTP and new covered storage

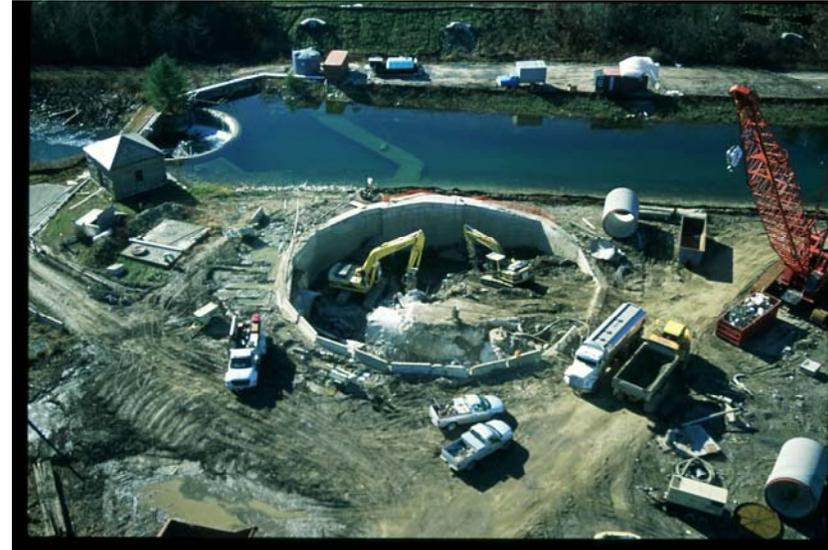
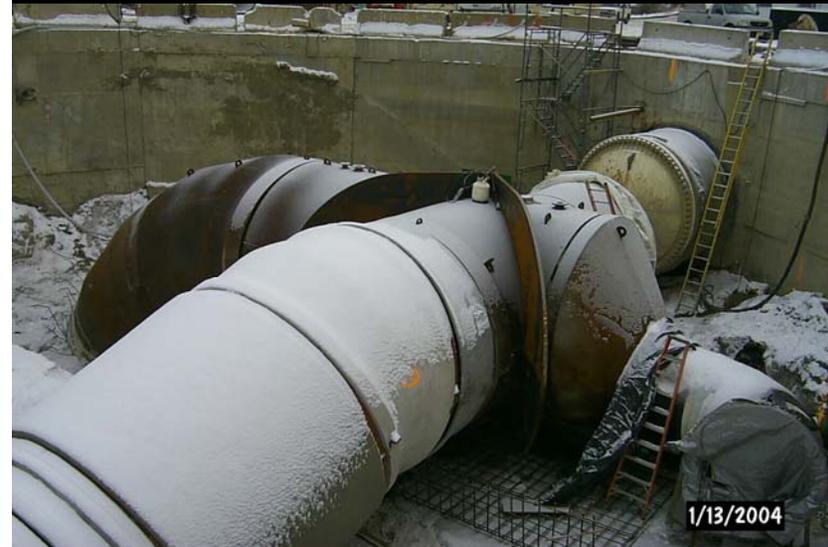
Connection Planning Critical

- Connecting New to Old Was a Major Effort
- Significant Investment in Temporary Facilities
 - Interconnects
 - Disinfection
 - Disposal of Water
- Capacity Analysis Forced Work During Winter Months
- Detailed Contingency Planning
- Missing Drop Dead Date for Start Would Have Caused a Full Year Delay in Start-Up

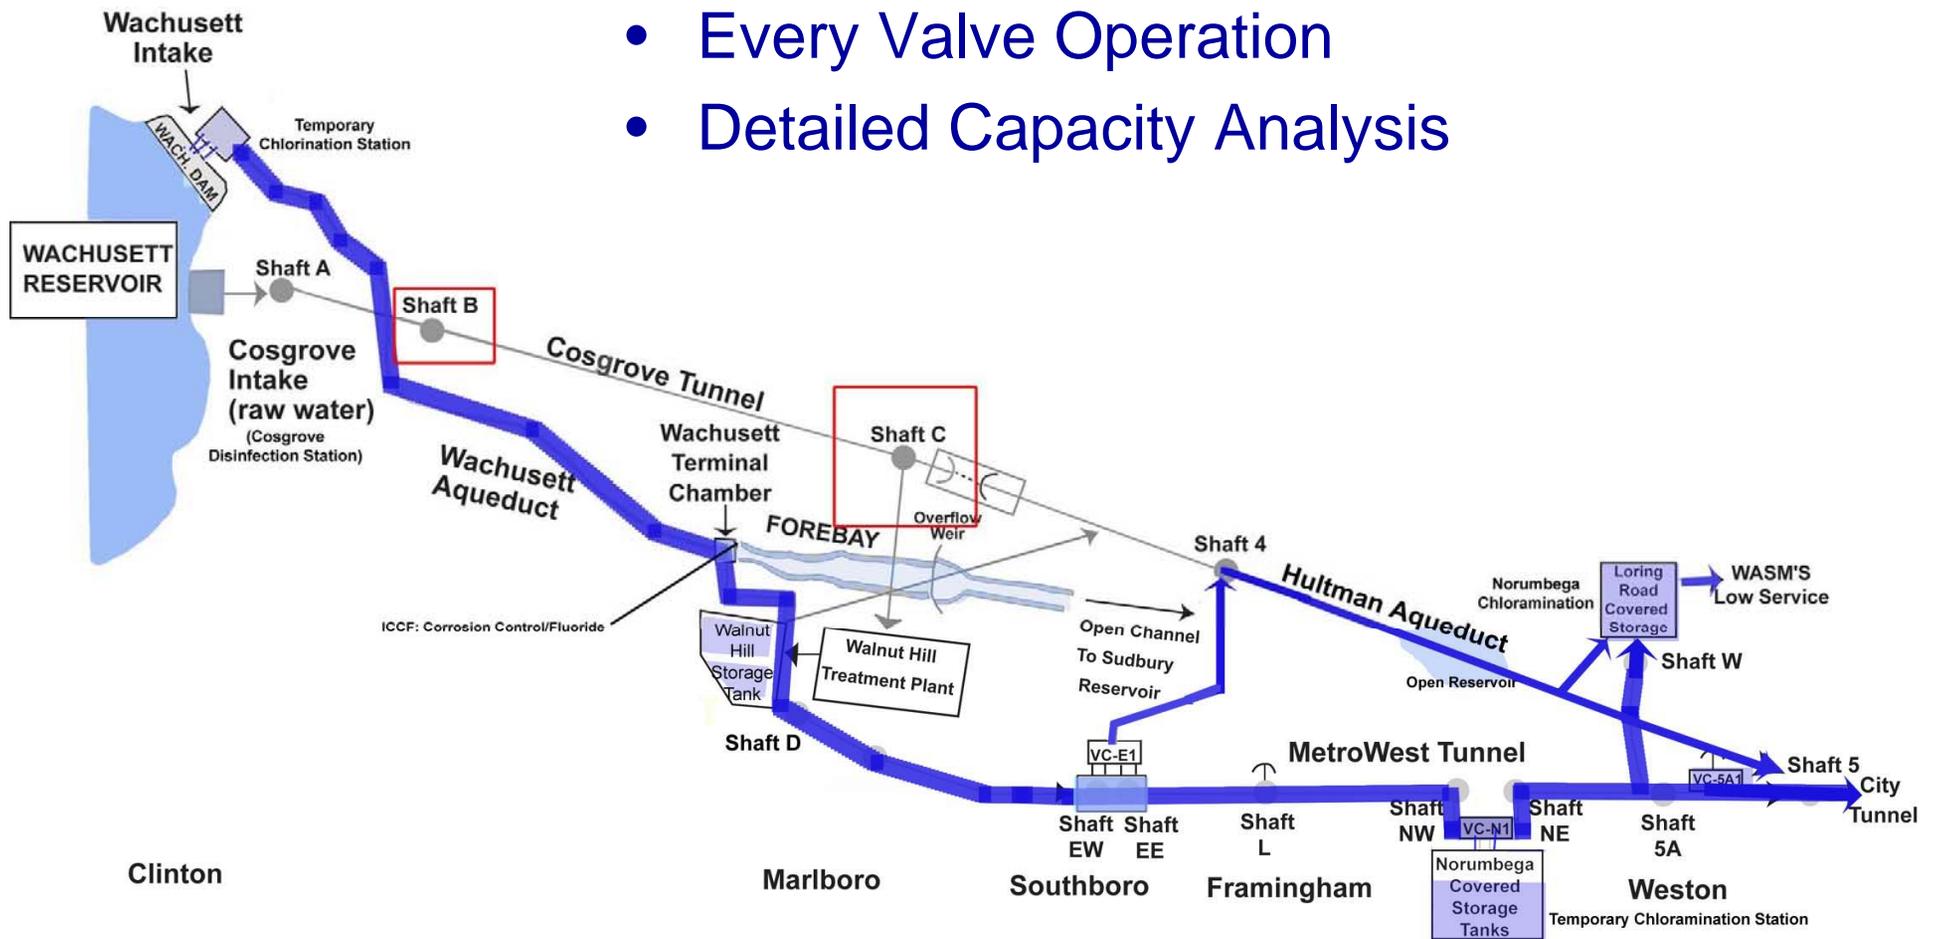
Phase 2

Detailed Planning For Connections and Transitions

- Hour by Hour Analysis
- Every Valve Operation
- Detailed Capacity Analysis

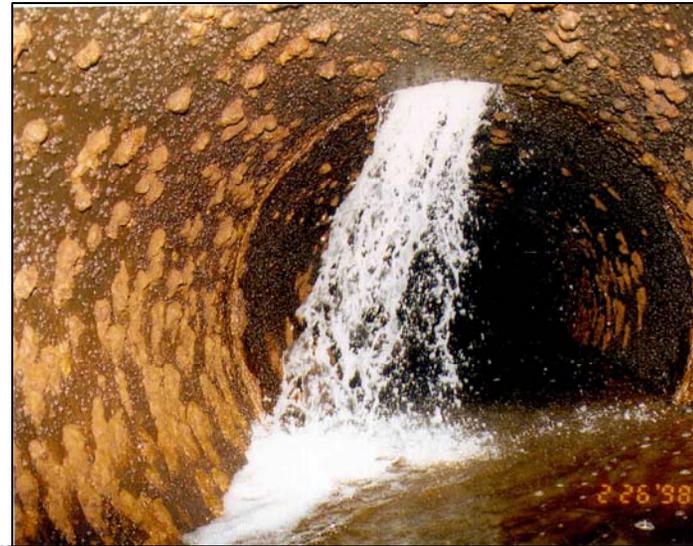
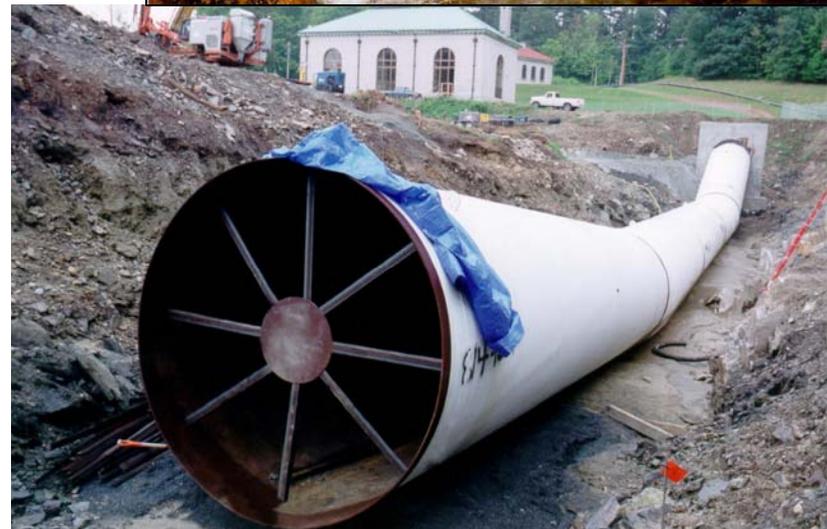
Rehab Hultman and Interconnect

- Don't Make Same Mistake Again
- Full Inspection and Rehab of Old Conduit
- Several Interconnection Points
- Ability to Do Partial Shut Downs of Both New Tunnel and Old Aqueduct
- Run Both in Parallel

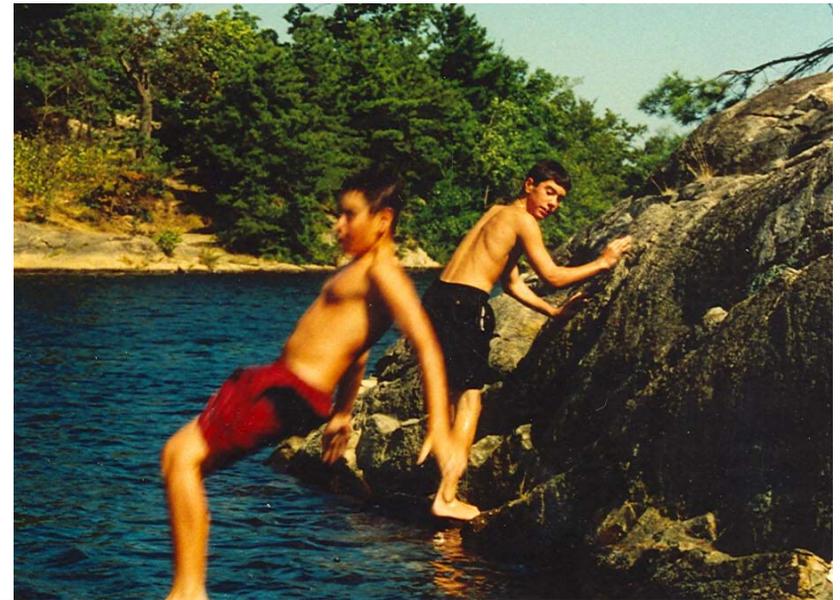
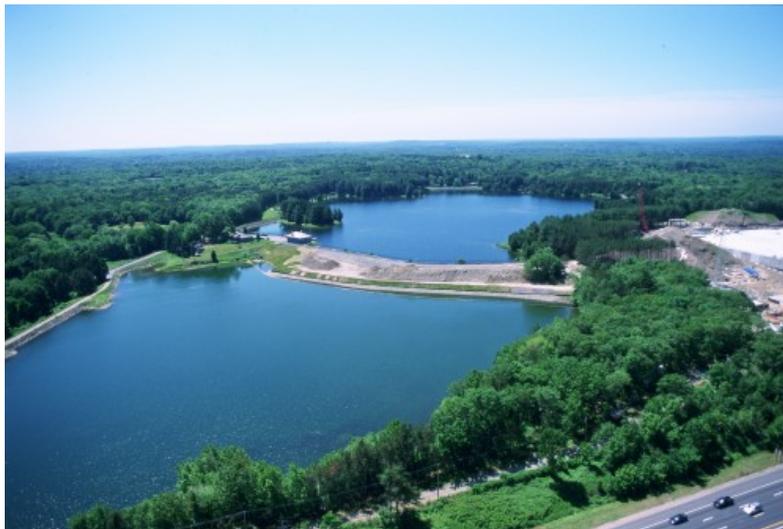
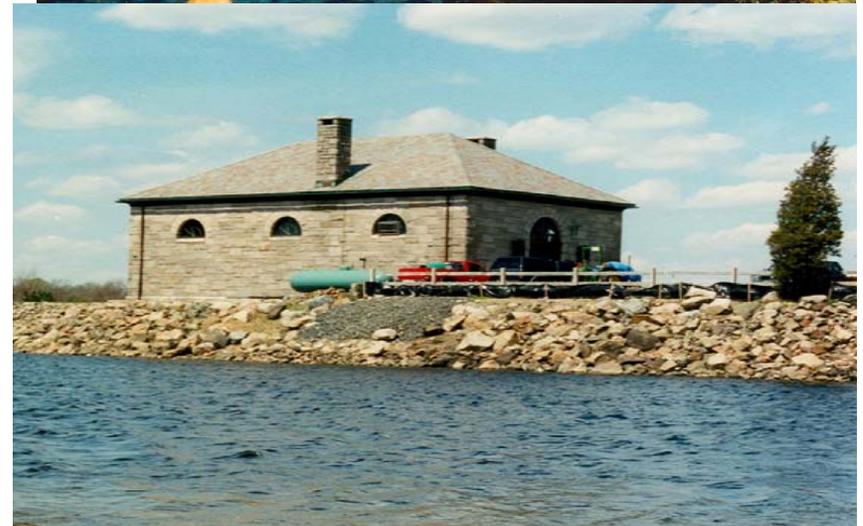
Open Reservoirs Offer Opportunities for Degradation

- Classic Unfiltered System Design
- Modern Water Quality and Security Concerns
- People, Animals, Pathogens and Chemicals
- Just Plain Changed Chemistry

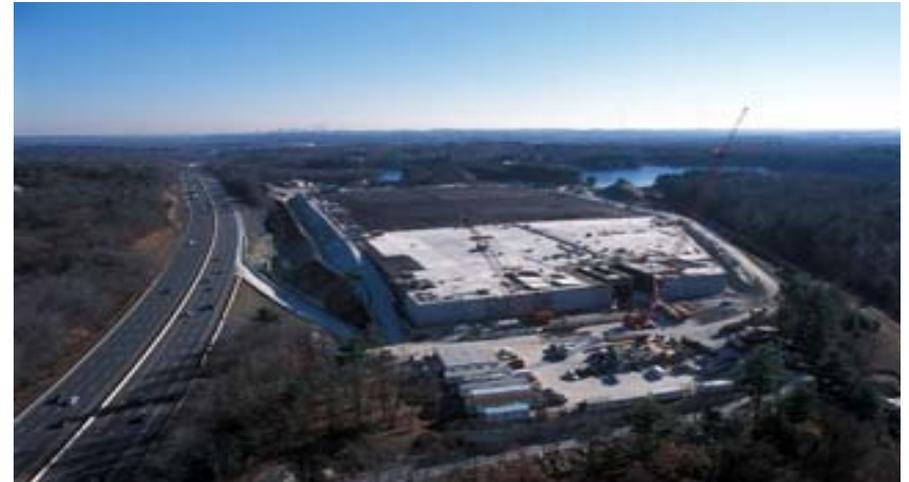
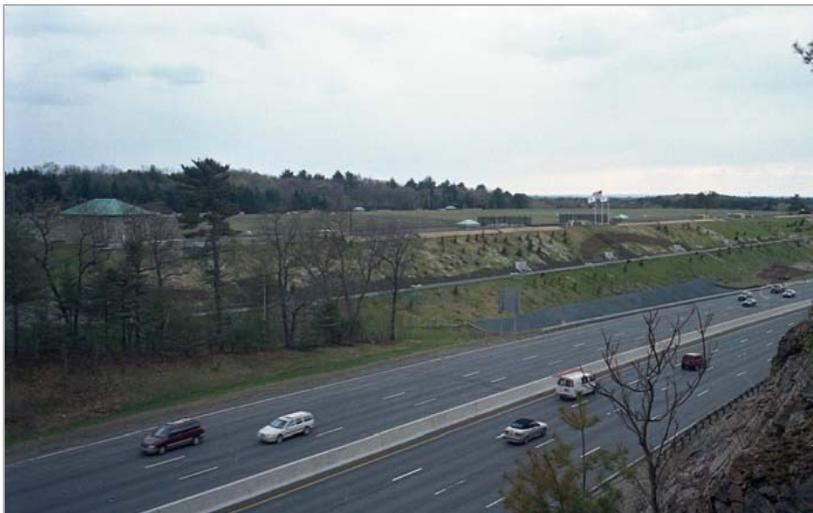
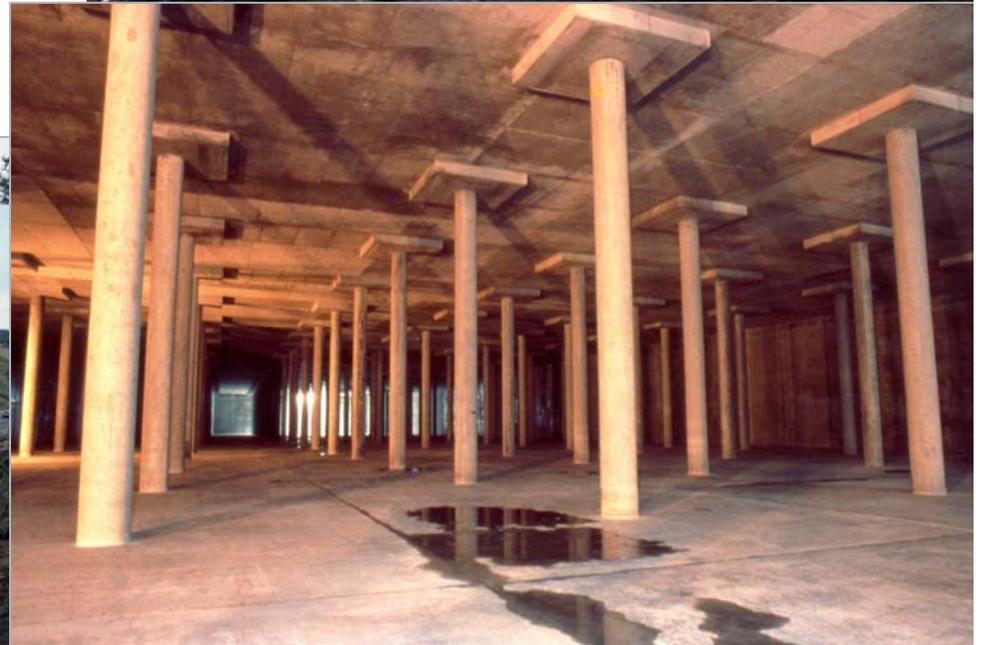
New Covered Storage

- From 10 Days Open Storage to 1 Day Covered Storage
- 6 Major Tanks from 20 to 115 million gallon capacity
- More Stable Water Quality
- Reduced Use of Chlorine
- Better Total Coliform Results

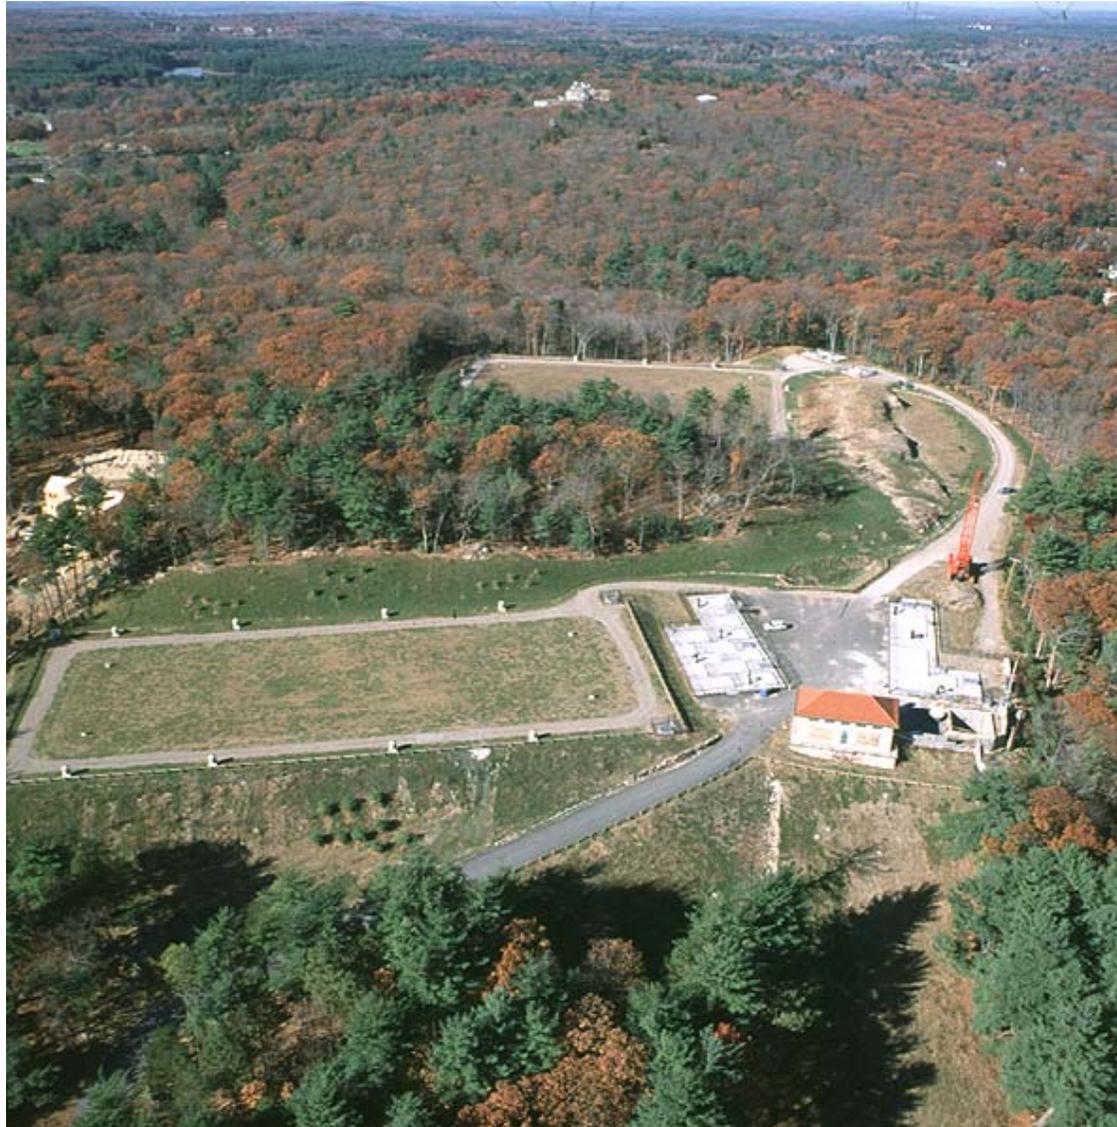
Buried Tanks Become Meadows

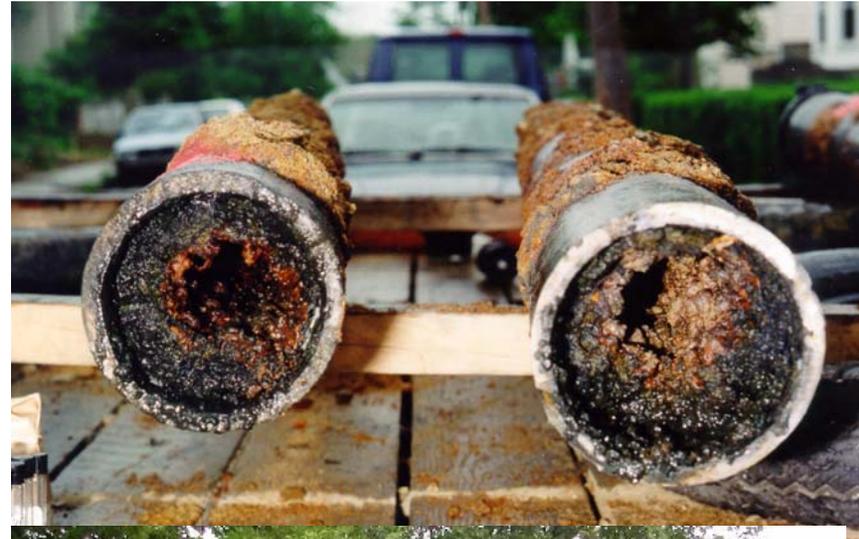
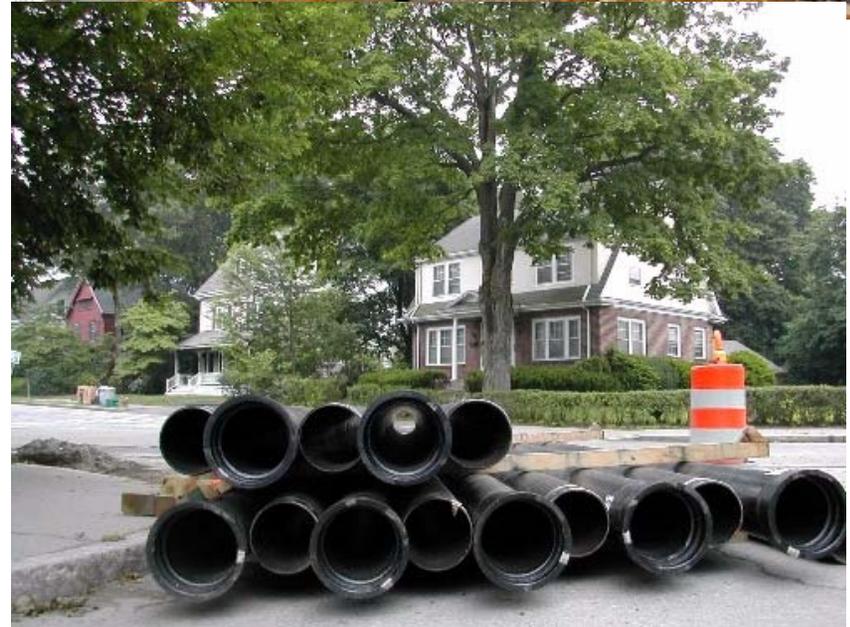
Pipes Are a Weak Link

- In 1993, Median Age of MWRA pipes was 85 years
- Over 80 Percent Unlined
- Half of valves were suspect
- More than half of community pipes were unlined
- Rehab of 2.5% per year on MWRA
- \$250 Million Zero-Interest loan program for community pipes

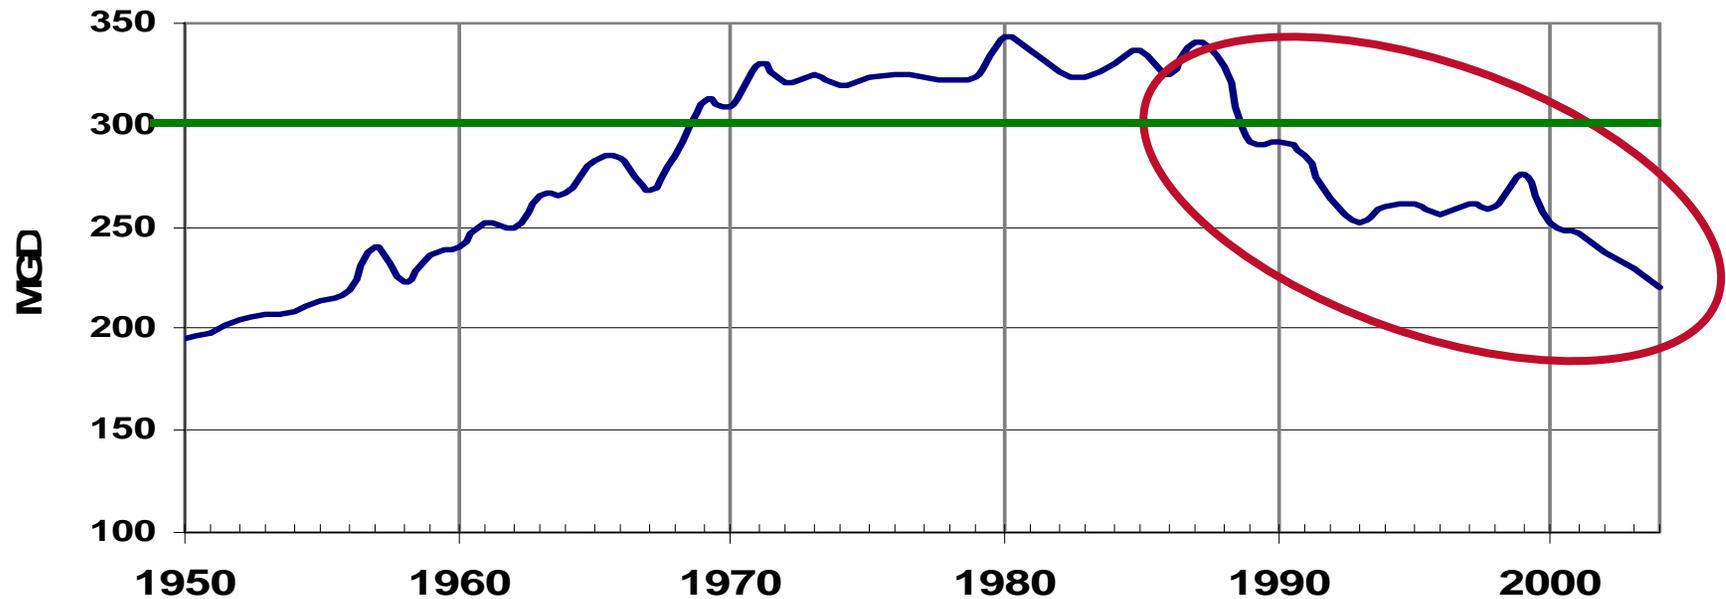
MWRA Annual Average System Demand

Dramatic Reductions in Demand Reduce Cost and Anxiety

- From 10% over Safe Yield to Almost One Third Under
- Treatment Plant Down-sized
- No Supply Plans On Books, In Fact, Looking For New Communities
