## 9.4 TOWN OF OLIVE

### 9.4.1 TOWN OF OLIVE PROJECT DESCRIPTION

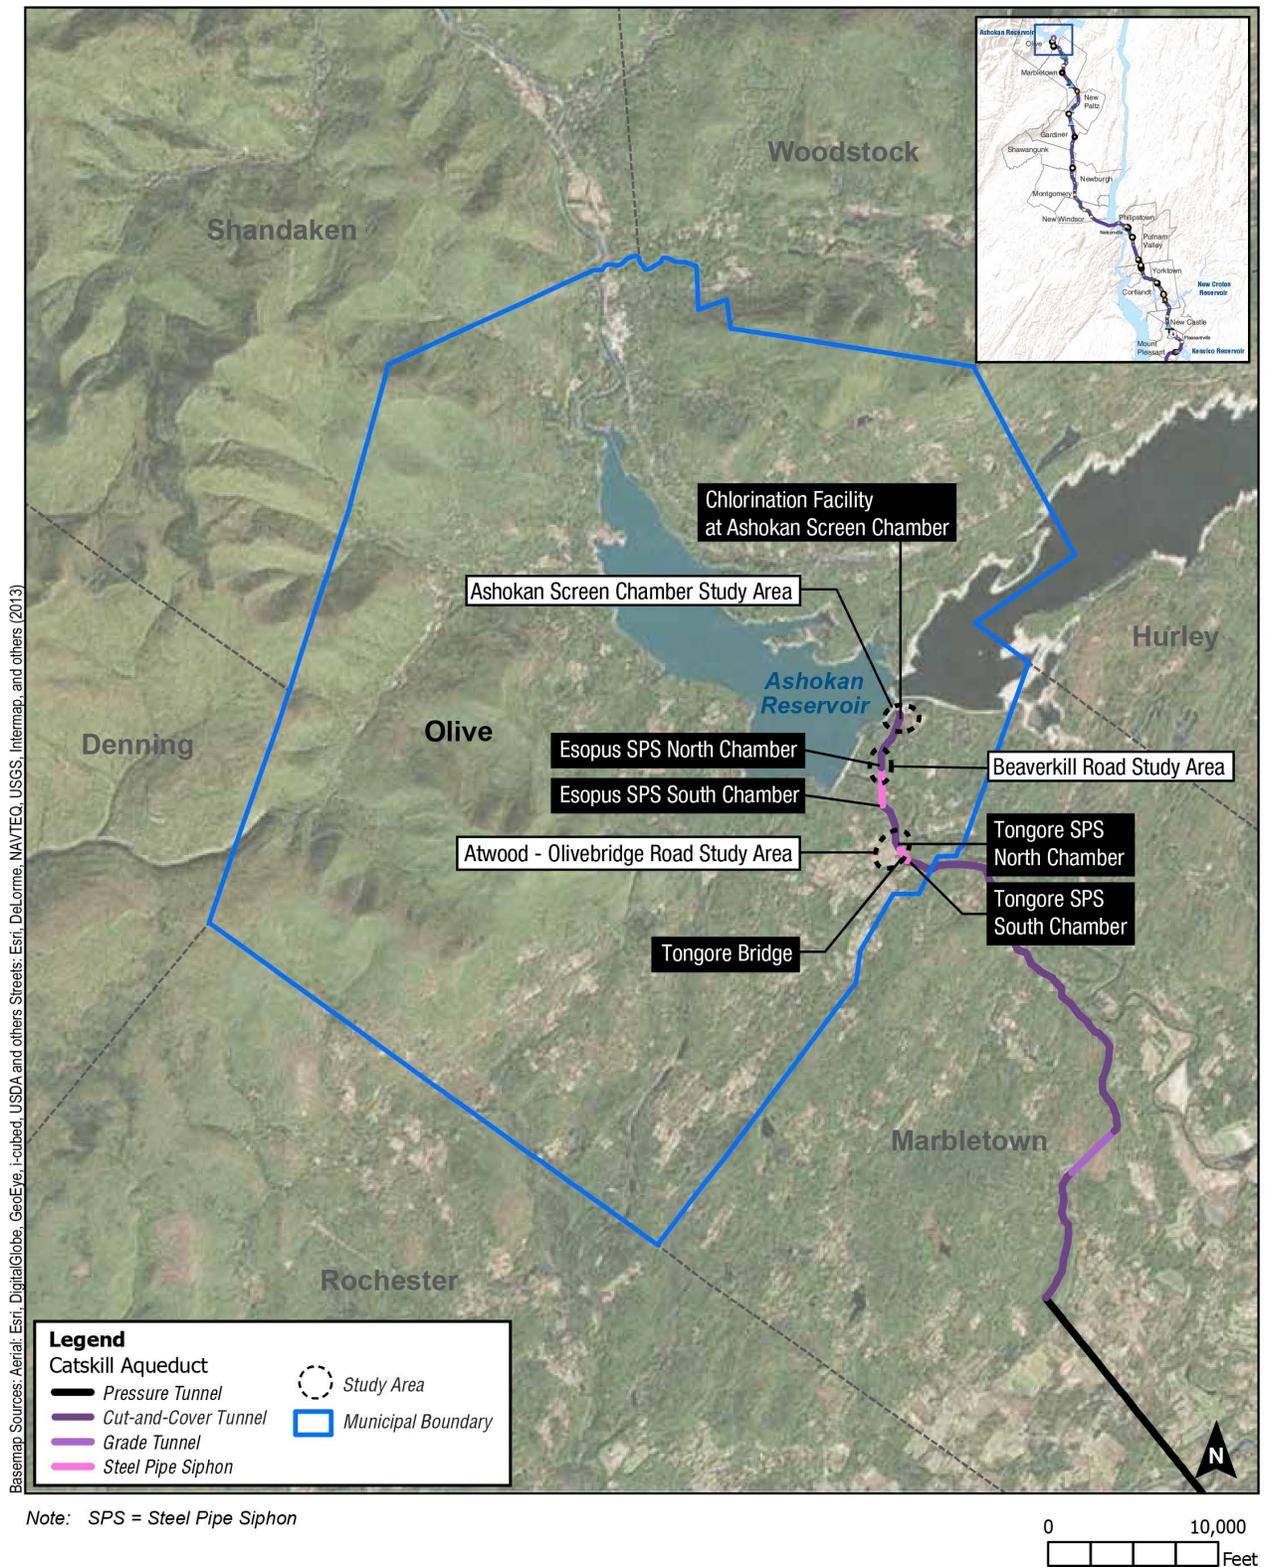
Figure 9.4-1: Town of Olive Study Areas

The Catskill Aqueduct stretches for approximately 2.3 miles in a southerly direction through the Town of Olive. Notable sites along the Catskill Aqueduct within the town include Ashokan Reservoir, Ashokan Screen Chamber, the Esopus Steel Pipe Siphon North and South Chambers, the Tongore Steel Pipe Siphon North and South Chambers, and Tongore Bridge. Proposed activities in the Town of Olive would occur within three study areas as shown in **Table 9.4-1**.

These three study areas in the Town of Olive encompass the majority of work that would occur as part of the repair and rehabilitation in this municipality. Additional work activities in the town do not warrant further analysis. Work sites located outside the study area include activities that would primarily be conducted within the aqueduct interior (see Section 9.3, “Screening Assessment and Impact Analysis Methodology”). In the Town of Olive, they include biofilm removal and condition assessment at access manholes not located in these study areas. See Section 9.2, “Project Description,” for an overall project description of the repair and rehabilitation. Section 9.4.2, “Town of Olive Impact Analysis” provides a discussion of local regulations in the Town of Olive’s jurisdictional limits. The following sections provide a description of the study area, proposed activities, and impact analysis for the three study areas:

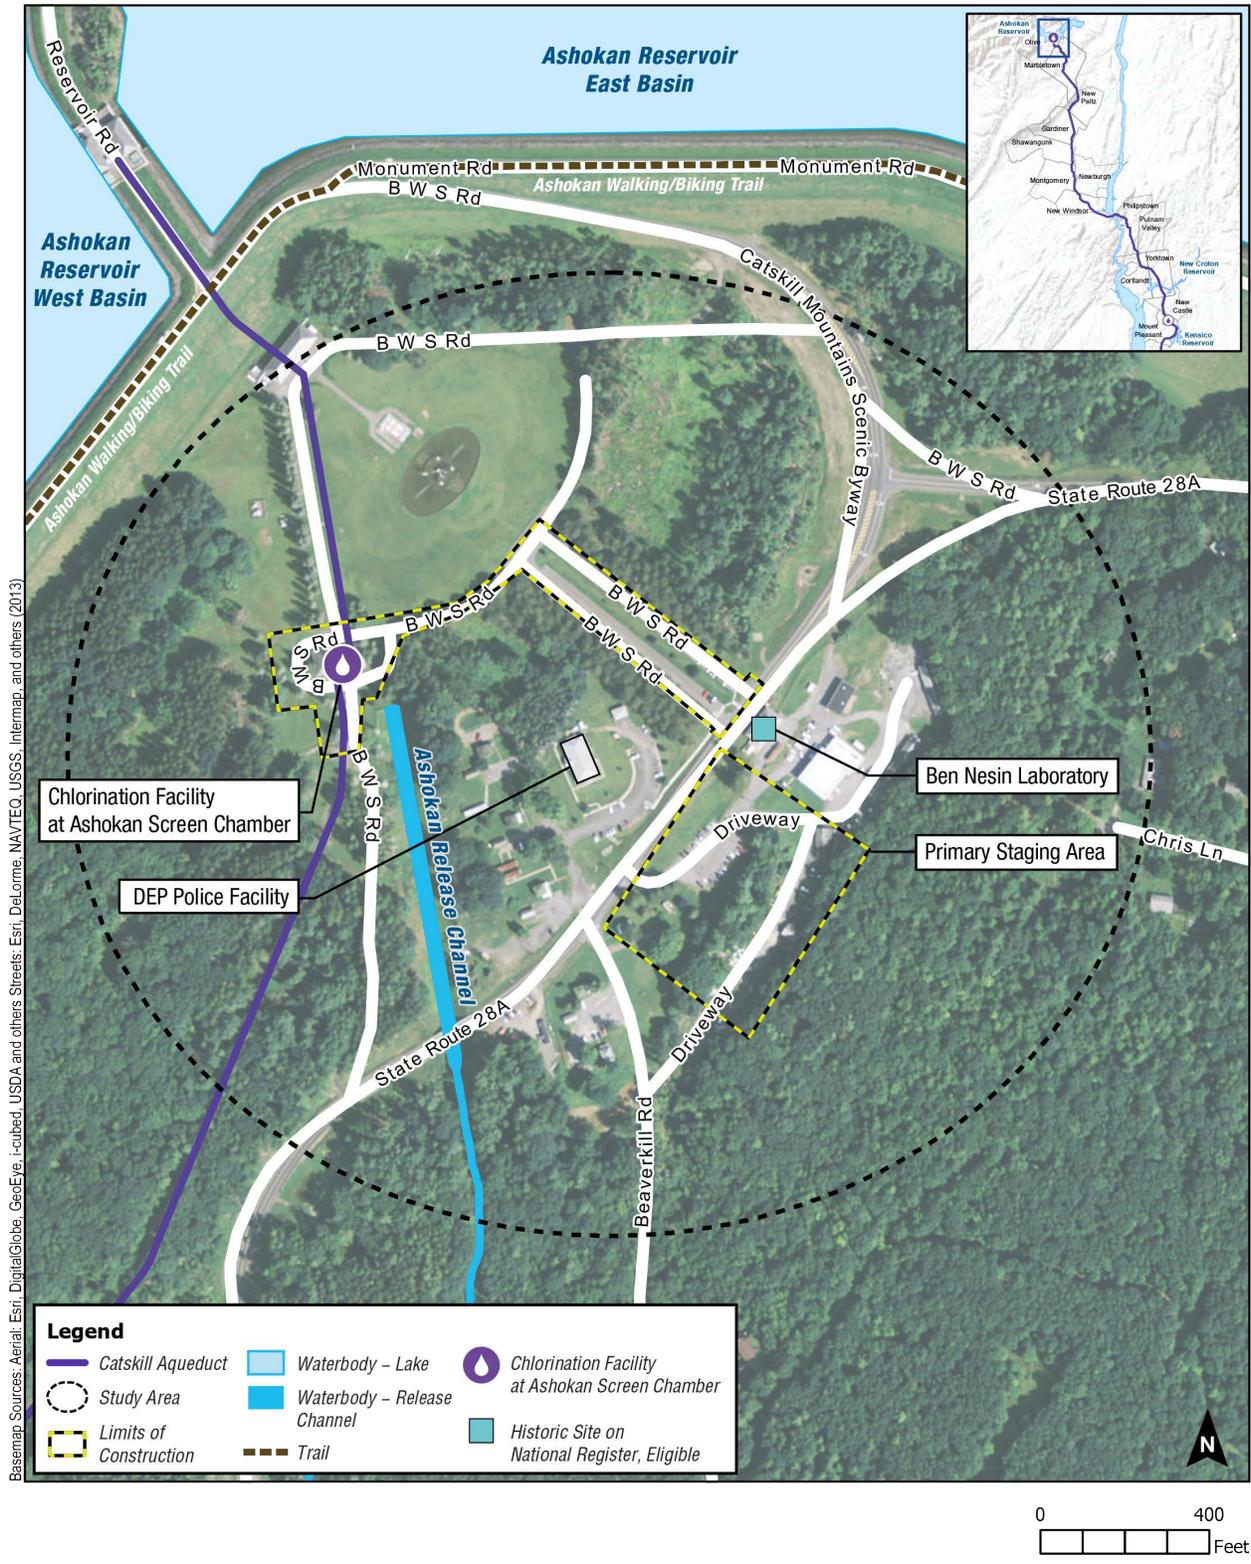
Figure 9.4-2: Study Area – Ashokan Screen Chamber

Work activities within the Ashokan Screen Chamber Study Area would include: establishment and use of a primary staging area; construction, start-up, testing, and operation of a new chlorination facility to provide temporary addition of chemical oxidants to the aqueduct; and biofilm removal and condition assessment.

For construction of the chlorination facility, two staging areas would be established: one in a grassy area adjacent to the Ashokan Screen Chamber and a second on BWS Road for contractor trailers. For the repair and rehabilitation, three staging areas, two to the south of State Route 28A and one on BWS Road, would collectively form a primary staging area for contractor trailers and parking to support construction activities along the first 18 miles of the aqueduct. The primary staging area would be established in 2017 and would be available for the duration of the repair and rehabilitation. Erosion and sediment control measures, such as silt fencing and hay bales, would be installed at the perimeter of the work sites as needed. A site plan showing a layout of the limits of construction for the work sites, which would occupy a total of approximately 8.8 acres, is shown on **Figure 9.4-6**. The schedule for work within the study area is shown in **Table 9.4-2**. The duration of active construction within the Ashokan Screen Chamber Study Area is estimated to total approximately 100 weeks over 3 years, with some overlapping work activities. During this time, the aqueduct would continue to be operated in accordance with the Interim Ashokan Release Protocol (or its successor).

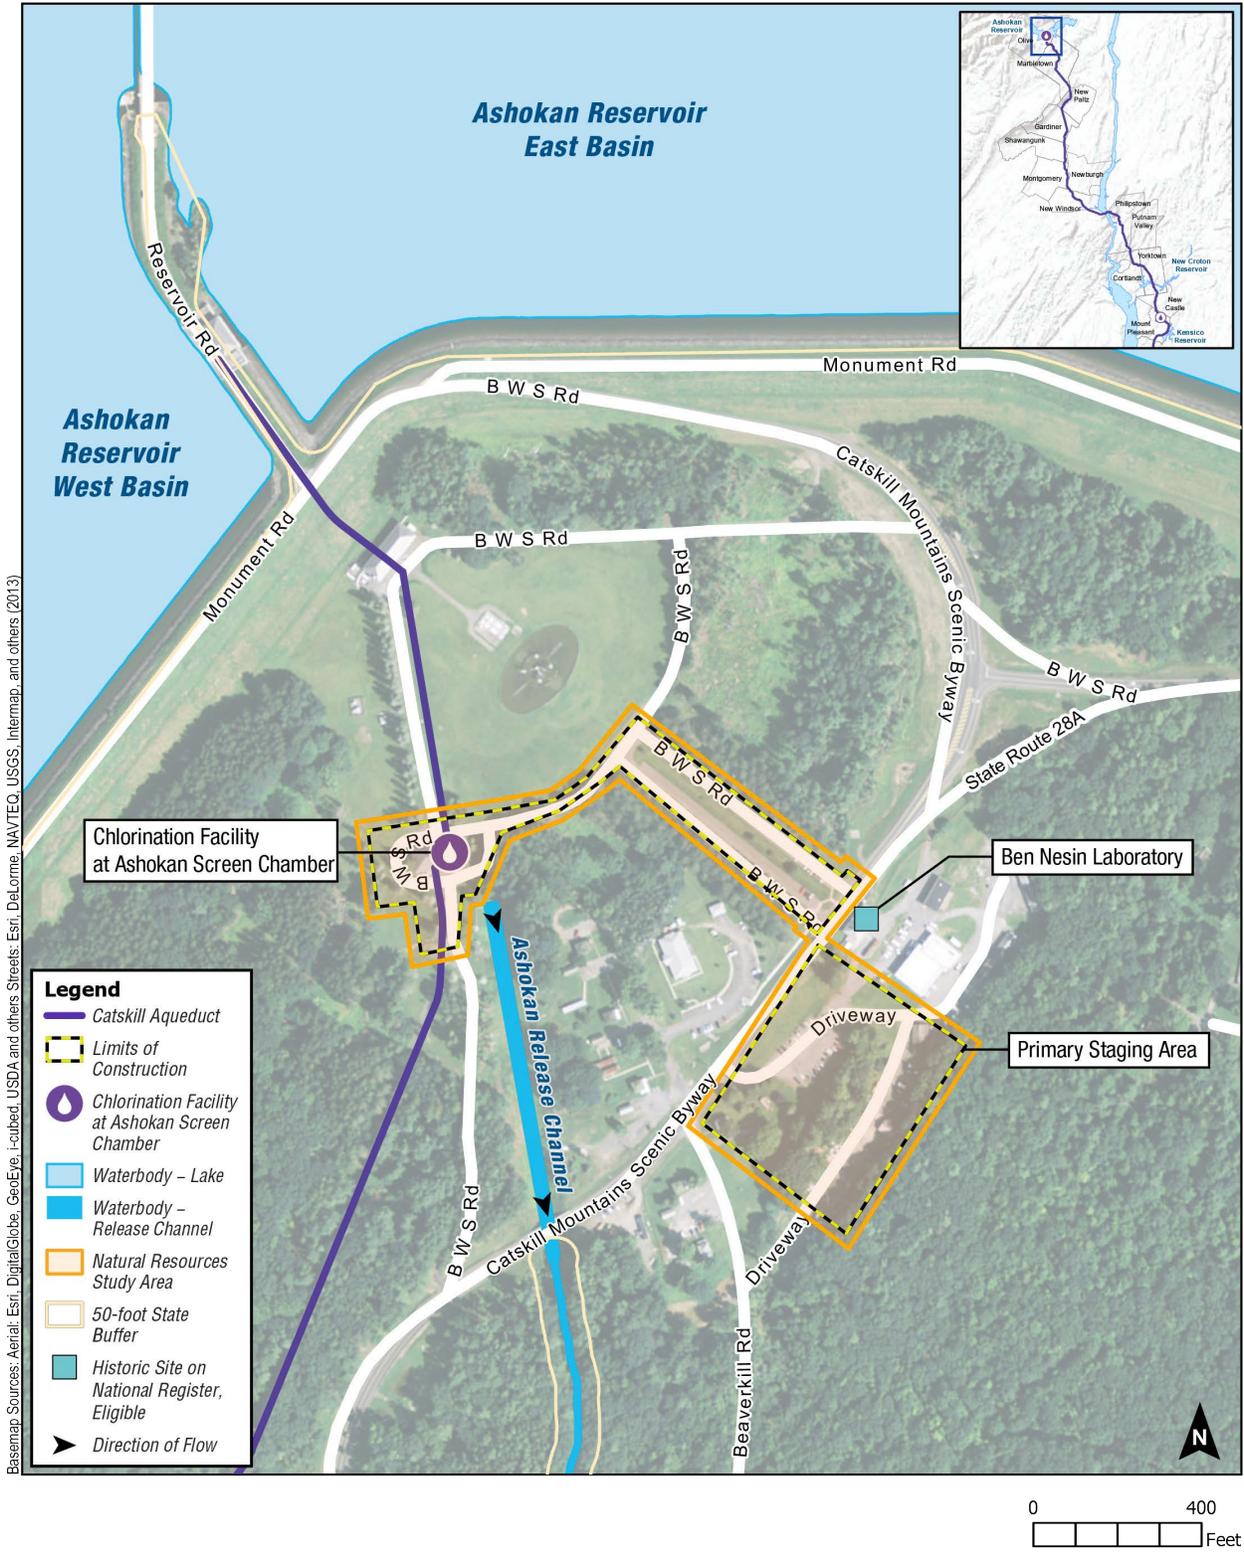
Figure 9.4-9: Natural Resources - Ashokan Screen Chamber Study Area

There are a few ornamental spruce trees around the Ashokan Screen Chamber. The edge of a forested community best characterized as hemlock-northern hardwood forest is located within the primary staging area. The hemlock-northern hardwood forest observed during field visits is not mapped as a significant natural community by the NYNHP database. While the Town of Olive does not regulate the removal of trees associated with the repair and rehabilitation, these terrestrial resources within the study area warrant an analysis.

In the future with the repair and rehabilitation, work activities would include minor tree clearing at the Ashokan Screen Chamber to expand the driveways for chemical deliveries. Five ornamental spruce trees adjacent to the building, with an average diameter at breast height (dbh) of 21 inches, may be removed. All tree removal would be conducted from November 1 through March 31 to avoid impacts to Indiana bats (*Myotis sodalis*) and northern long-eared bats (*Myotis septentrionalis*). Removal of these ornamental trees would not affect terrestrial resources in the study area, therefore, tree replacement is not proposed. The area is currently developed as a DEP facility for operating the Catskill System. Grading of the areas outside of the driveway and in the primary staging area would be conducted in a manner that limits disturbance to nearby trees.

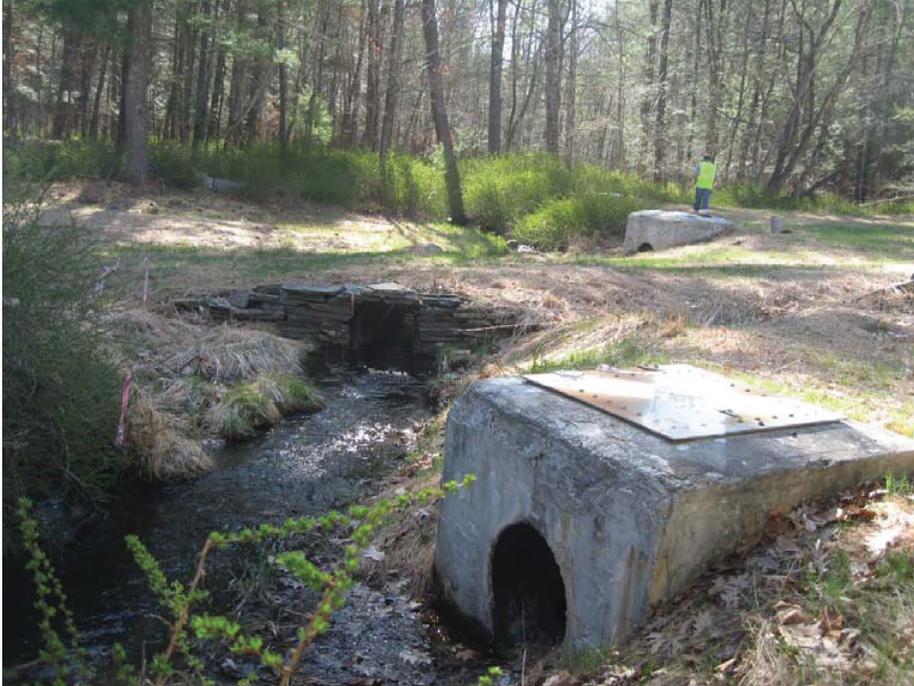
**Photograph 1:** West and middle siphon blow-off chambers in the relic channel of Esopus Creek. Existing stream crossing located between the two blow-off chambers.

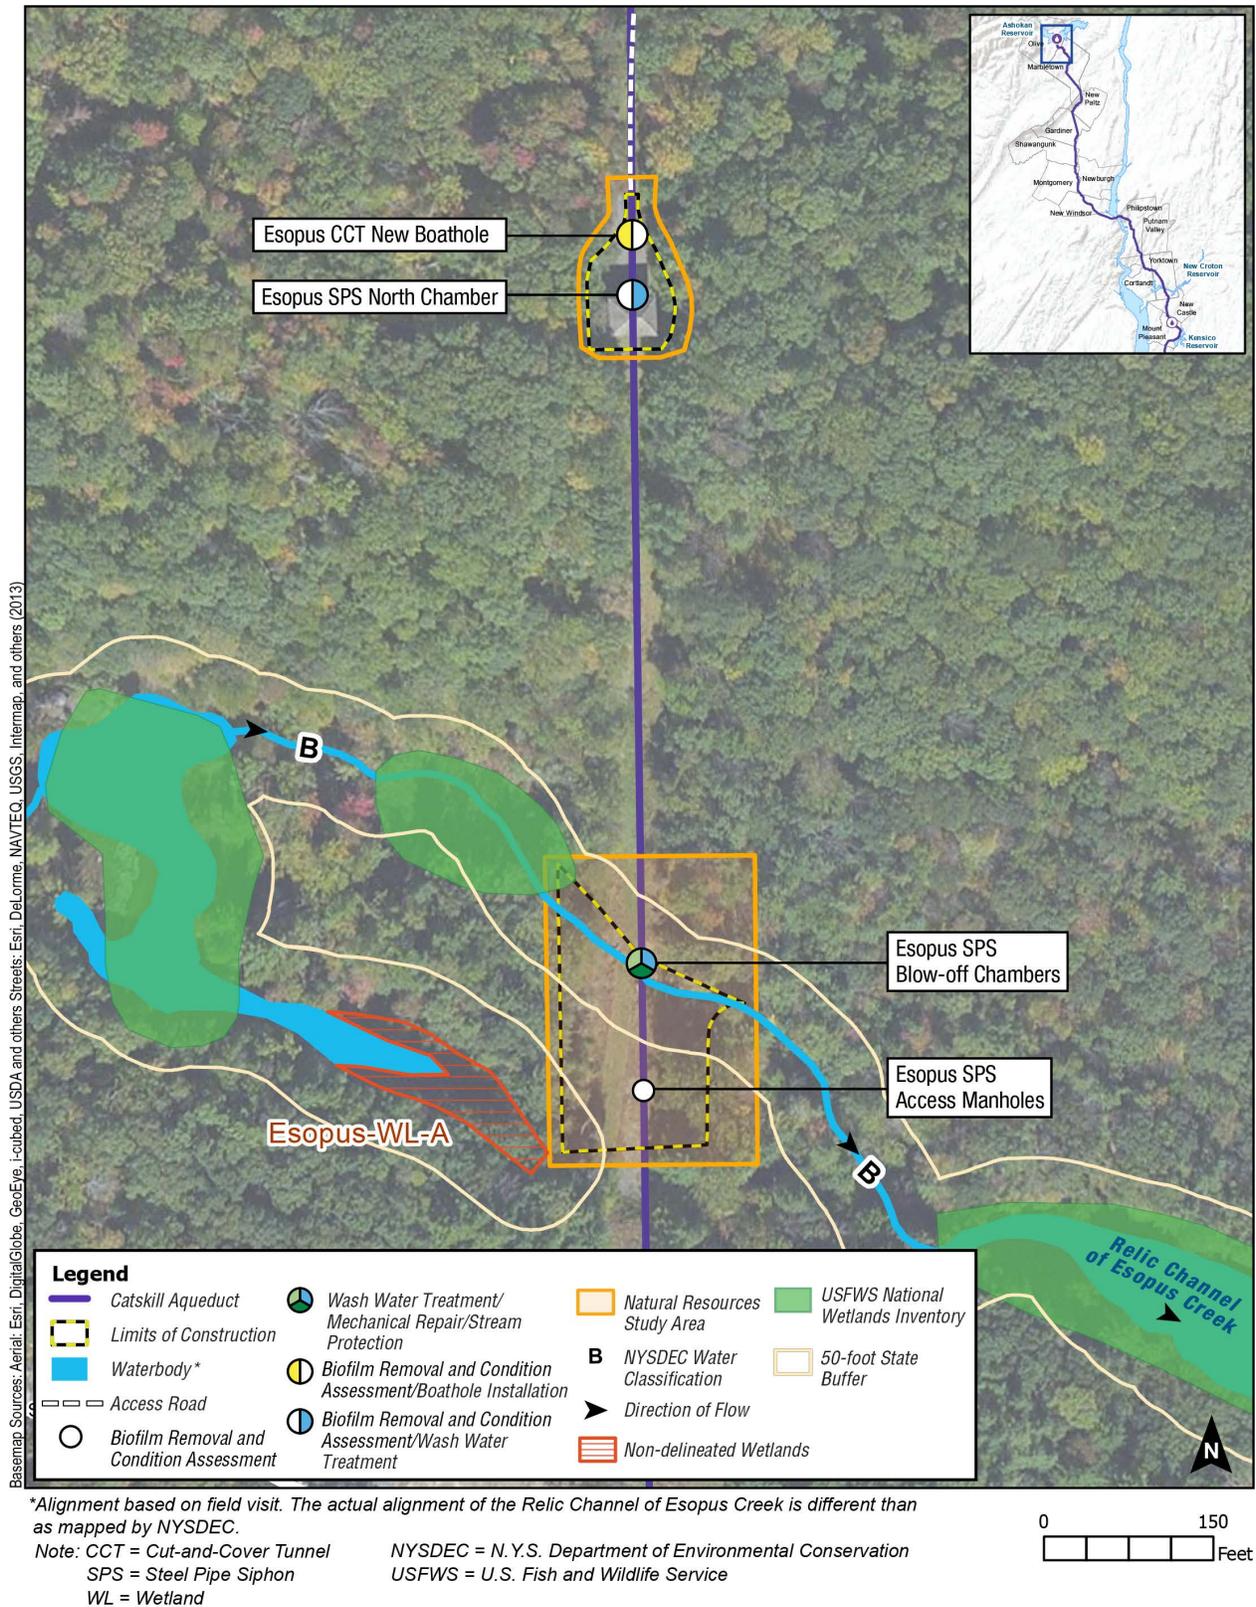
**Figure 9.4-20: Natural Resources for Esopus SPS North Chamber and Blow-off Chambers - Beaverkill Road Study Area**

As shown on **Figure 9.4-20**, the study area for the natural resources analysis is comprised of two sections. One of these sections includes the limits of construction, including the area required for staging, clearing and grading for boathole installation, wash water treatment and biofilm removal and condition assessment at the North Siphon Chamber. Another section to the south includes limits of construction for the area required for staging, streambank protection measures (i.e., riprap aprons), wash water treatment, and biofilm removal and condition assessment for the Blow-off Chambers. A third section of the study area located at the South Siphon Chamber

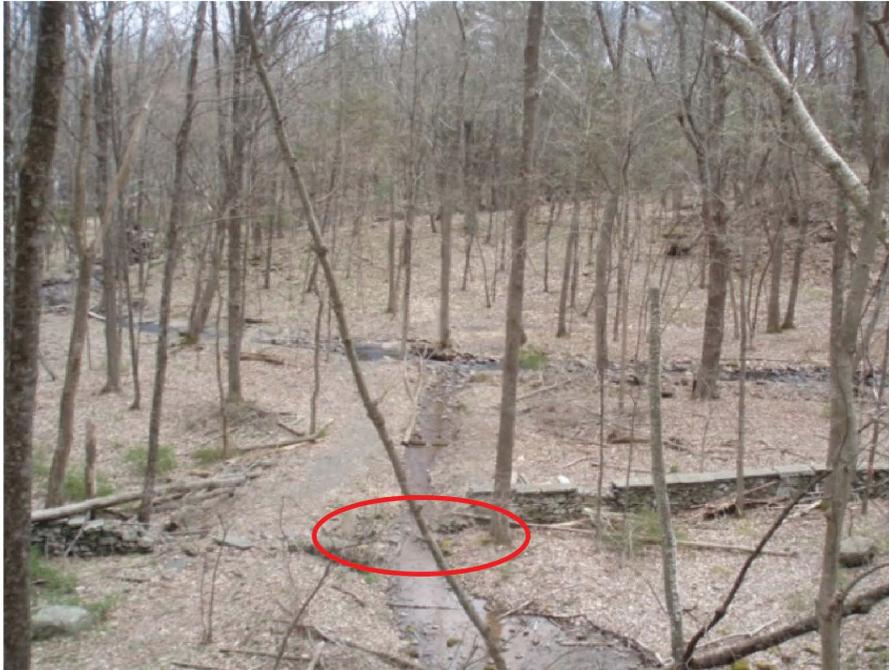
**Photograph 1:** Leaks 1A and 1B merge near the rock boundary wall (red circle) and flow into Hendricks Killitje, a tributary of the lower Esopus Creek, visible in the background. Photograph facing east.

Leak 1B is located approximately 30 feet south of Leak 1A, as depicted on **Figure 9.5-4**. The Leak 1B flowpath, 1B-FP, flows east approximately 15 feet within an undefined channel, then flows northward beneath a rock wall for approximately 40 feet before converging with the flow from 1A-FP and entering Hendricks Killitje.

After the leak flows merge with the Hendricks Killitje (see Photograph 2 on **Figure 9.5-3**), the watercourse flows eastward beyond the study area beneath a culvert under Atwood Road to lower Esopus Creek. The maximum observed flow of the combined leaks is approximately 12.7 gpm (or approximately 18,000 gpd).

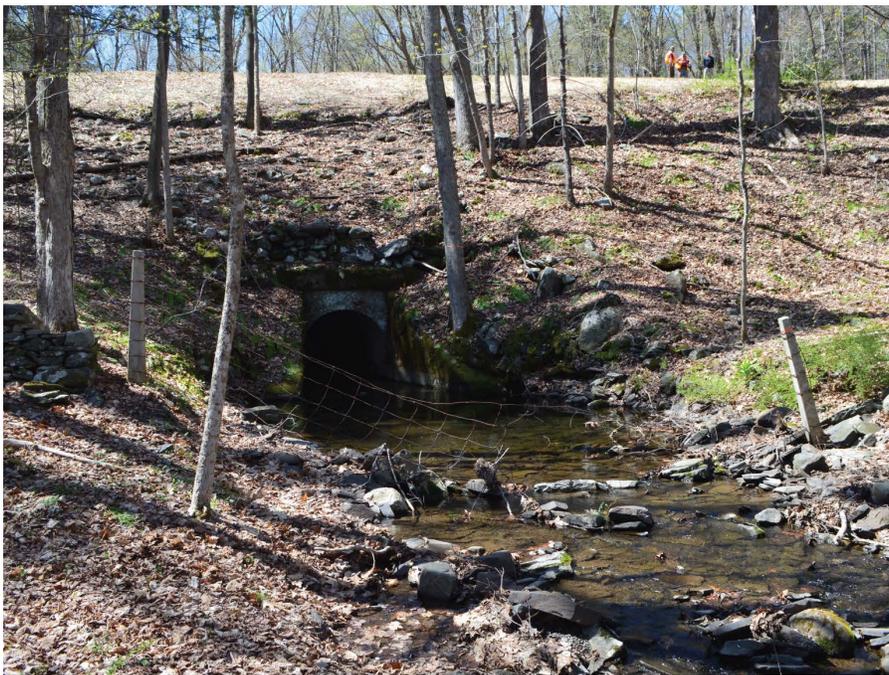
**Photograph 2:** Hendricks Killitje flowing through the culvert under the Catskill Aqueduct. Approximate location of the temporary stream crossing, upstream of the confluence with Leaks 1A and 1B.

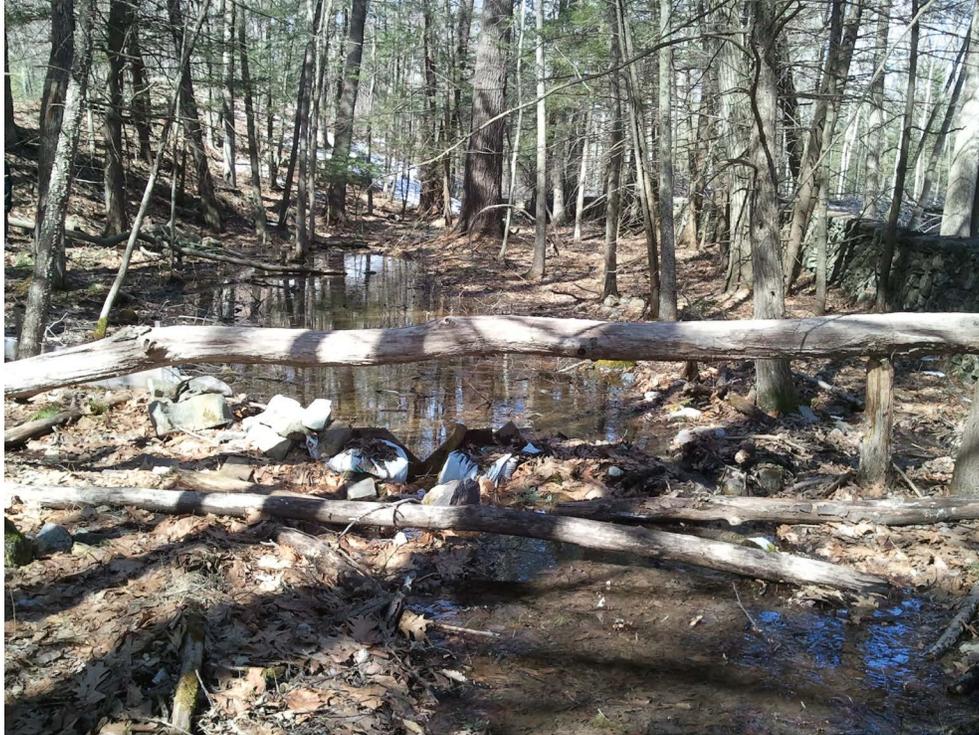
**Figure 9.5-5: Photograph – Leak 2 – Vly Atwood Road Study Area**

**Photograph 3:** Poned area at Leak 2 flowing towards the weir. Photograph taken facing north.

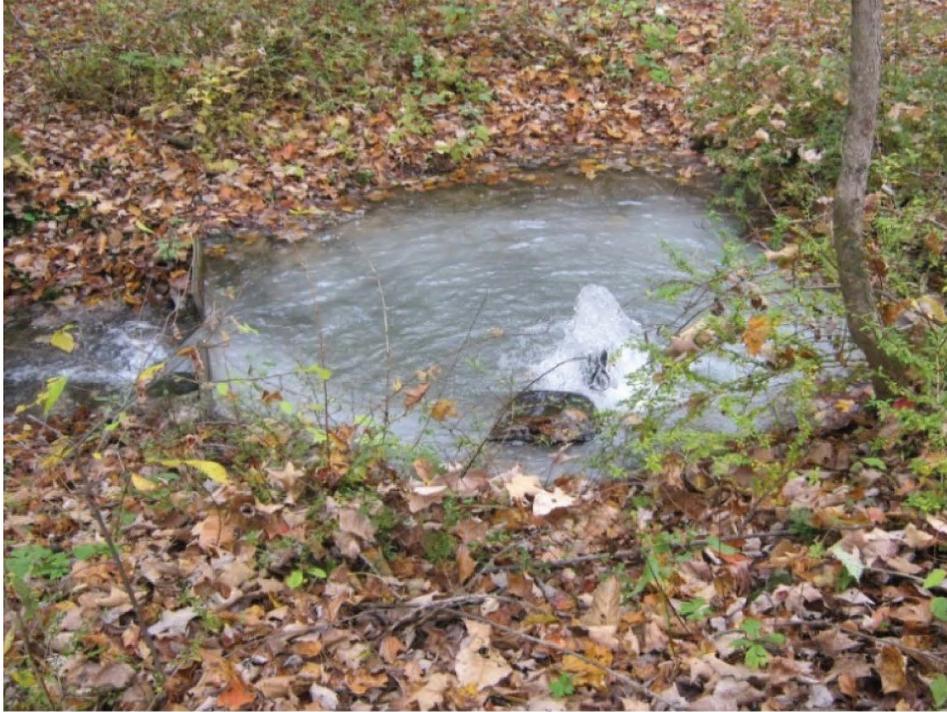
**Photograph 1:** Leak 3A flows through weir into well-defined shallow channel, referred to as Flowpath 3A-FP.

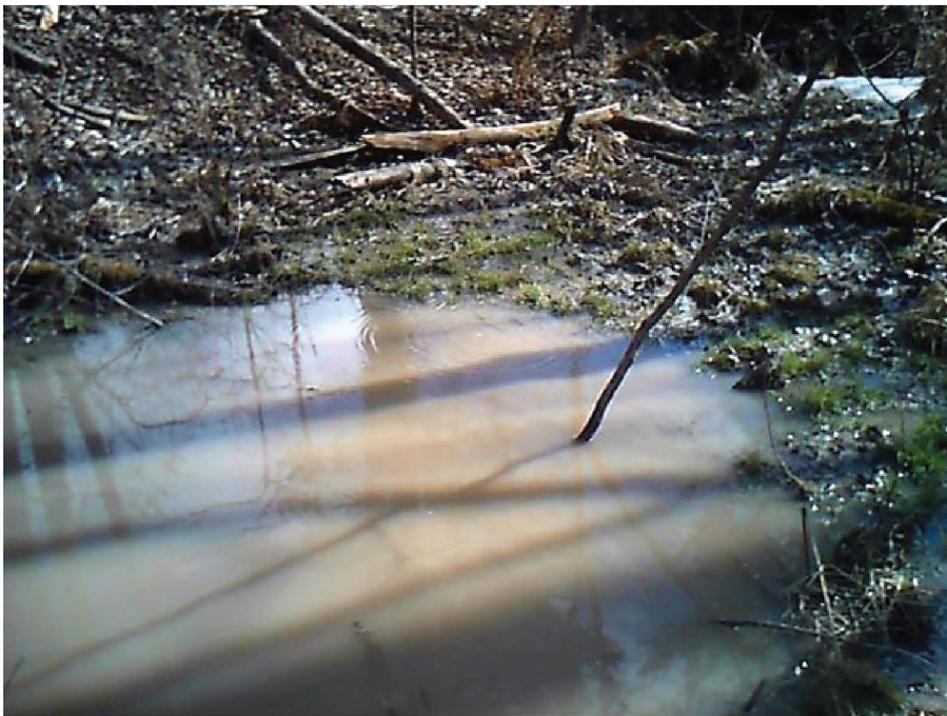
**Photograph 2:** View of the ponded area at Leak 3B.

Leak 3B is located approximately 100 feet southeast of Leak 3A. Similar to Leak 3A, Leak 3B forms a ponded area at the surface (see Photograph 2 on **Figure 9.5-22**). However, no noticeable flow enters or exits the pond, and Leak 3B does not have an associated flowpath.

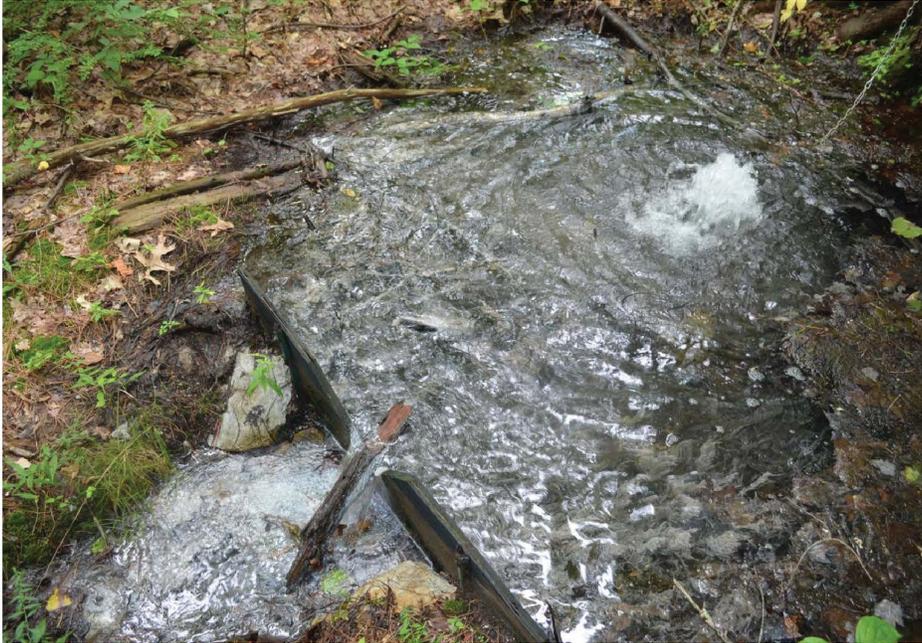
**Photograph 3:** Leak 4 flows through weir.

Similar to Leaks 3A and 3B, Leak 4 is located in a heavily wooded area and lies approximately 750 feet southeast of Leak 3A near Shaft 4 (sealed in 1912) of the Rondout Pressure Tunnel. Leak 4 has a strong sulfur smell and bubbles into a pond at the surface, which is impounded by a wooden weir (see Photograph 3 on **Figure 9.5-23**). The flowpath from Leak 4 (4-FP) flows over the weir before traveling southwest and combining with the flow from 3A-FP (see **Figure 9.5-21**). The maximum observed flow of Leak 4 is approximately 10.8 gpm (16,000 gpd).

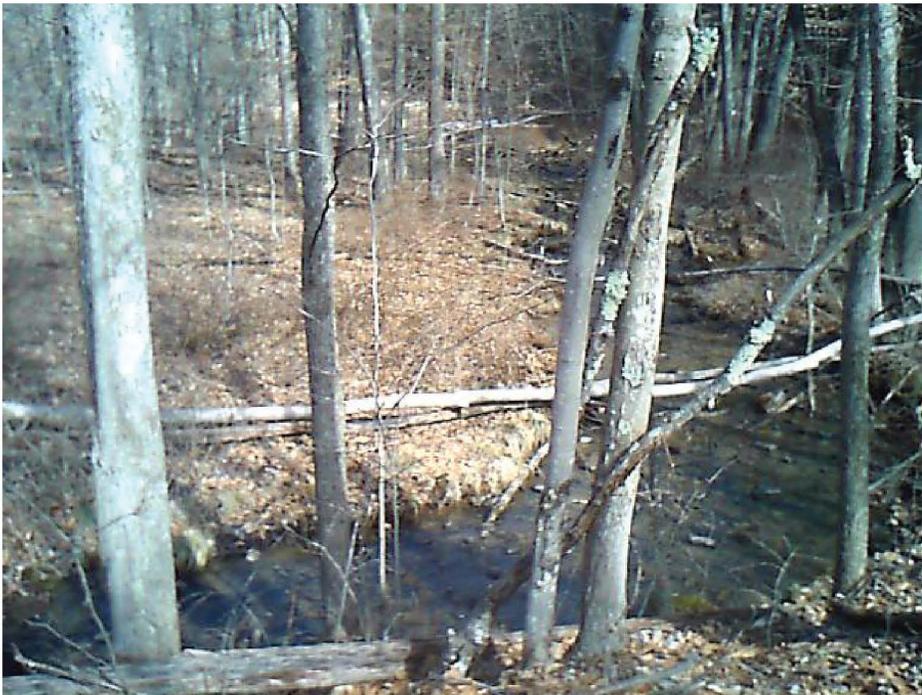
**Photograph 4:** View of Flowpath 3A-FP, after merging with Flowpath 4-FP, from the southern portion of the natural resources study area (facing upstream). Wetlands are located along Flowpath 3A-FP.

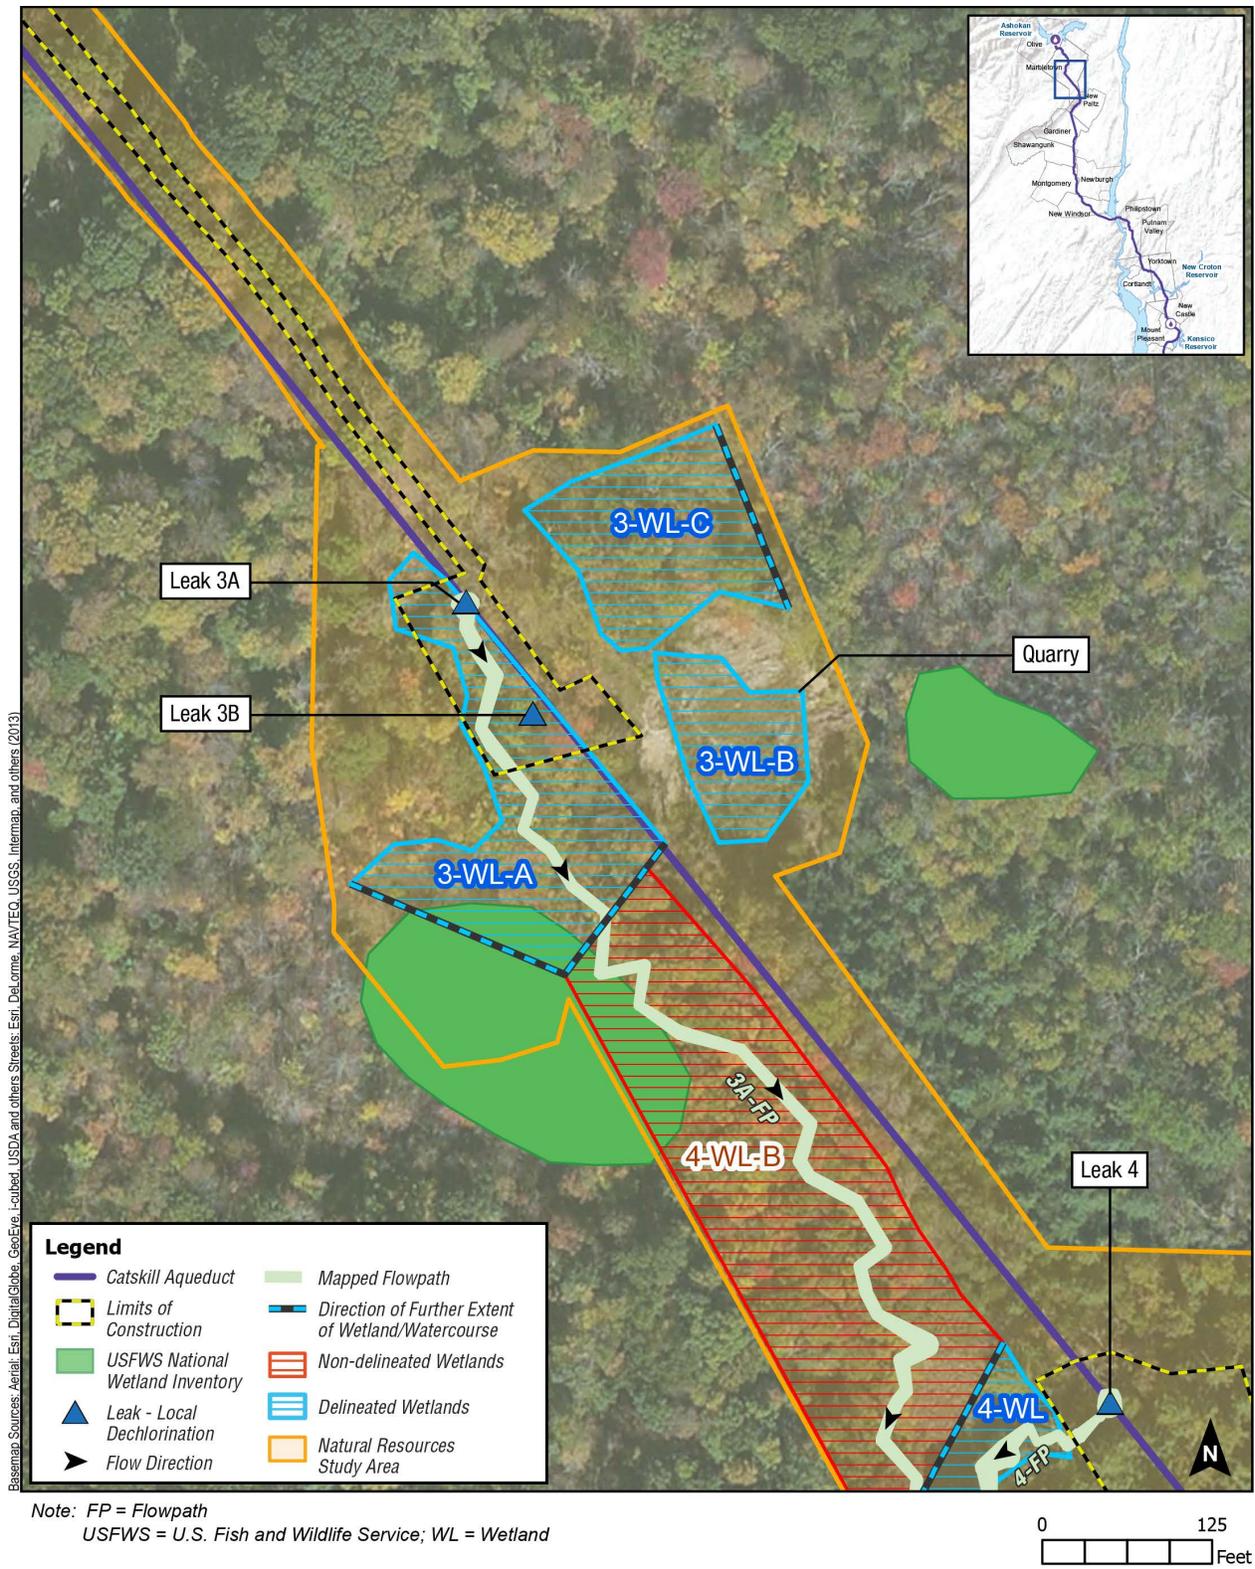
**Figure 9.5-32: Watercourses and Wetlands at Leaks 3A and 3B – Lucas Turnpike Study Area**

The watercourse is densely shaded within the study area. Flowpath 3A-FP is considered perennial due to permanent flows from leaks in the Catskill Aqueduct, and is best classified as a “Riverine, Upper Perennial, Unconsolidated Bottom, Cobble-Gravel, Permanently Flooded” system based on the Cowardin System (Cowardin et al. 1979).

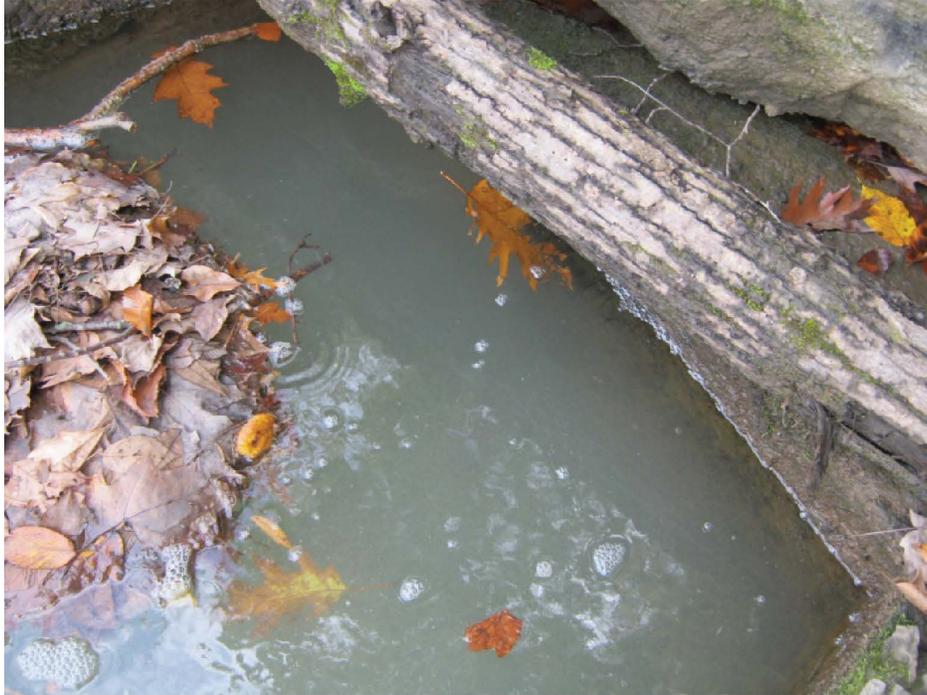
**Photograph 1:** View of Leak 5 at Rondout Creek, with bubbles indicating the location of the submerged conduit pipe. Concrete headwall is visible in the upper right-hand corner.

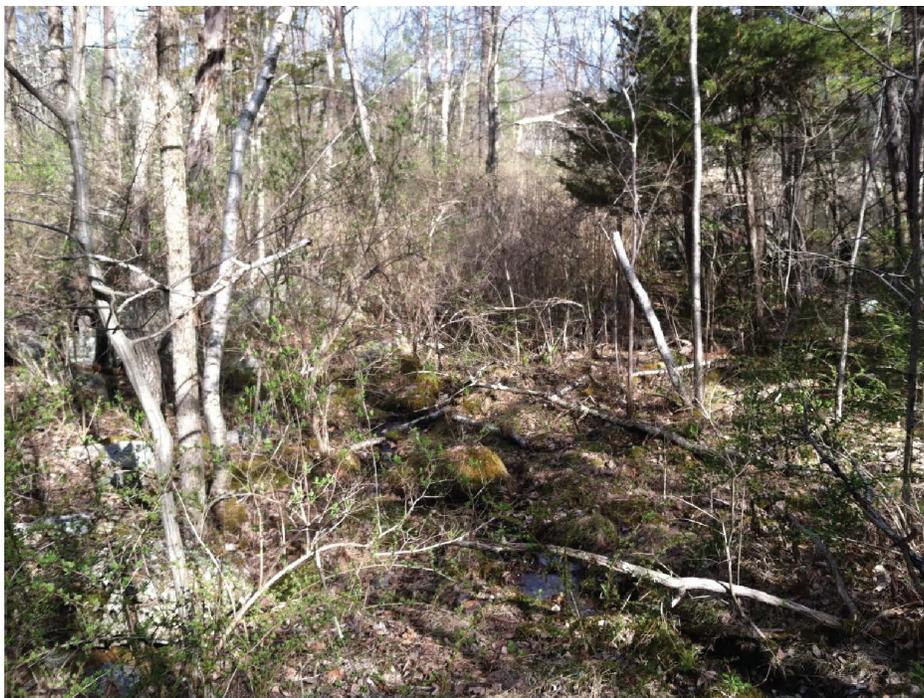
**Photograph 1:** Rondout Pressure Tunnel Shaft 7 Leak. Photograph taken facing northwest.

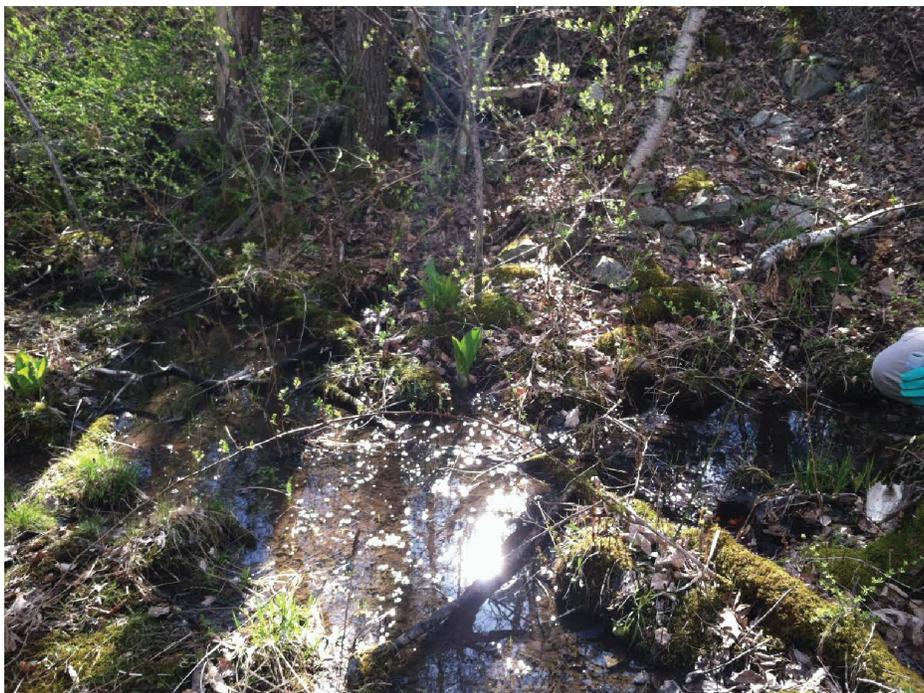
**Photograph 2:** Ponded area from Rondout Pressure Tunnel Shaft 7 Leak. Photograph taken facing north.

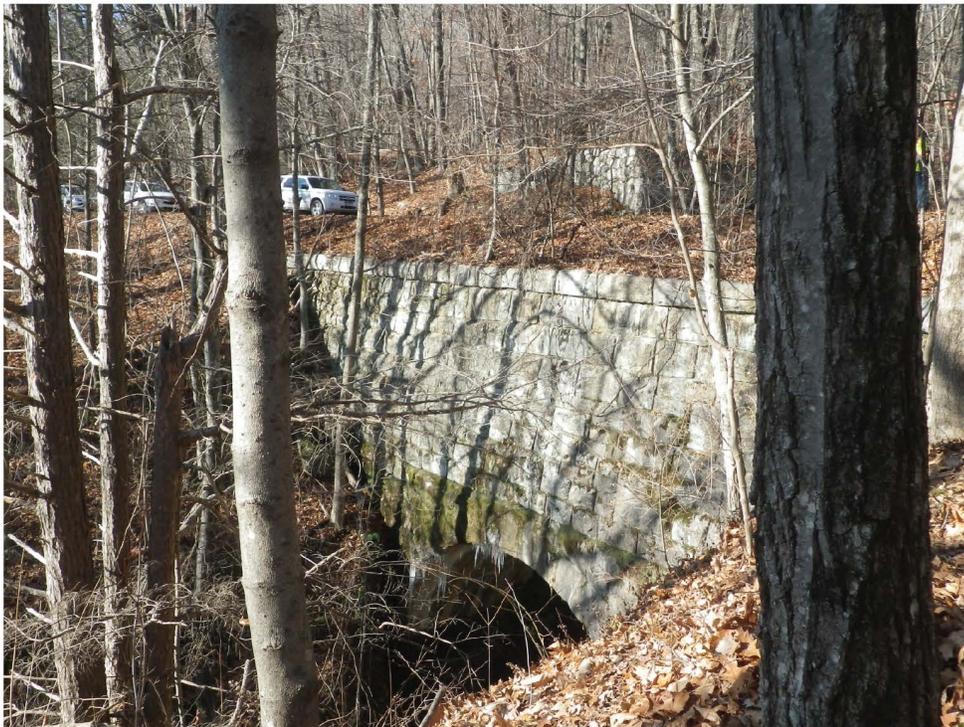
**Photograph 4:** Poor Farm Arch Bridge, facing southwest.

The Poor Farm Arch Bridge is a concrete bridge structure with stone masonry facing crossing the Kleine Kill. Approximately 40 feet of the Wallkill North Cut-and-Cover Tunnel is enclosed by the bridge. During a November 2014 inspection, areas of deteriorated concrete, corroded support structures, and surface defects were documented at various locations within the concrete arch. Access to the underside of the arch is via difficult terrain and steep slopes from the top of the bridge.

The Poor Farm Arch Leak results from cracks at construction joints along the interior of the tunnel and root infiltration north of the bridge. The leak discharges approximately 0.7 gpm (or approximately 1,000 gpd) to Kleine Kill. Because the leak expresses from the concrete bridge abutment directly to the stream below, there is no associated overland flowpath.

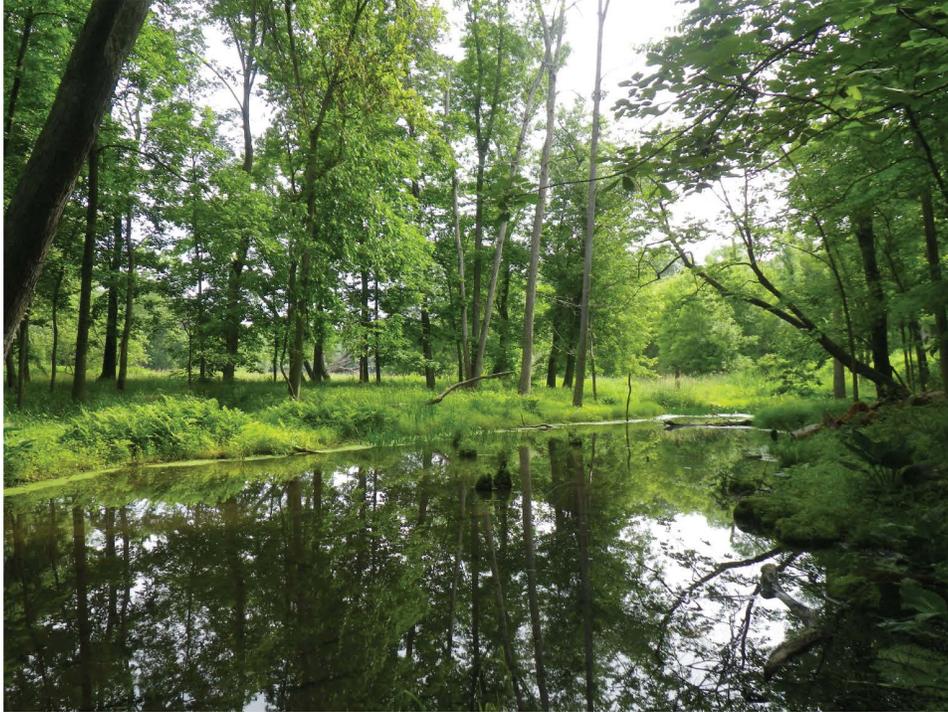
**Photograph 1:** Ponding from Leak 6 near headwall to subsurface blow-off conduit.

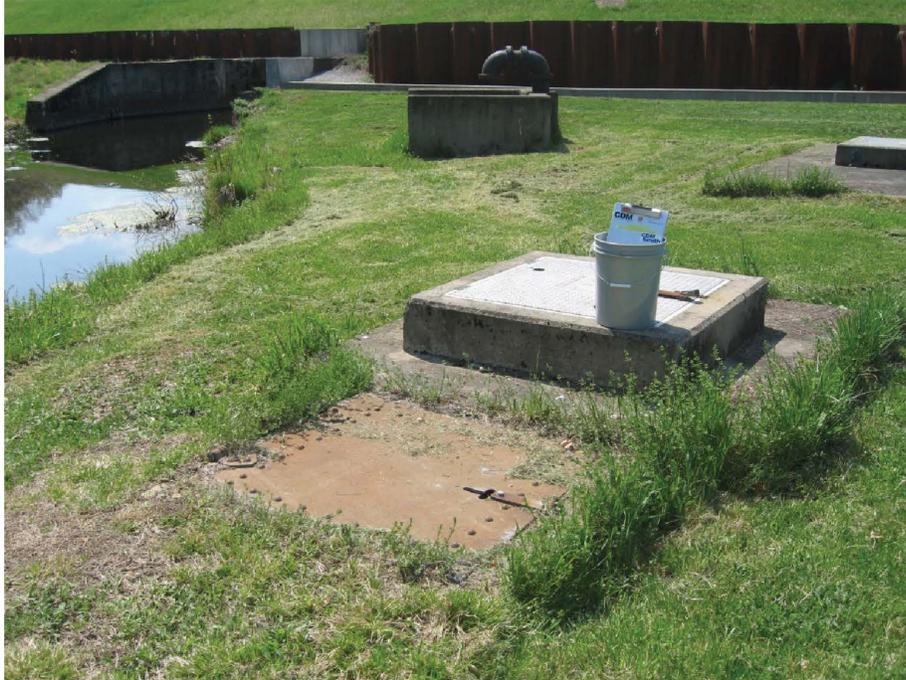
**Photograph 1:** Washington Square Steel Pipe Siphon west blow-off chamber exterior, valve vault, manway, and vent; looking southwest.

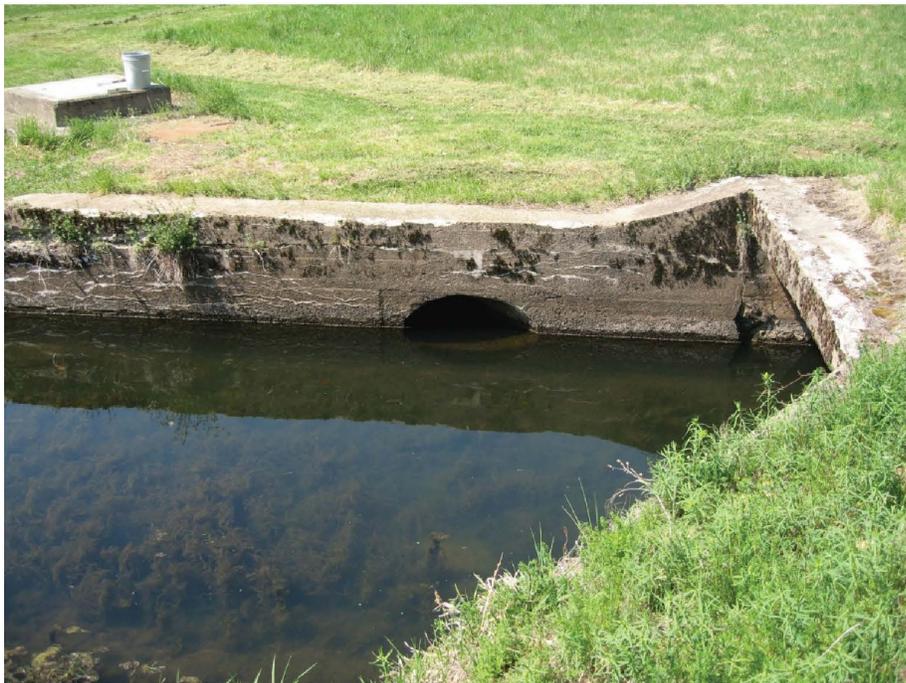
**Photograph 2:** Washington Square Steel Pipe Siphon west blow-off chamber discharge pipe to Silver Stream; looking west.
