**New York City Department of Transportation
Office of School Safety Engineering**

School Safety Engineering Project

FINAL REPORT: P.S. 306 (The Arts Village Complex), Bronx

**Prepared by
The RBA Group/Urbitran Associates**

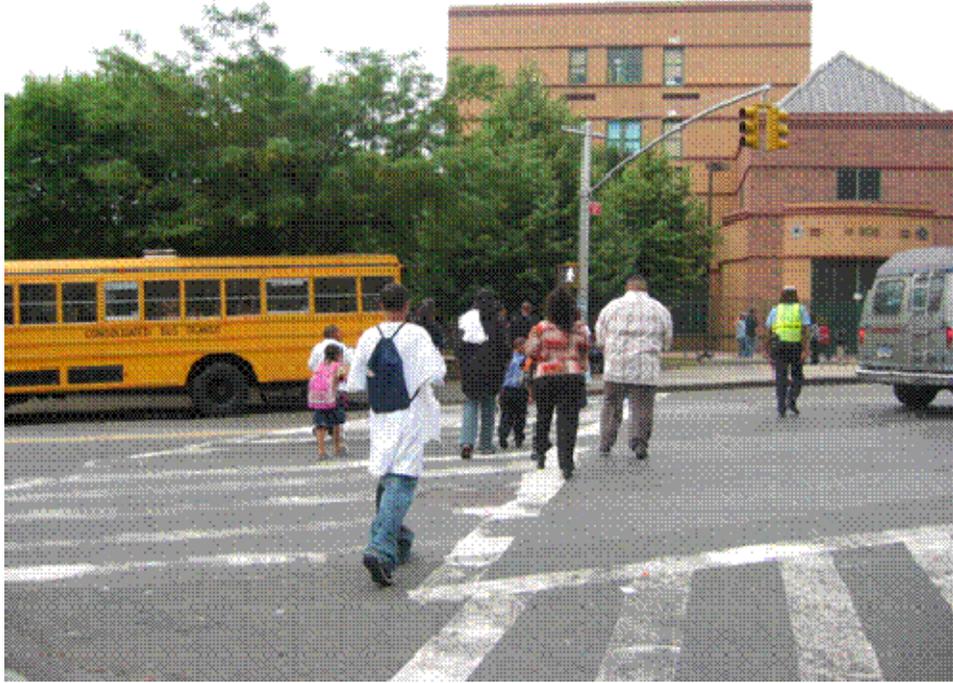
Figure 1: School crossing guard shown at the intersection of West Tremont Avenue and Davidson Avenue (P.S. 306 is visible in the background).

As shown in Figures 1 and 2 below, and in Exhibit 4, a crossing guard is assigned to the intersection of West Tremont Avenue and Davidson Avenue on school days.

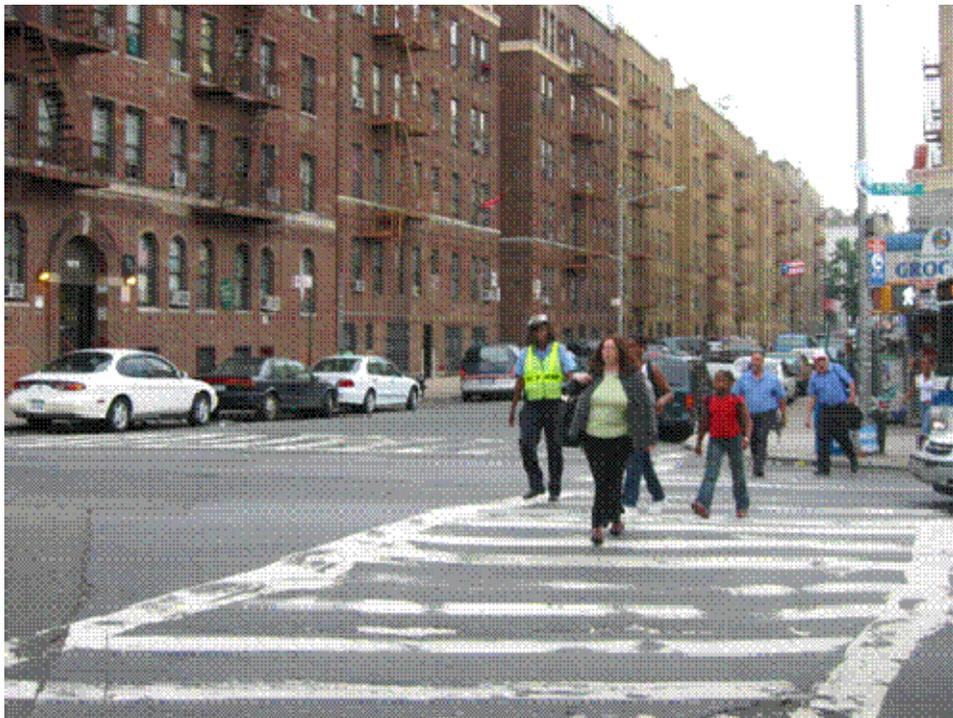
Figure 2: School crossing guard shown facilitating pedestrian crossings at the intersection of West Tremont Avenue and Davidson Avenue.

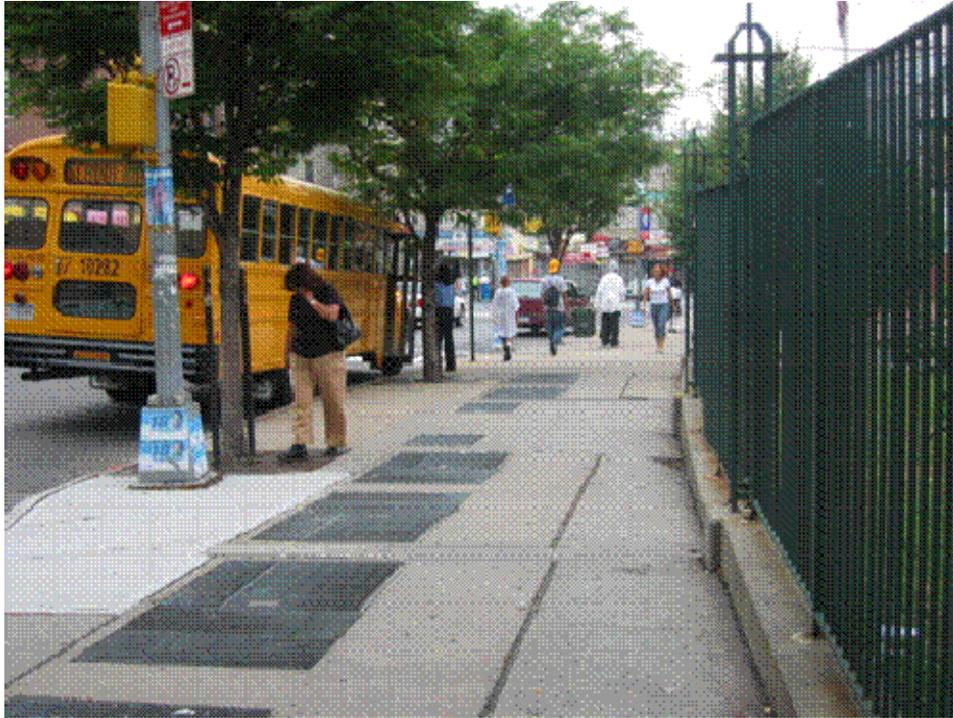
Figure 3: Yellow school bus parked on the south side of West Tremont Avenue near the intersection with Davidson Avenue.

During the site visit, yellow school buses (both regular buses and mini-wagons) were observed parked on West Tremont Avenue near the intersections with Davidson Avenue and Kingsland Place (see Figures 3 and 4).

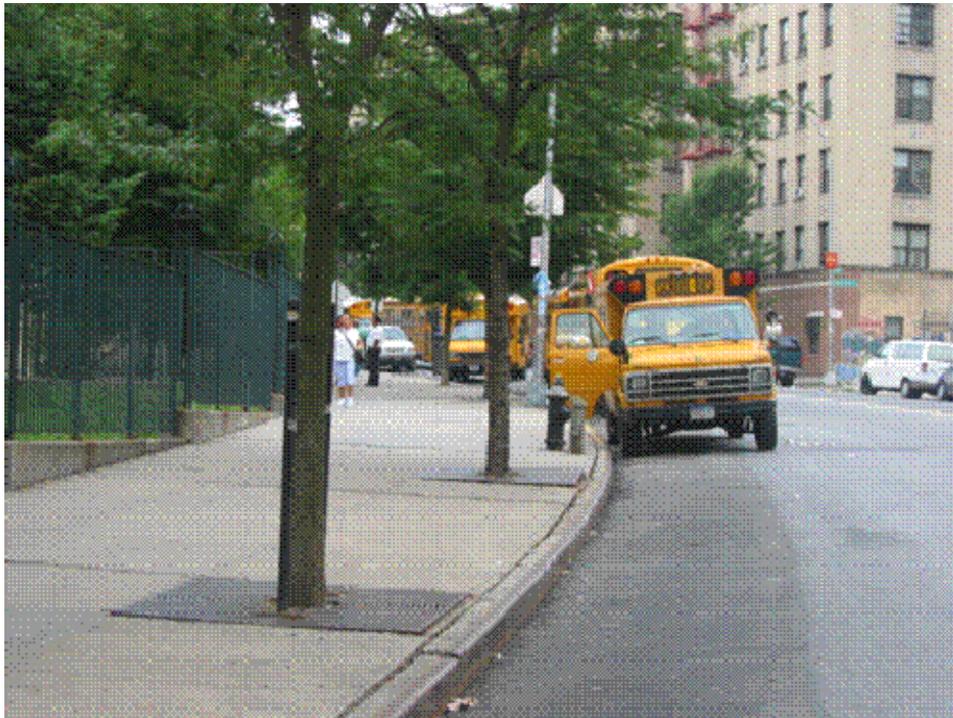
Figure 4: School buses parked along West Tremont Avenue near the intersection with Kingsland Place.

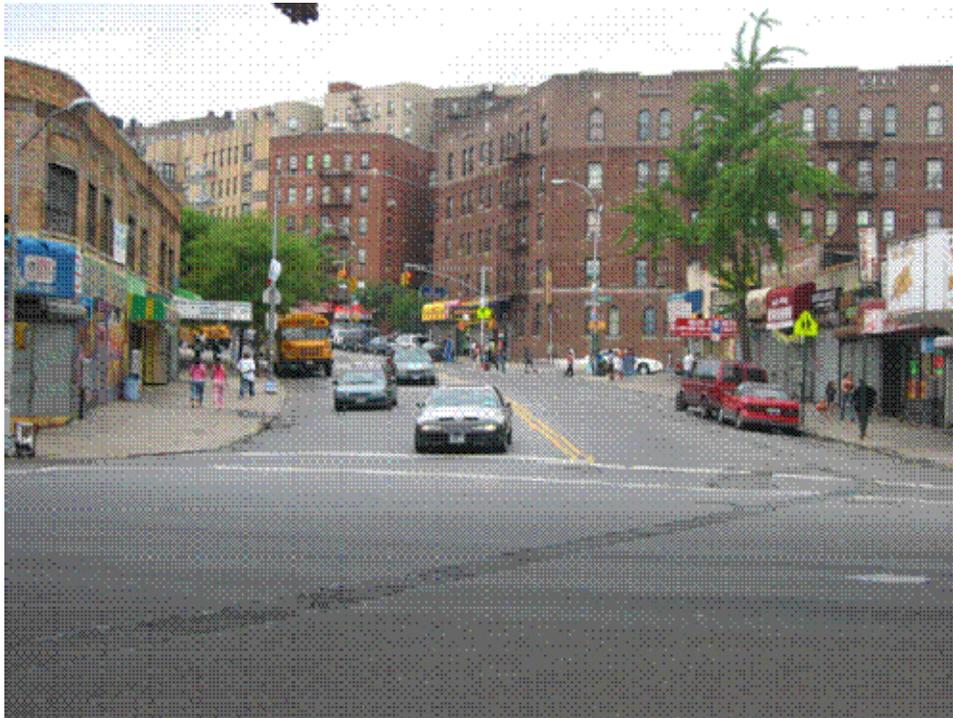
Figure 5: Looking west on Tremont Avenue at the signalized intersection with Jerome Avenue.

The existing pedestrian crosswalk across the west leg of the Tremont Avenue and Jerome Avenue intersection should be converted to a school crosswalk. This crosswalk is adjacent to the school block, is located in close proximity to the main entrance to P.S. 306, and provides a key pedestrian crossing of West Tremont Avenue which is a relatively high-volume roadway.

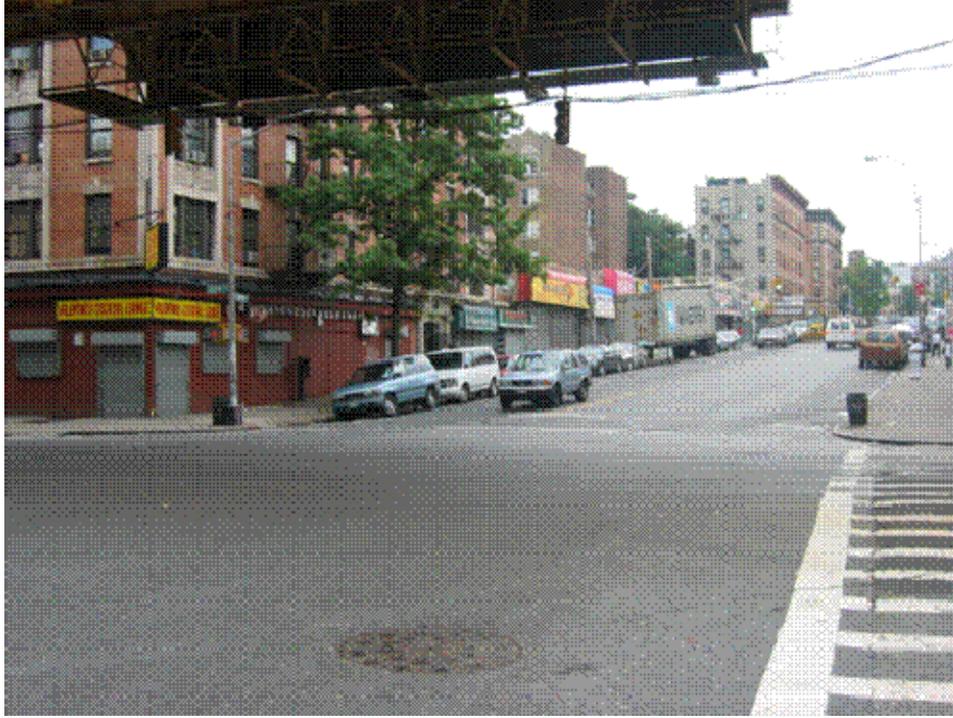
Figure 6: Looking east on Tremont Avenue at the signalized intersection with Jerome Avenue.

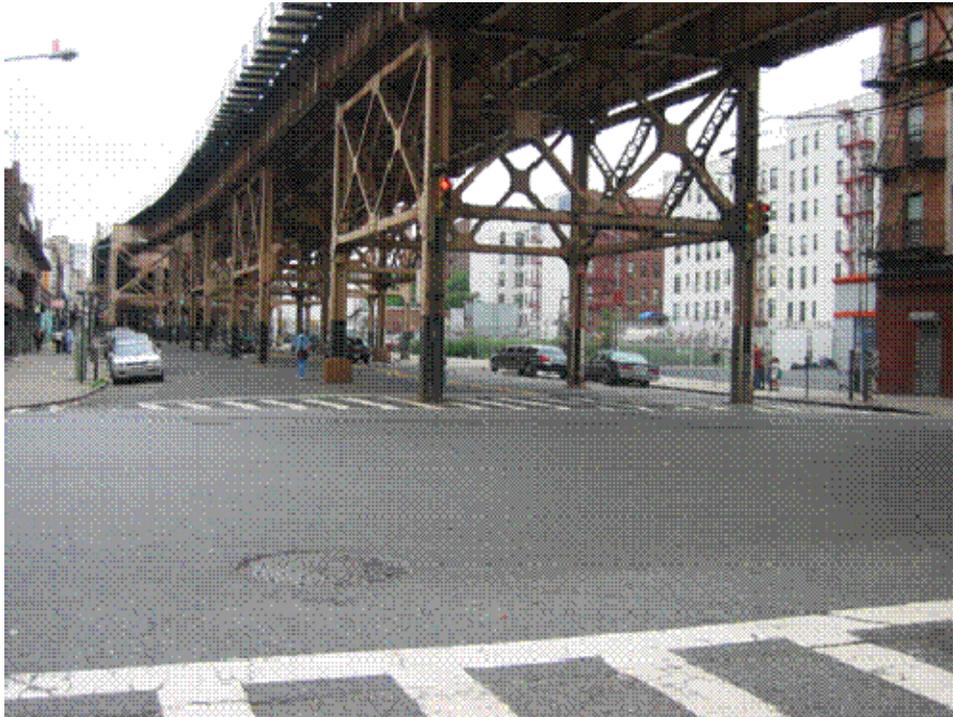
This is a four-leg signalized intersection with school crosswalks located across the north and south legs, and pedestrian crosswalks located across the east and west legs. Tremont Avenue is a two-way east-west street with one travel lane and one on-street parking lane on each side of the roadway (see Figures 5 and 6). Jerome Avenue is a two-way north-south street with two travel lanes and one on-street parking lane on each side of the roadway. Jerome Avenue also has an elevated subway structure aligned over the center of the roadway. The supports for the subway structure are located so that they provide an inner and an outer lane in each direction of travel (see Figures 7 and 8).

Figure 7: Looking north on Jerome Avenue at the signalized intersection with Tremont Avenue.

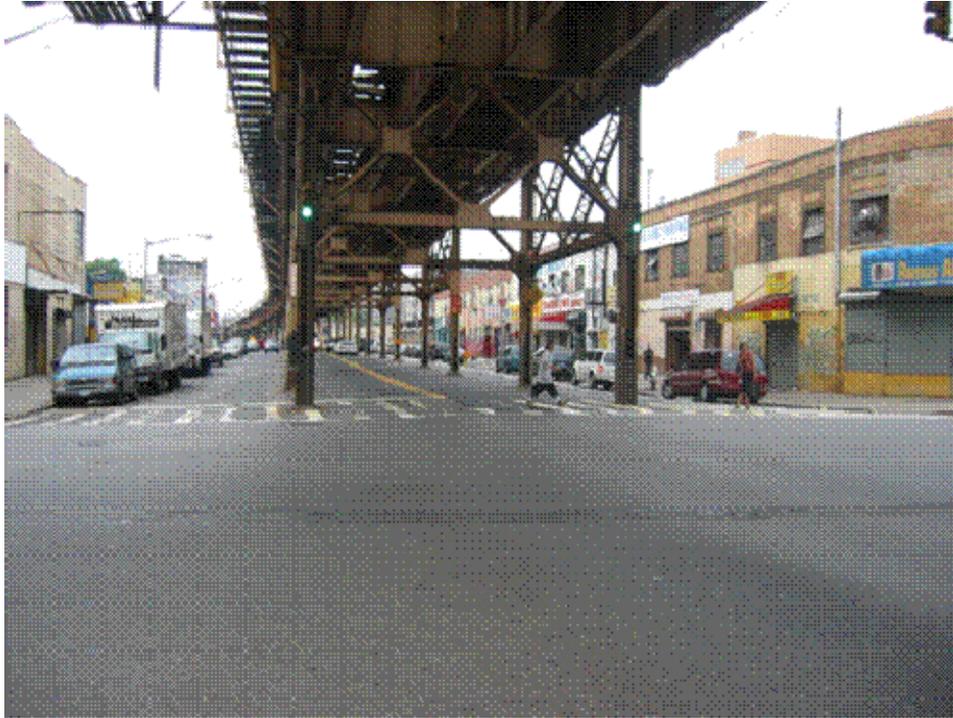
Figure 8: Looking south on Jerome Avenue at the signalized intersection with Tremont Avenue.

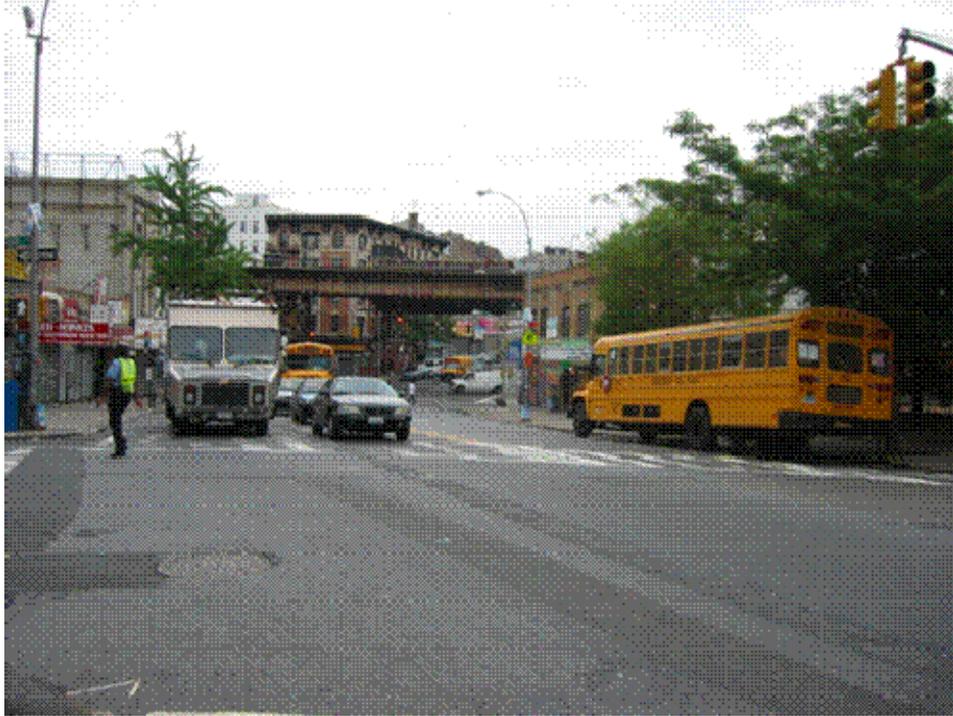
Figure 9: Looking east on West Tremont Avenue at the signalized intersection with Davidson Avenue.

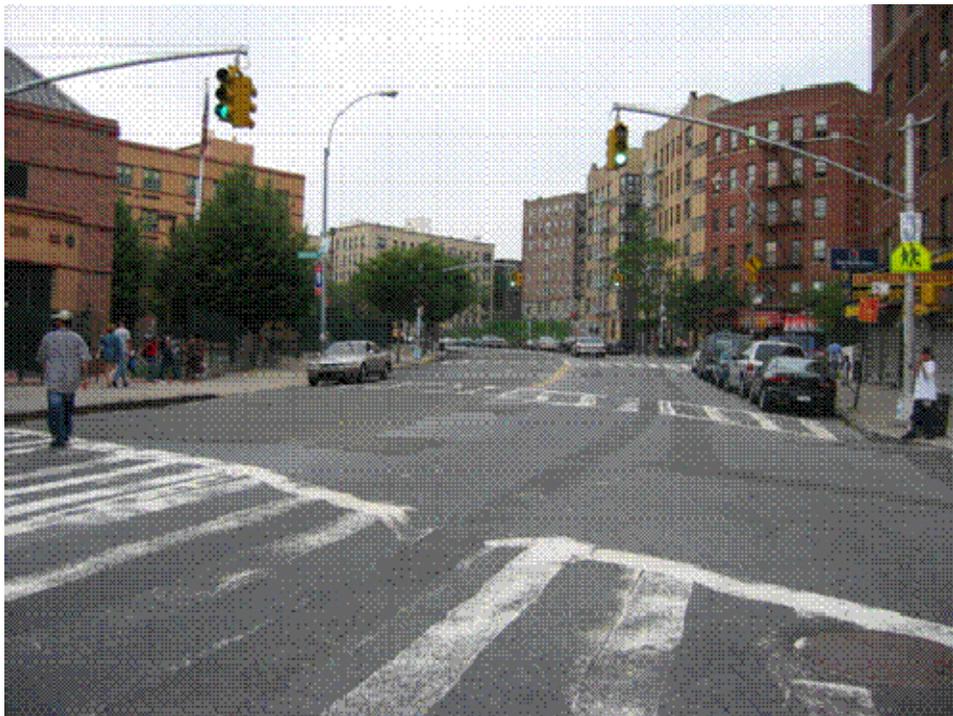
Figure 10: Looking west on West Tremont Avenue at the signalized intersection with Davidson Avenue.

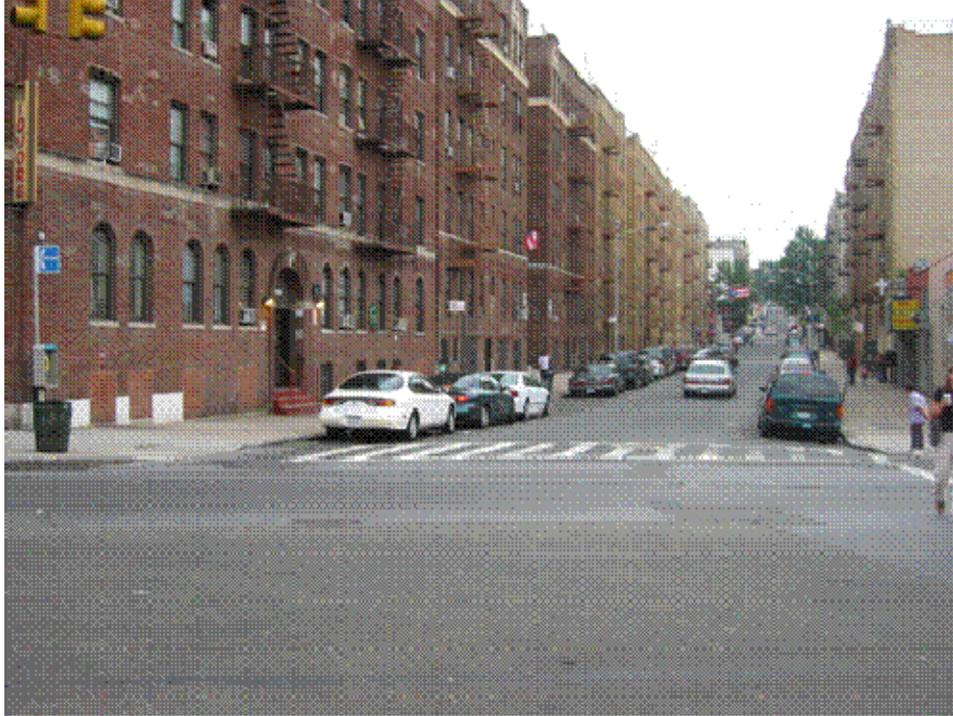
This is a signalized “T”-intersection with school crosswalks located across all three legs. West Tremont Avenue is a two-way east-west street with one travel lane and one on-street parking lane on each side of the roadway (see Figures 9 and 10). Davidson Avenue is a one-way northbound street with on-street parking permitted on both sides of the roadway (see Figure 11).

Figure 11: Looking north on Davidson Avenue at the signalized intersection with West Tremont Avenue.

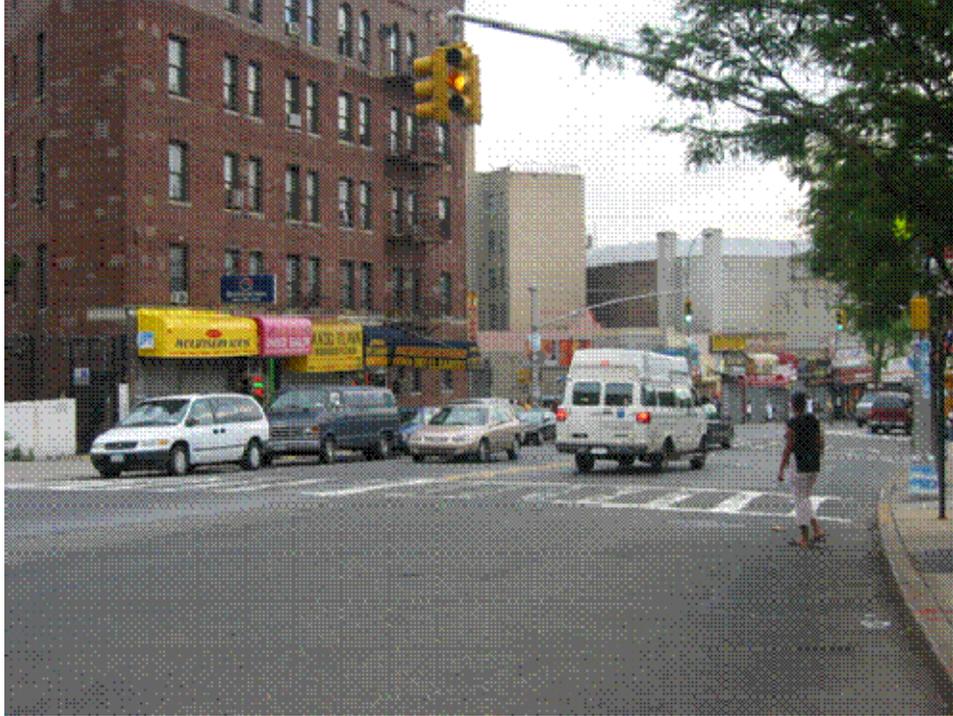
Figure 12: Looking east on West Tremont Avenue at the signalized intersection with Grand Avenue (north leg).

In addition, the existing pedestrian crosswalk across the west leg of the West Tremont Avenue and Grand Avenue (north leg) intersection should be converted to a school crosswalk. This crosswalk is adjacent to the school block, is located in close proximity to the westerly entrance to P.S. 306, and provides a key pedestrian crossing of West Tremont Avenue which is a relatively high-volume roadway.

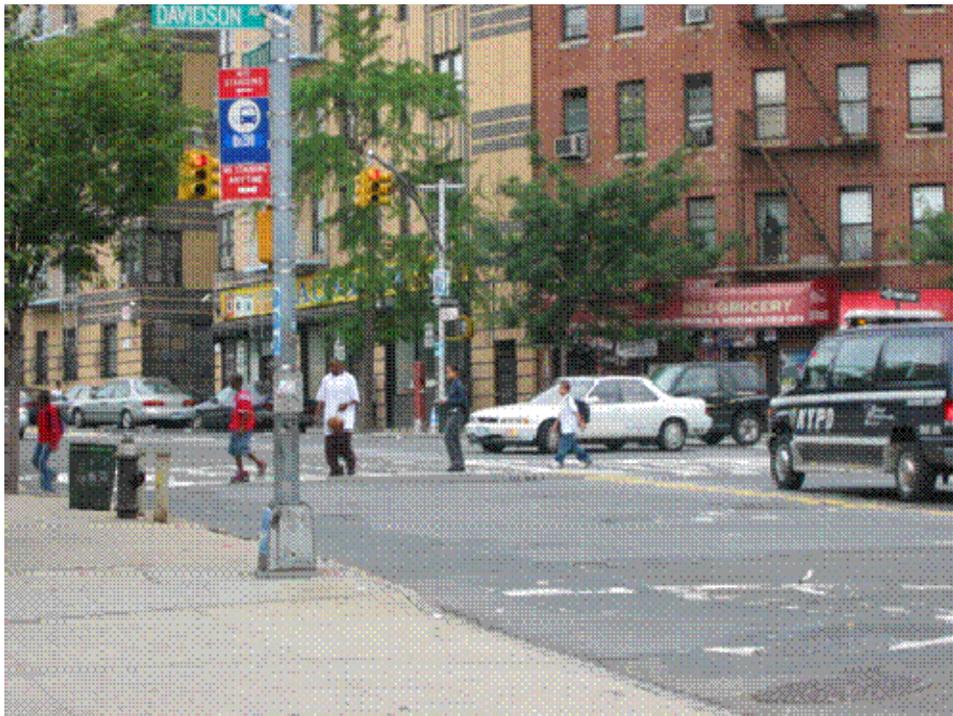
Figure 13: Looking west on West Tremont Avenue at the signalized intersection with Grand Avenue (north leg).

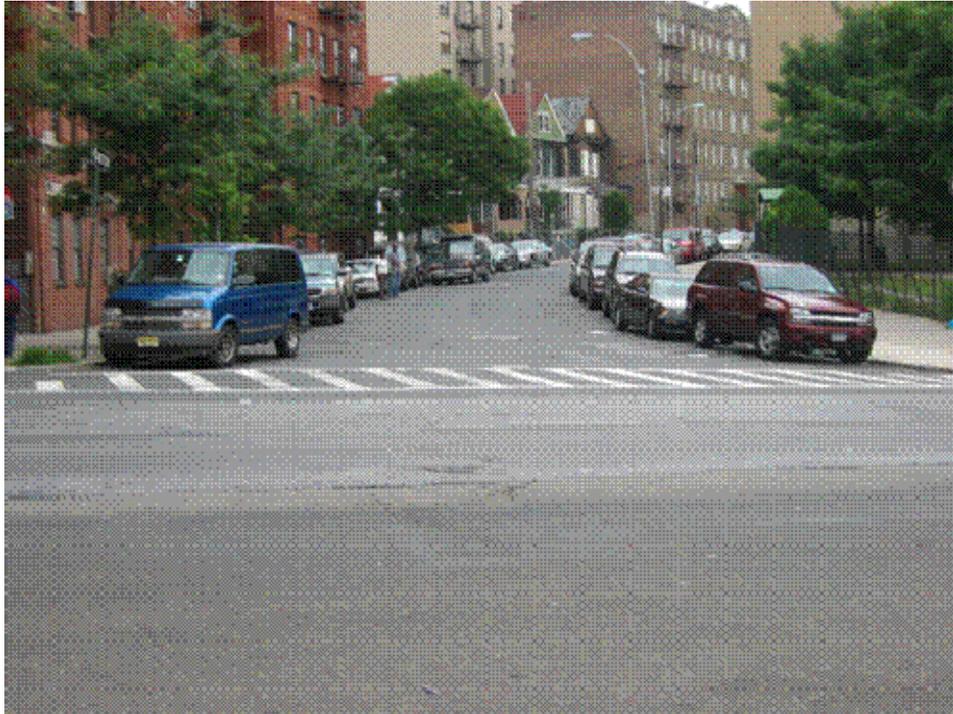
Figure 14: Looking north on Grand Avenue at the signalized intersection with West Tremont Avenue.

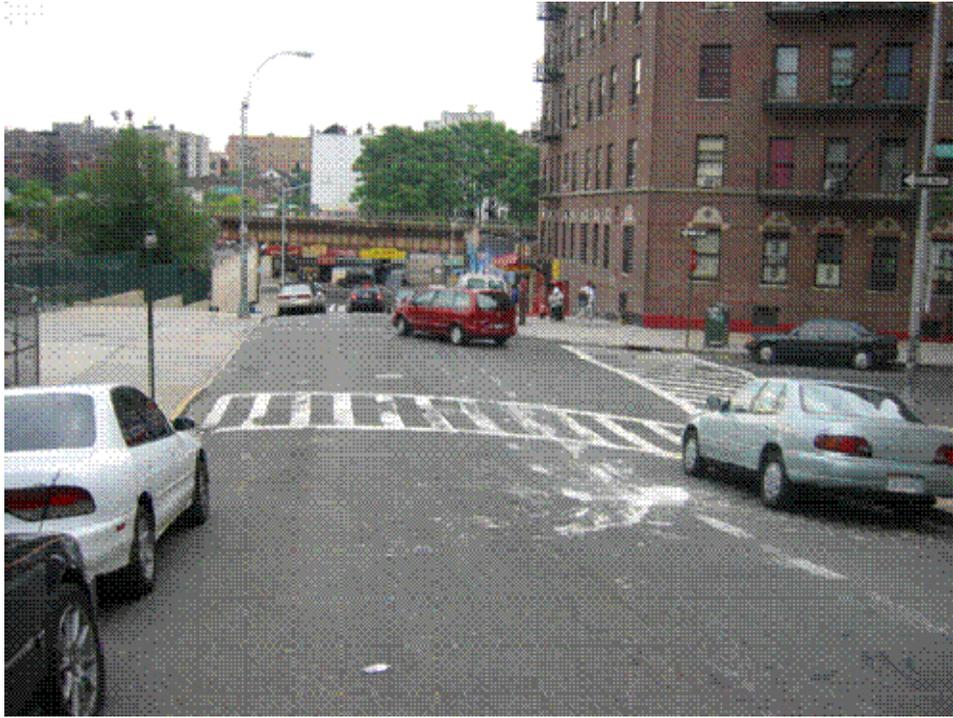
A field visit by members of the consultant team indicated a possible speeding problem in this location as well. Therefore, a spot speed survey was conducted on West 177th Street between West Tremont Avenue and Davidson Avenue in order to verify the existence of a speeding problem and to determine its extent.

The results of the spot speed survey indicated that eastbound vehicles on West 177th Street between West Tremont Avenue and Davidson Avenue were traveling at an 85th percentile speed of 23 mph. Because this is lower than the 30 mph threshold, no speed reduction measures are recommended on West 177th Street as part of this study. The detailed results of the spot speed survey are shown in the Appendix at the end of this document.

Figure 15: Looking east on West 177th Street at the unsignalized intersection with Davidson Avenue.

A designated school crosswalk is located on the west leg of this intersection. However, there is no positive traffic control for vehicles traveling eastbound on West 177th Street. In addition, West 177th Street has an “S”-shaped horizontal alignment with poor sight distance and a downgrade on the eastbound approach to Davidson Avenue. Because the entrance to the schoolyard is located opposite Davidson Avenue at this intersection, there were a significant number of students who use the westerly crosswalk (see Table 4 and Exhibit 7).

- Request that NYPD assign a school crossing guard at the intersection of West 177th Street and Davidson Avenue.

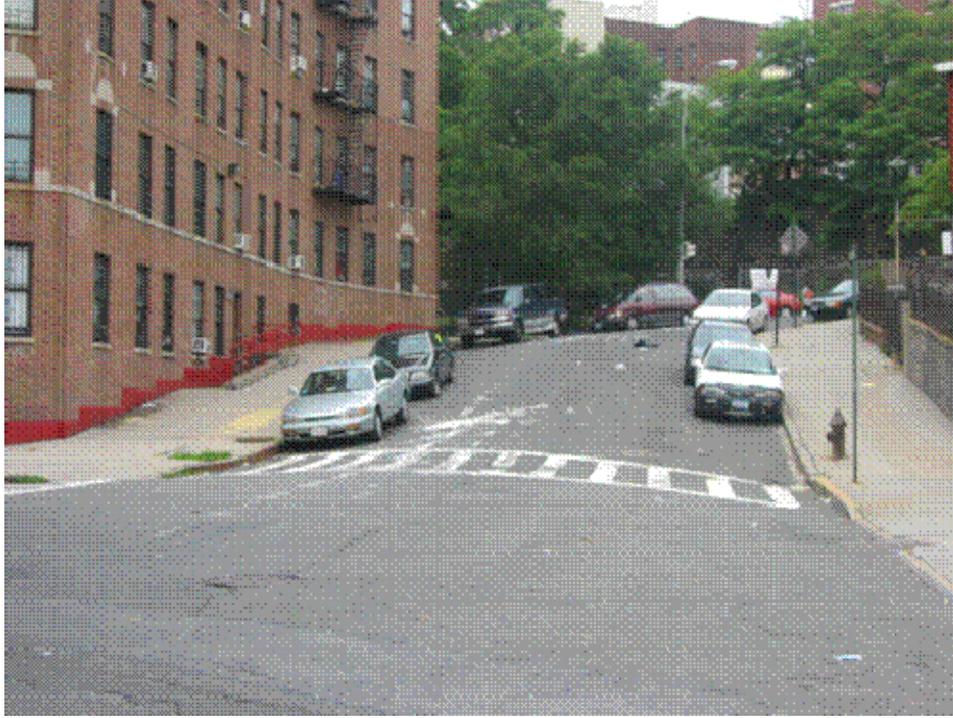
Figure 16: Looking west on West 177th Street at the unsignalized intersection with Davidson Avenue.

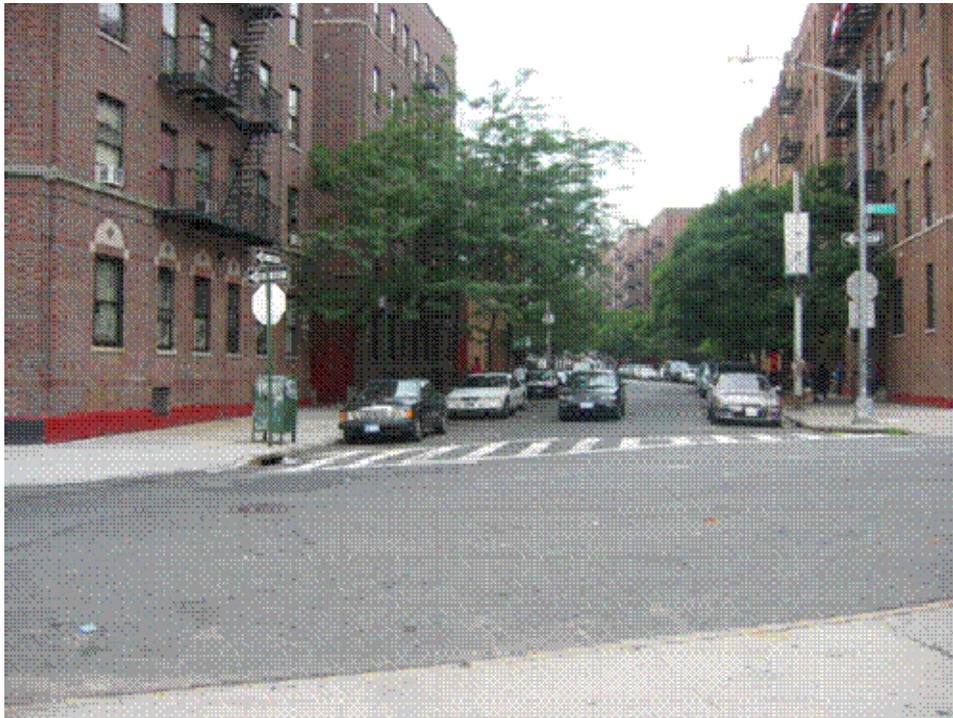
Figure 17: Looking south to Davidson Avenue at the unsignalized intersection with West 177th Street.

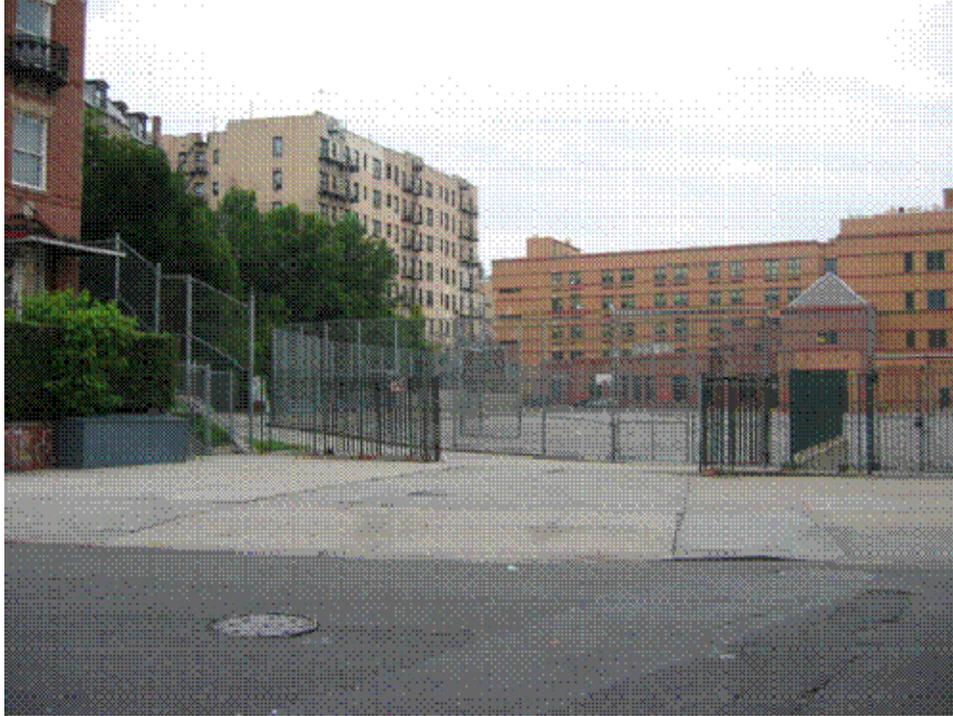
This is an unsignalized “T”-intersection with school crosswalks located across the south and west legs. At the intersection with Davidson Avenue, West 177th Street is a one-way eastbound street with one travel lane and on-street parking permitted on both sides of the roadway (see Figures 15 and 16). Davidson Avenue is a one-way northbound street with on-street parking permitted on both sides of the roadway (see Figure 17). A gated entrance to P.S. 306 is located opposite Davidson Avenue at the intersection with West 177th Street (see Figure 18).

Figure 18: Looking north from the intersection of West 177th Street and Davidson Avenue at the gated entrance to the P.S. 306 school yard and staff parking area (P.S. 306 is visible in the background).

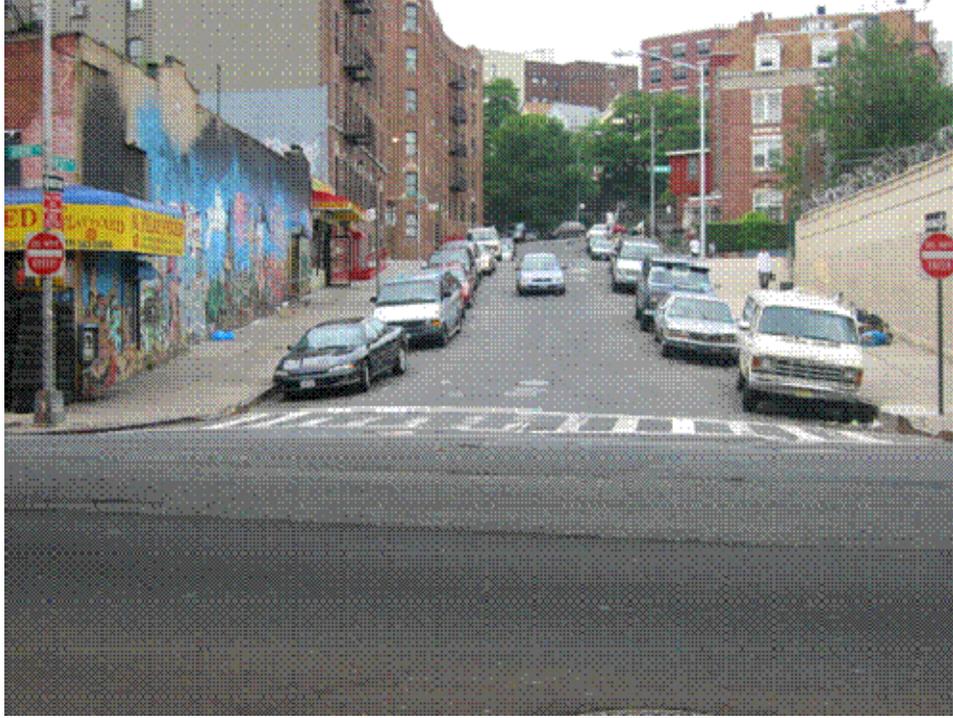
Figure 19: Looking west to West 177th Street at the signalized intersection with Jerome Avenue.

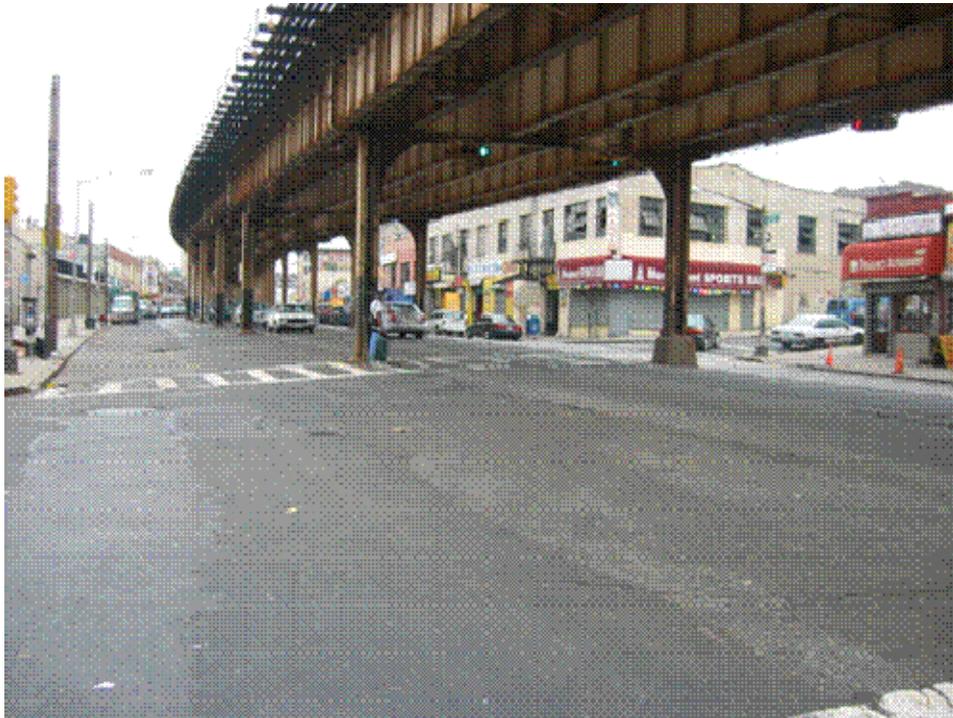
Figure 20: Looking north on Jerome Avenue at the signalized intersection with West 177th Street.

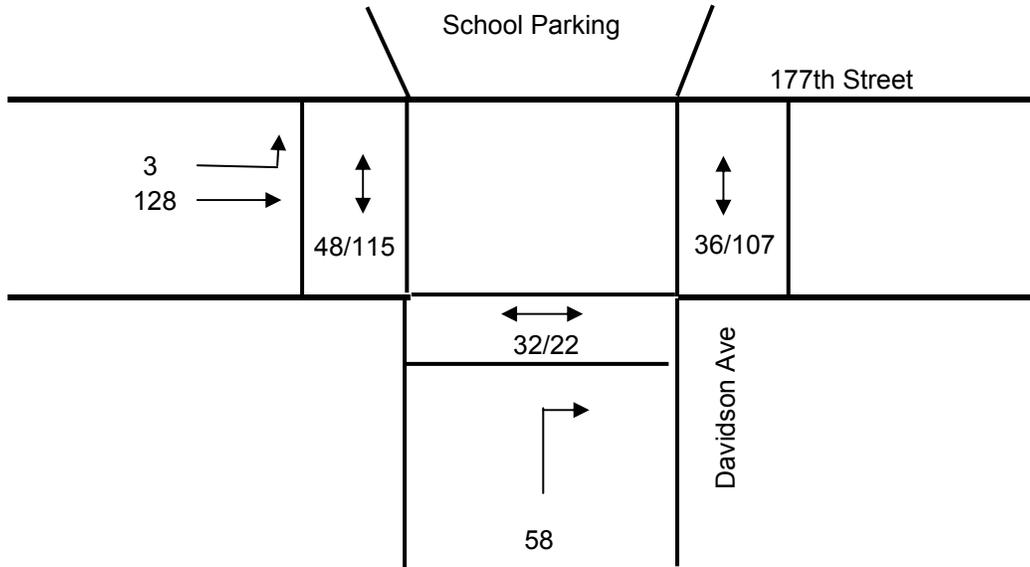
EXHIBIT 7
P.S. 306
ALBERT EINSTEIN SCHOOL
TRAFFIC AND PEDESTRIAN COUNTS

As shown in Table 5, the pedestrian crossing count indicated that there were 163 pedestrians (including 48 adults and 115 students) utilizing the school crosswalk located across the west leg of West 177th Street, and 143 pedestrians (including 36 adults and 107 students) utilizing the pedestrian crosswalk located across the east leg of West 177th Street. This is a total of 306 pedestrians crossing West 177th Street at the intersection with Davidson Avenue (84 adults and 222 students) during the weekday morning peak hour (7:45 to 8:45 am).

One Hour Traffic Volumes
Friday, September 16th, 2005 7:45am - 8:45am

Intersection of Davidson Avenue and 177th Street

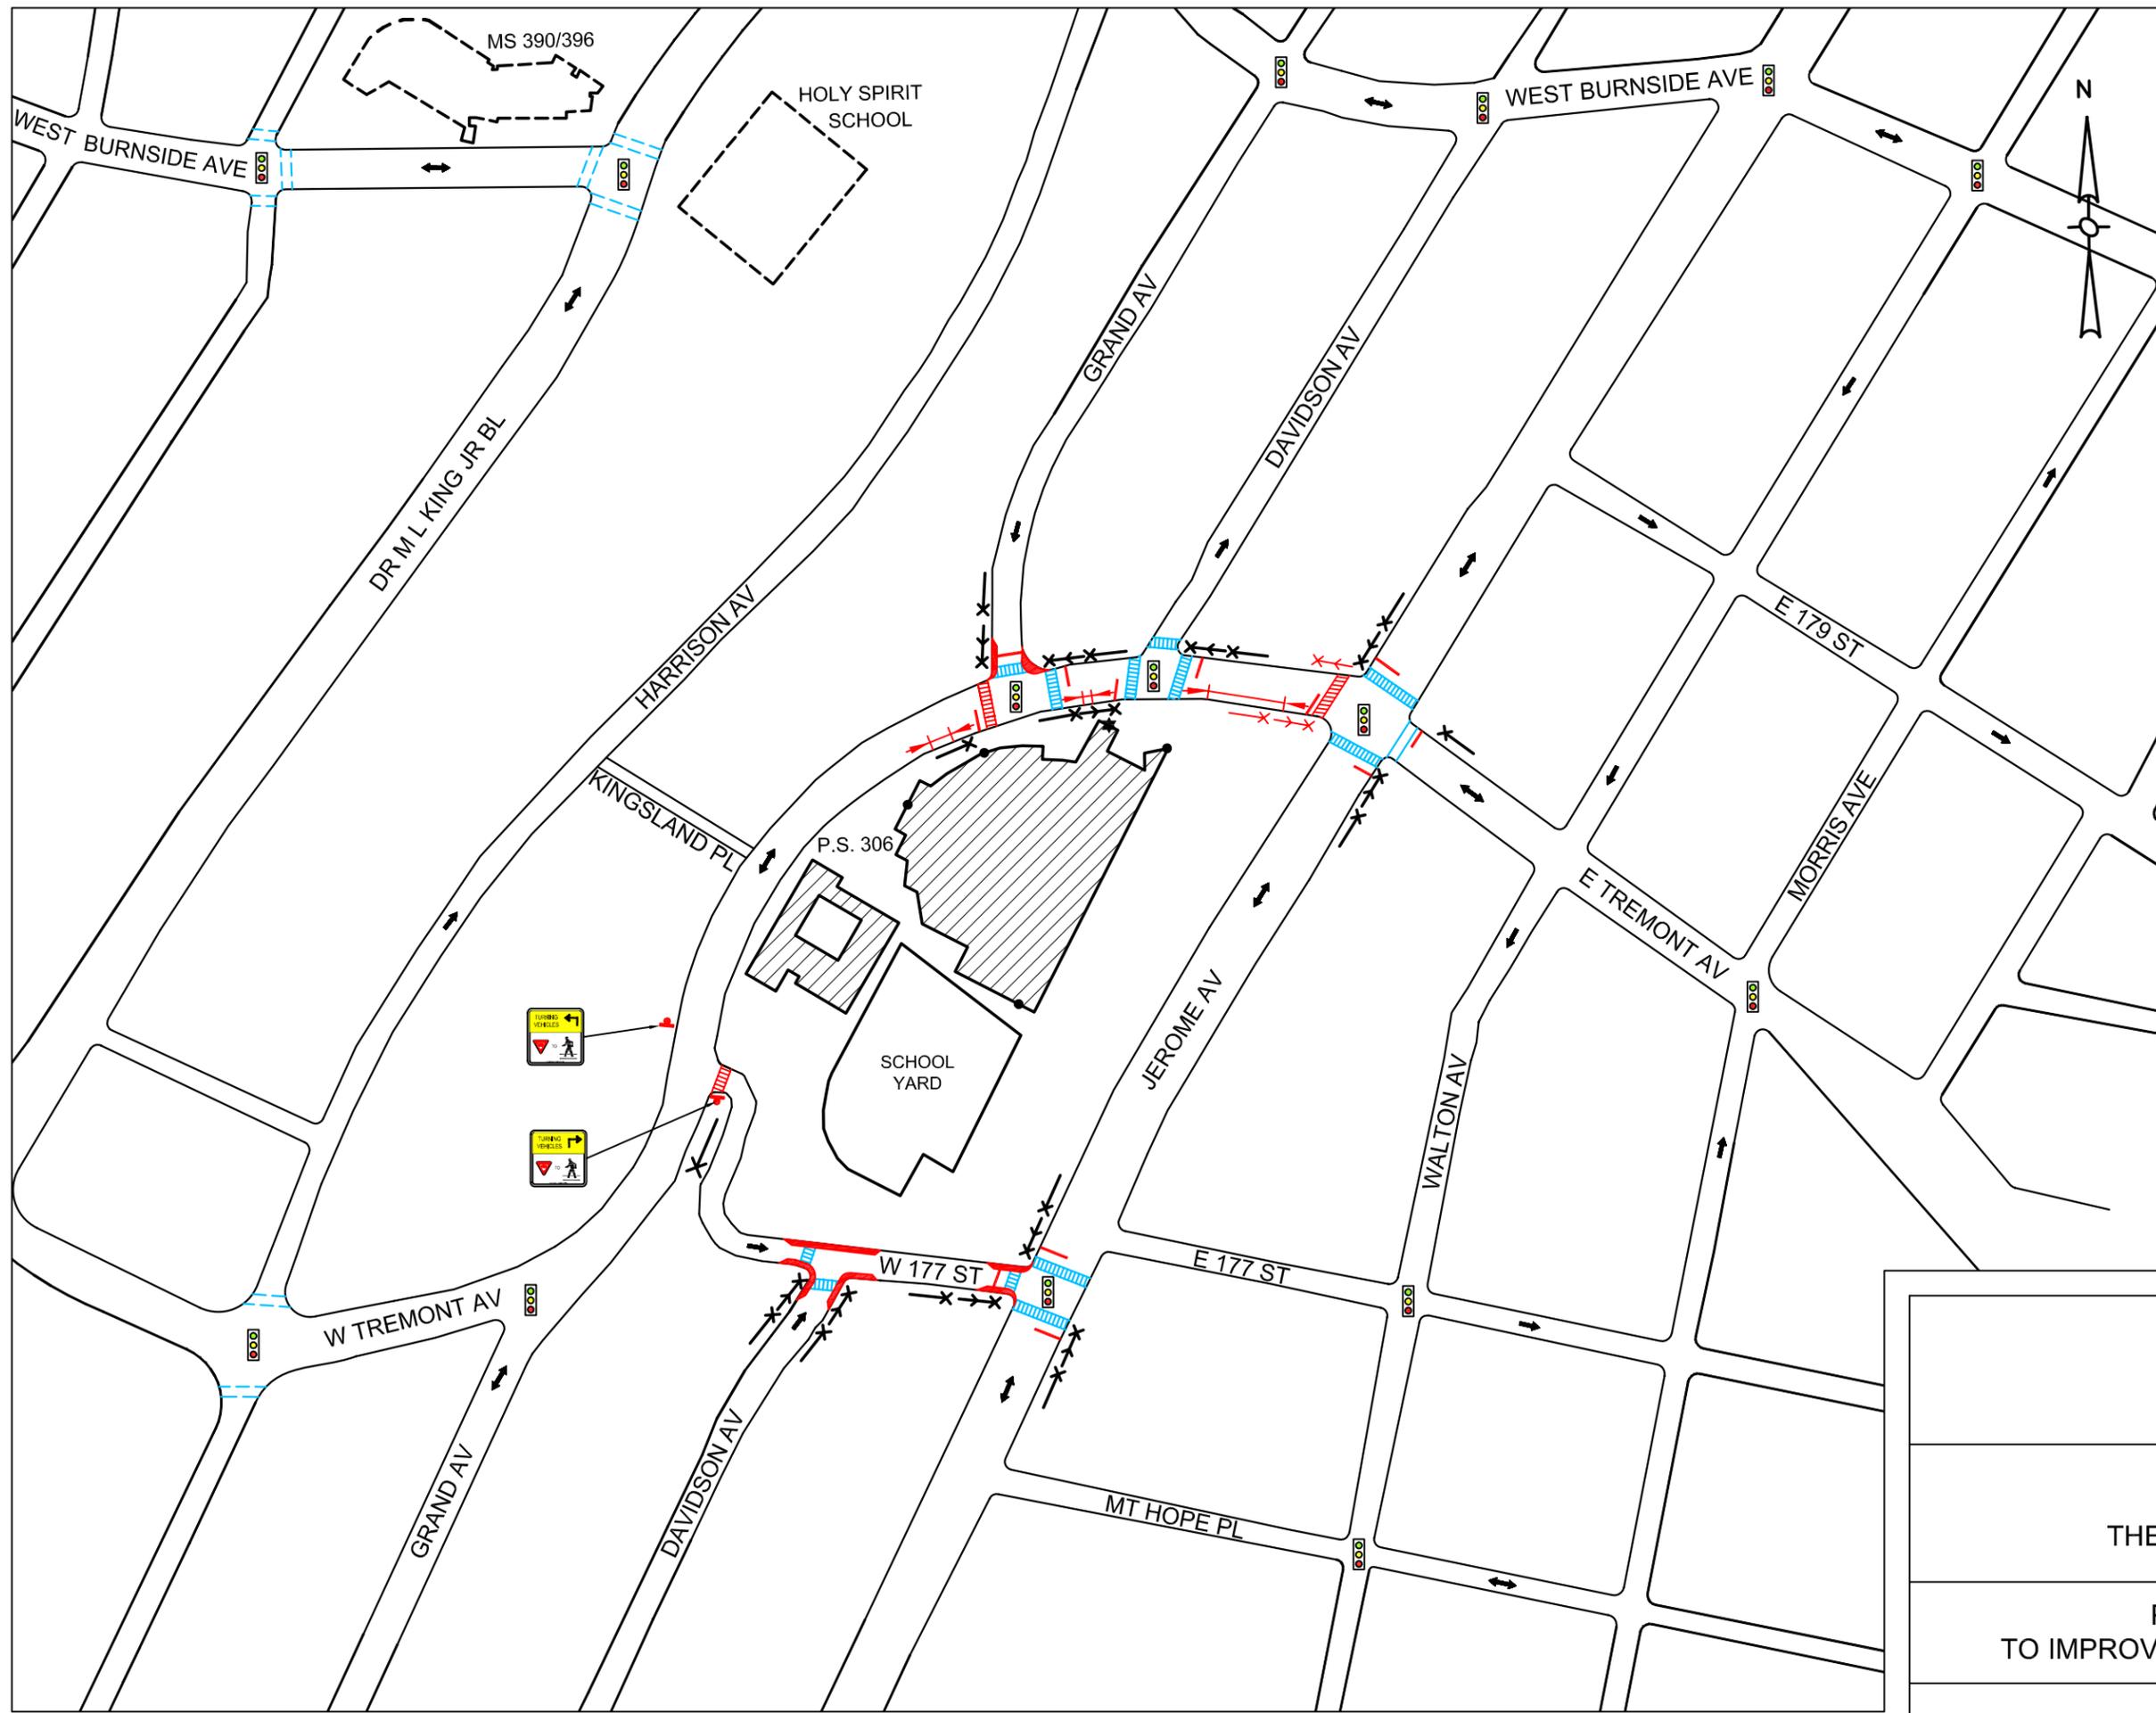
This section describes proposed measures to improve school pedestrian safety around P.S. 306. The proposed recommendations are divided into short-term and long-term measures. Short-term measures are those that potentially can be performed in-house. Long-term measures involve capital improvements. Each of the short- and long-term measures recommended for the P.S. 306 is discussed as follows, and is shown in more detail in Exhibit 8 at the end of this section.

➤ Install “NO STANDING 7AM - 4PM SCHOOL DAYS” signs

➤ Place ten foot stop bars in advance of school crosswalks

- Provide a school crosswalk at east leg of the intersection, on West 177th Street.

The purpose of the curb extensions is to shorten the crossing distance for pedestrians, and to reduce speeds of vehicles approaching and turning at these heavily utilized school crosswalks. These curb extensions would not eliminate or reduce the width of any moving lanes.
