**New York City Department of Transportation
Office of School Safety Engineering**

School Safety Engineering Project

FINAL REPORT: P.S 90 (The Horace Mann School), Queens

**Prepared by
The RBA Group and URBITRAN Associates Inc.**

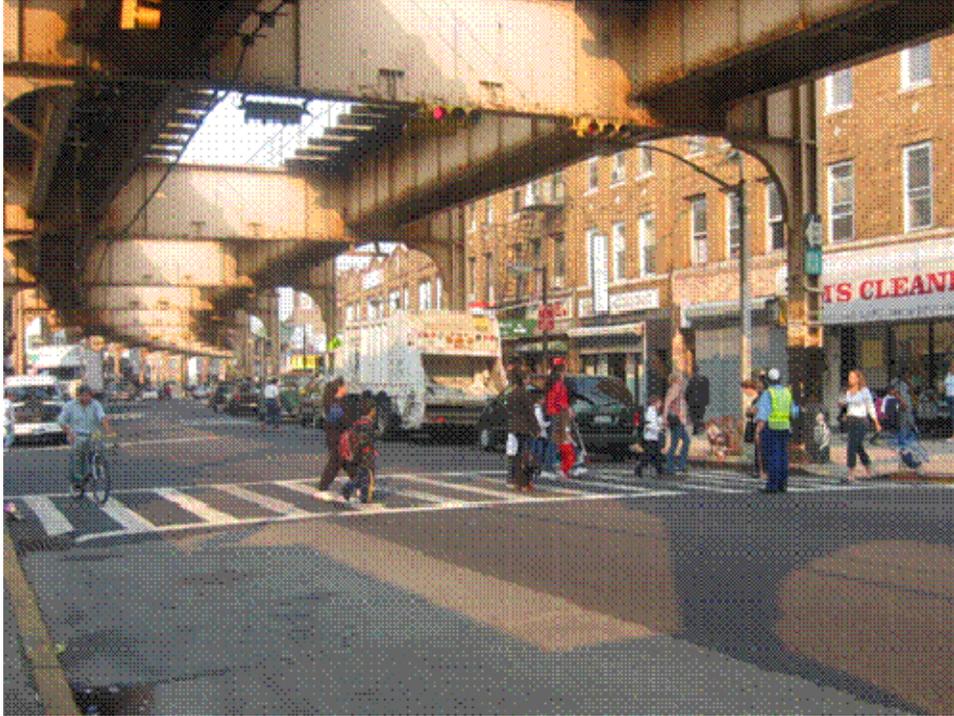
Figure 2: Looking west on Jamaica Avenue at 109th Street at the school crossing guard on duty

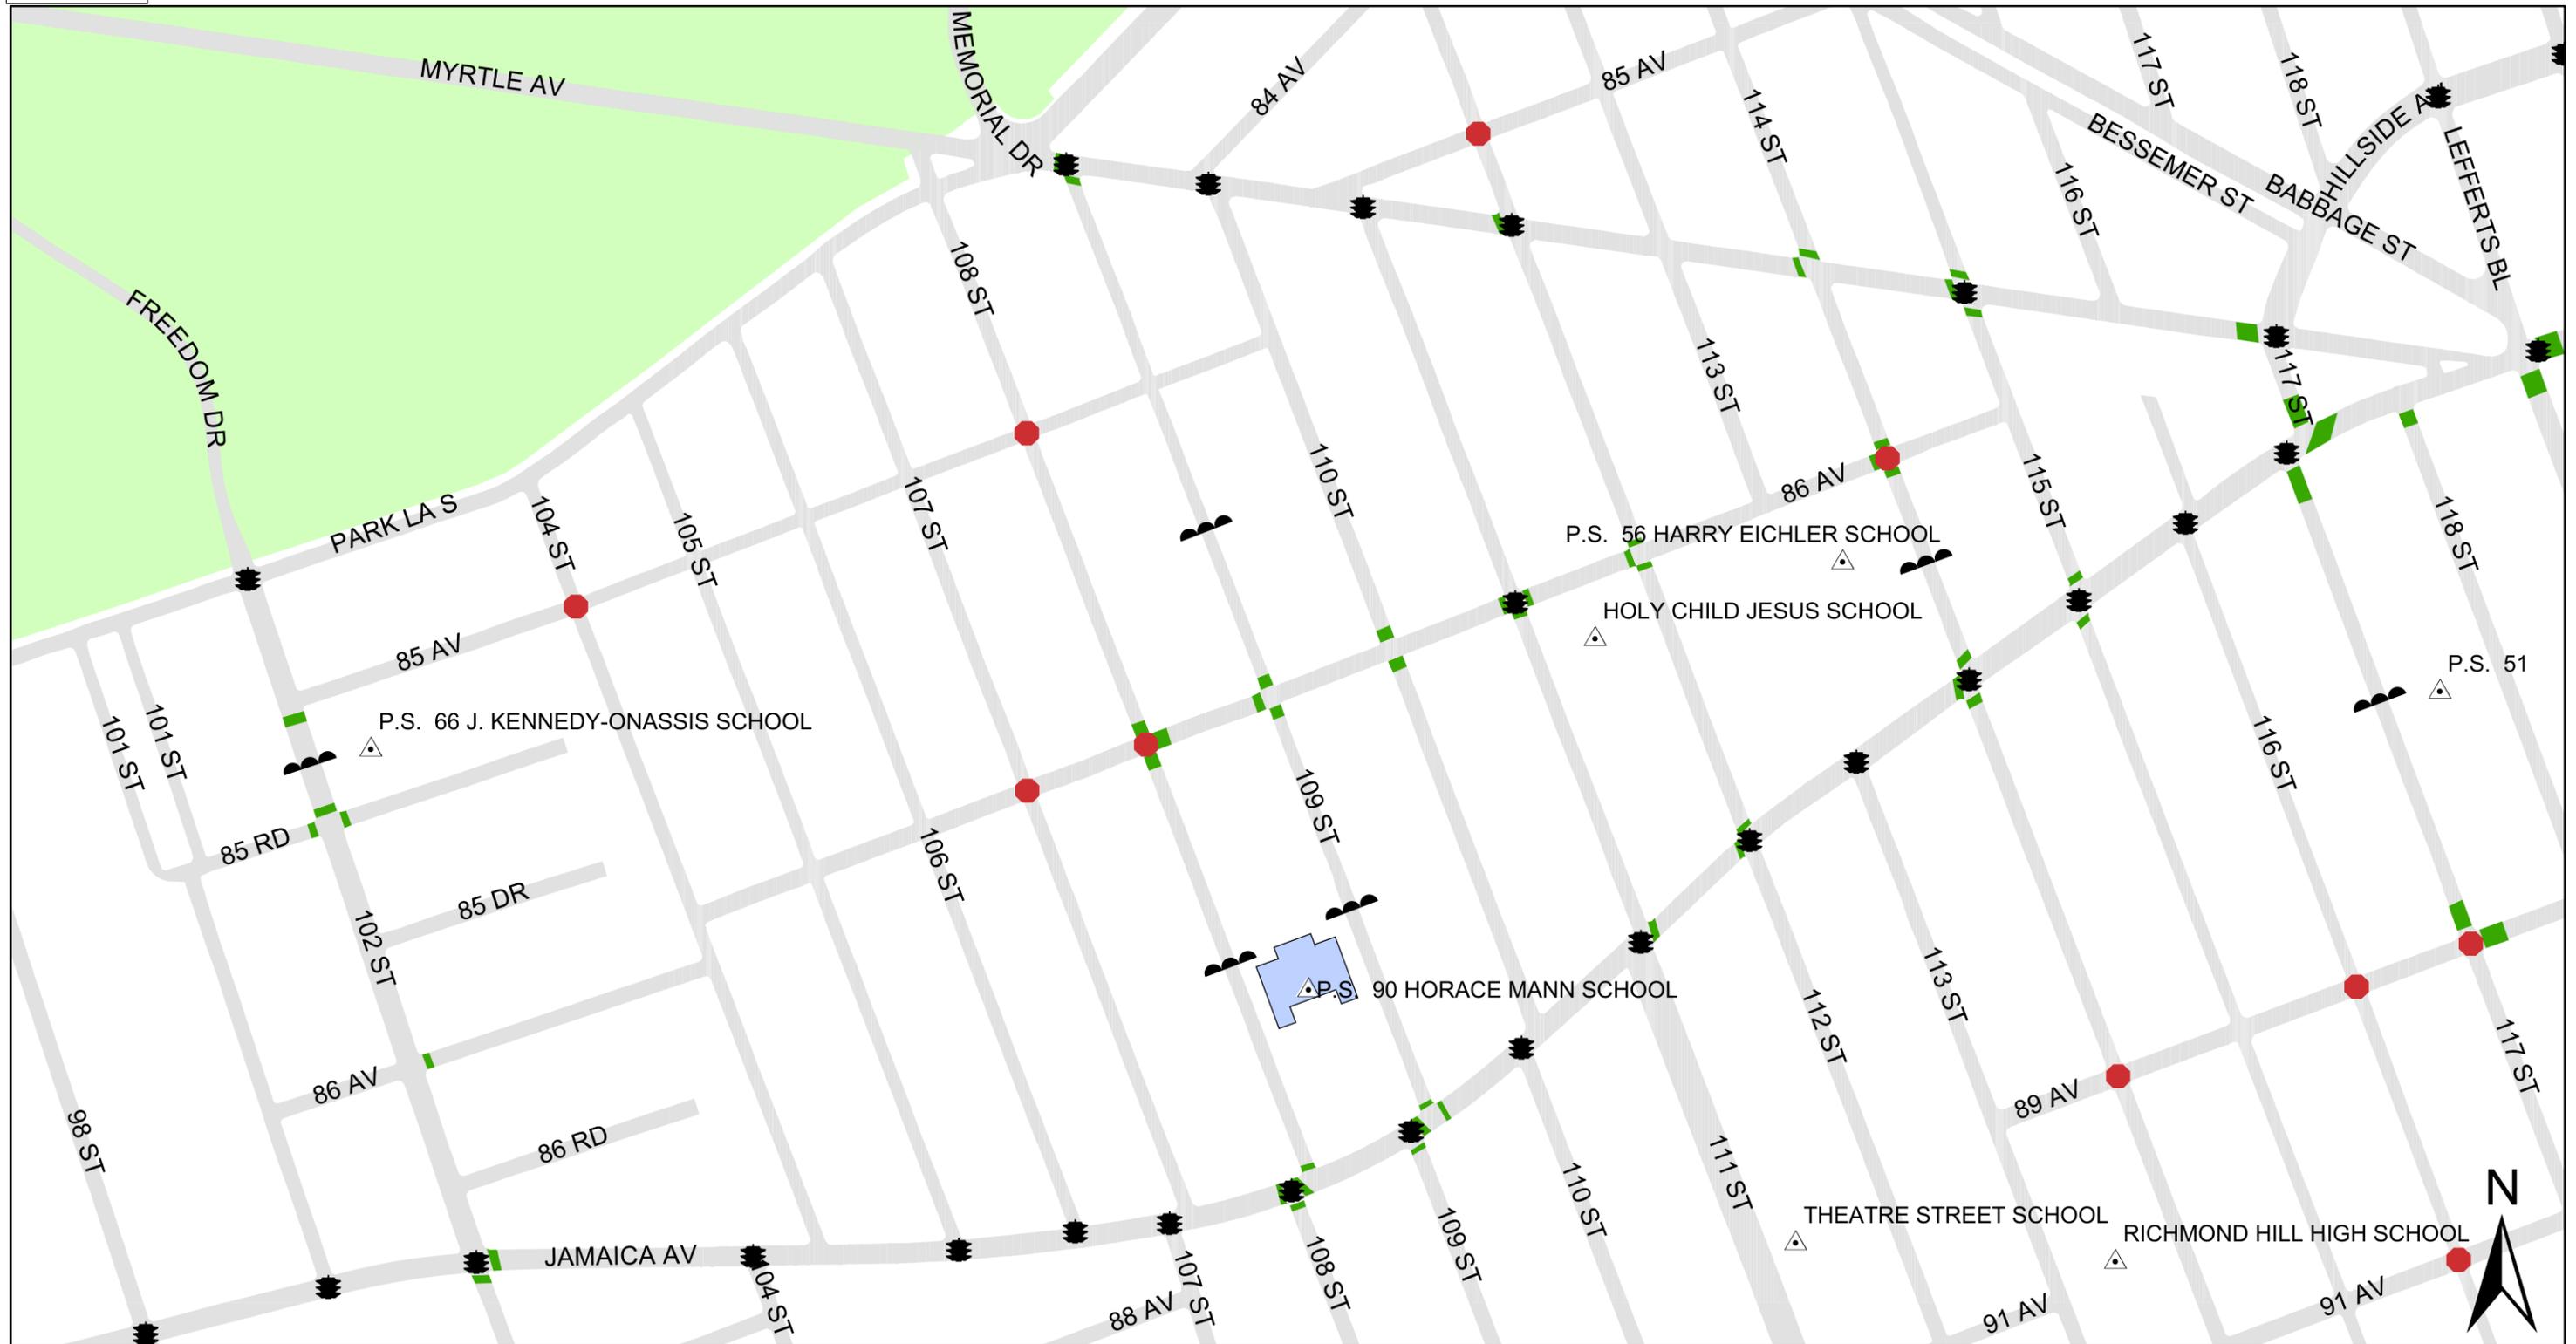
EXHIBIT 3

Exhibit 3 shows the existing school signals and pavement markings around P.S. 90. It should be noted that a citywide signage program is currently underway to upgrade school signage to current Federal Manual on Uniform Traffic Control Devices (MUTCD) standards of fluorescent yellow-green signs accompanied by downward pointing arrows. Signs scheduled to be installed under this program are shown as “existing” in Exhibit 8.

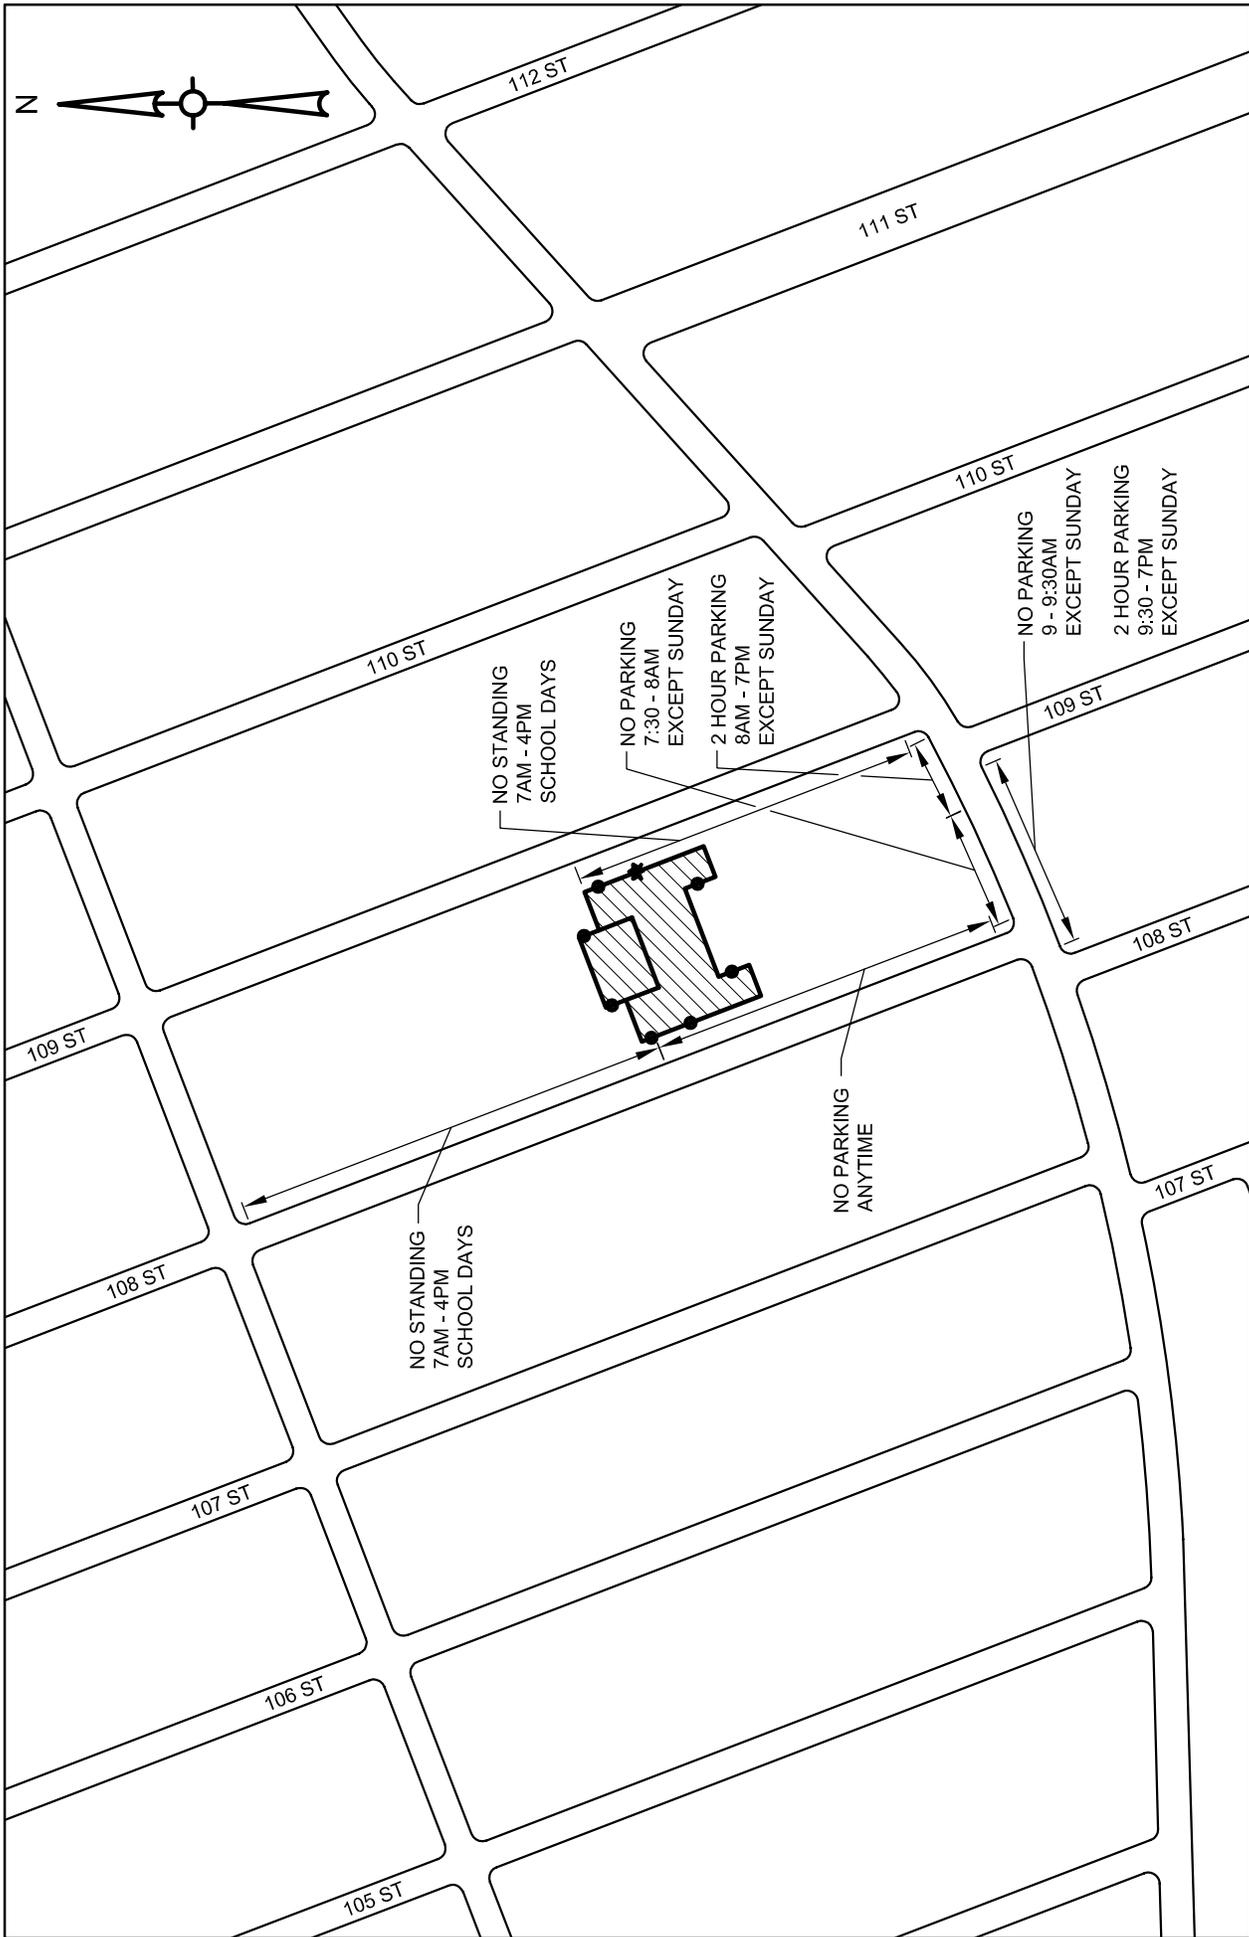
EXHIBIT 5
 P.S. 90 QUEENS
 HORACE MANN SCHOOL
 EXISTING PARKING REGULATIONS

There are “NO STANDING 7AM - 4PM SCHOOL DAYS” signs along the west side of 109th Street between Jamaica Avenue and the northern limit of the school building, including the main entrance to the school.

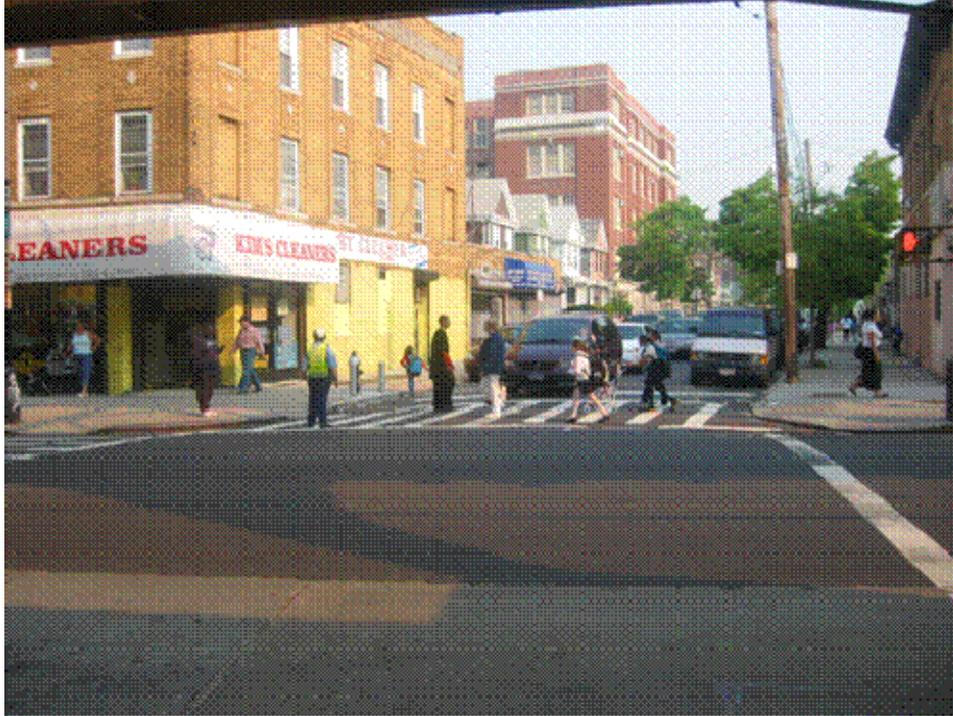
This is an offset signalized intersection with school crosswalks located across the north and south legs of 109th Street, the east leg of Jamaica Avenue, and the center section of Jamaica Avenue between the offset north and south legs of 109th Street (see Figures 4 and 5). Jamaica Avenue is a two-way street with one travel lane and on-street parking on each side of the roadway. Jamaica Avenue also has an elevated subway train running over the center of the roadway. 109th Street is a one-way southbound street with one travel lane and parking on both sides of the roadway. The north leg of 109th Street is offset to the east of the south leg of 109th Street (see Exhibits 3 and 8).

There were a total of 10 accidents reported at this intersection between 1998 and 2000 (Table 2), including one pedestrian accident that was not school-related. However, one school-related pedestrian accident was reported mid-block on Jamaica Avenue between 109th Street and 110th Street. This particular accident occurred at approximately 3:00 pm on November 4, 1999 when a six-year-old pedestrian suffered a “possible injury.” The pedestrian’s actions were unreported. The road surface was dry, the weather was clear, and the accident occurred during daylight conditions. There were no pedestrian fatalities reported at this intersection.

Figure 4: Looking north across Jamaica Avenue along 109th Street (P.S. 90 can be seen on the left side of 109th Street)

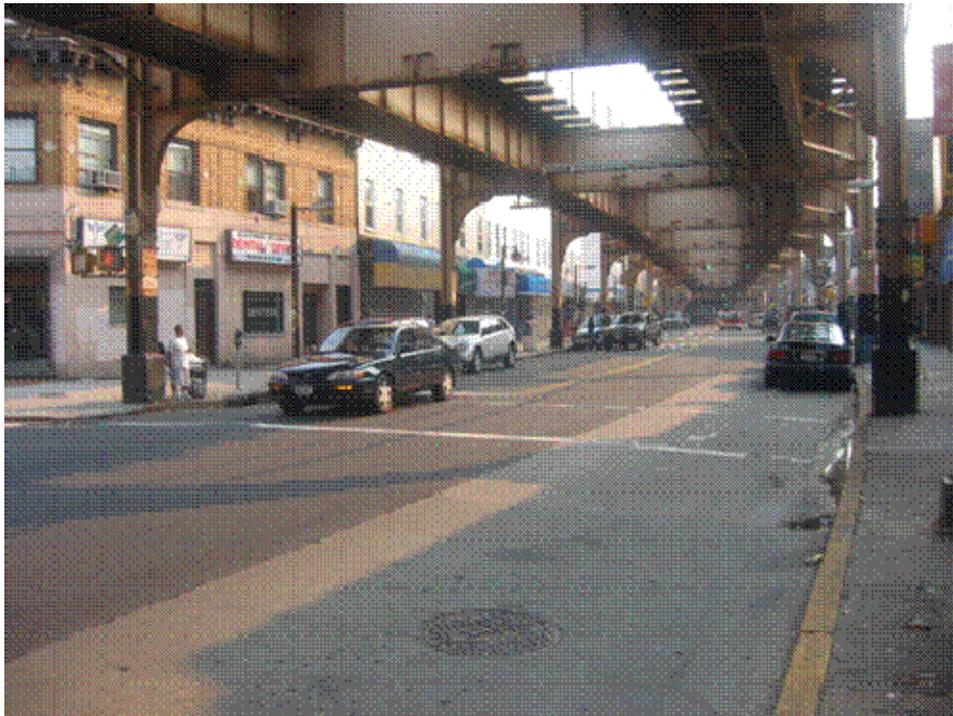
Figure 5: Looking east on Jamaica Avenue across the intersection with 109th Street

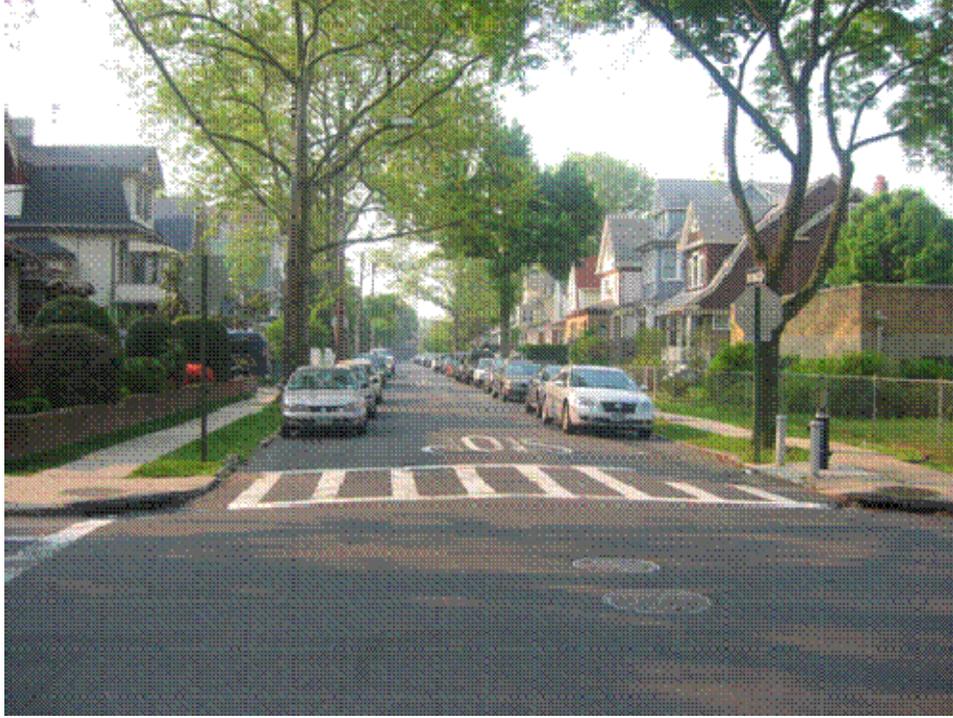
This is a four-leg, all-way stop-controlled, intersection with school crosswalks located across the north and south legs of 108th Street, and the east leg of 86th Avenue. 86th Avenue is a two-way street with one travel lane and on-street parking on each side of the roadway. 108th Street is a one-way northbound street with one travel lane and parking on both sides of the roadway (see Figures 6 and 7).

There were five accidents reported at this intersection between 1998 and 2000 (Table 2), but none of these involved pedestrians.

Figure 6: Looking south along 108th Street across 86th Avenue

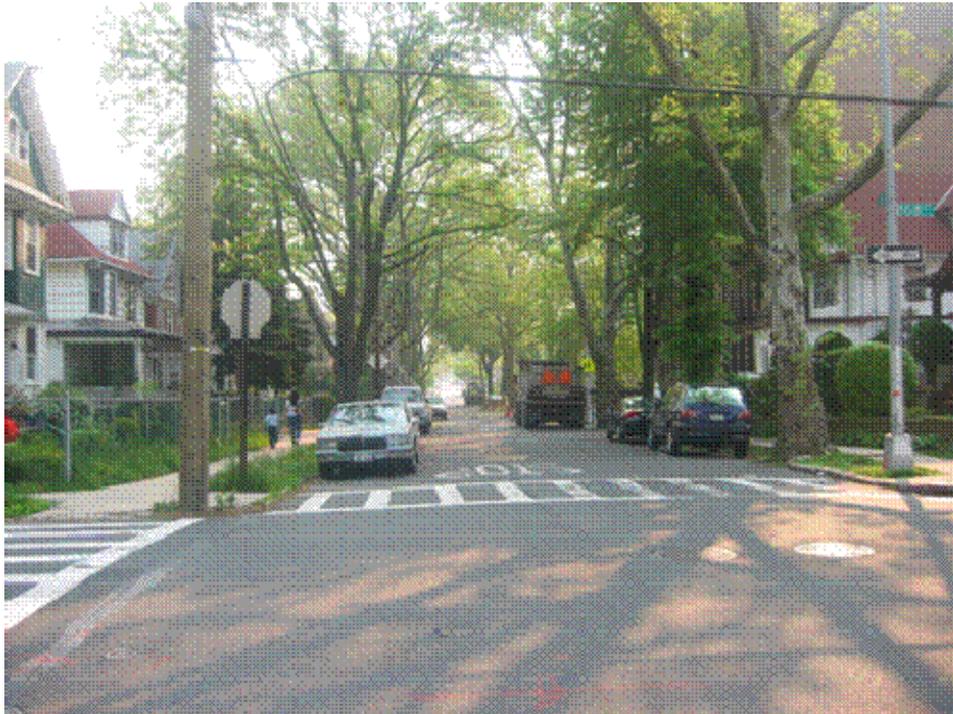
Figure 7: Looking east on 86th Avenue across 108th Street

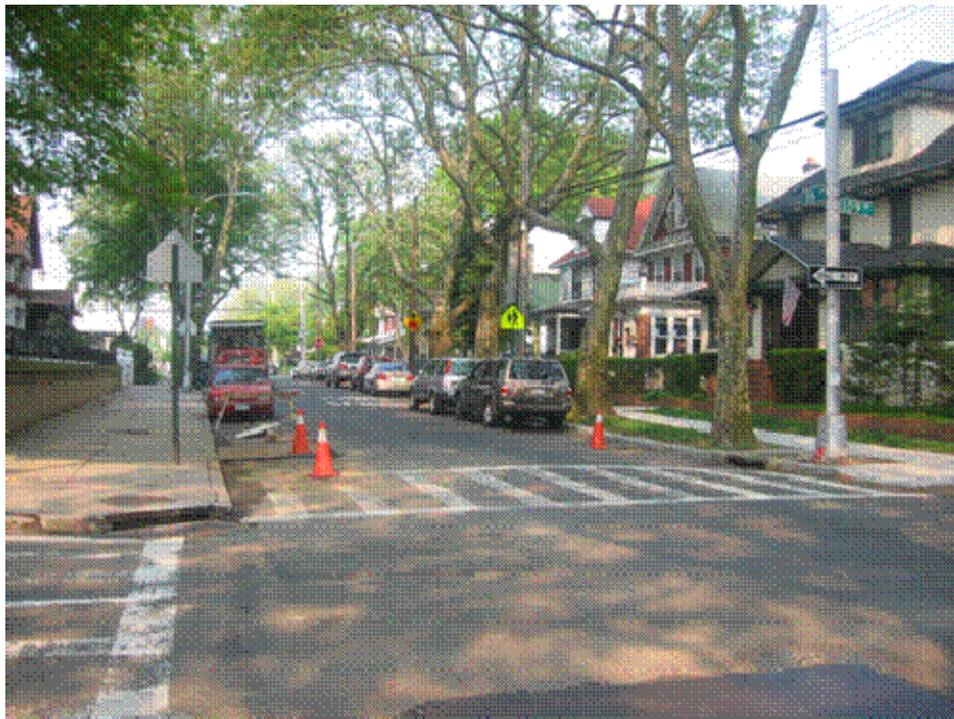
This is a four-leg unsignalized intersection with school crosswalks located across the north and south legs of 109th Street, and the west leg of 86th Avenue. 86th Avenue is a two-way street with one travel lane and on-street parking on each side of the roadway. 109th Street is a one-way southbound street with one travel lane and parking on both sides of the roadway. There is a stop sign for southbound 109th Street and 86th Avenue is the through street (see Figures 8 and 9).

An uncontrolled school crosswalk is located across the west leg of 86th Avenue. In order to determine the most appropriate type of traffic control for the school crosswalk, a preliminary traffic signal warrant assessment was performed. As part of this assessment, a traffic count was conducted at the intersection of 86th Avenue and 109th Street from 7:30 to 9:00 am on Wednesday, November 2, 2005 to better understand the pedestrian/vehicle conflict at the intersection. The results of the peak hour (7:30 to 8:30 am) count are shown in Table 4 and in Exhibit 7 at the end of this section.

Figure 8: Looking west on 86th Avenue across the intersection with 109th Street

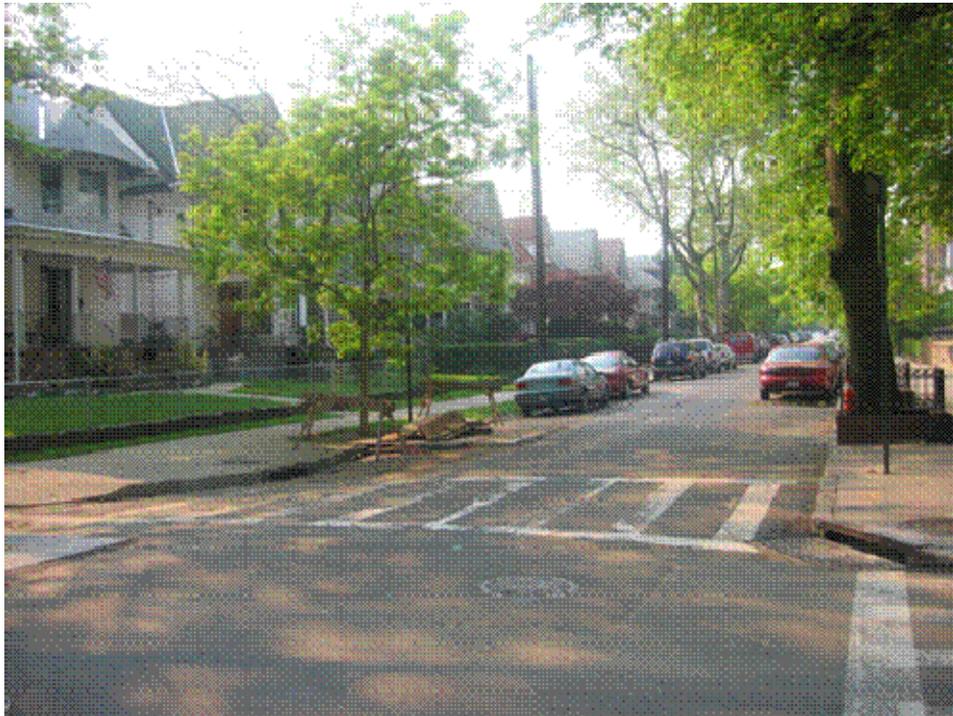
Figure 9: Looking south on 109th Street across the intersection with 86th Avenue

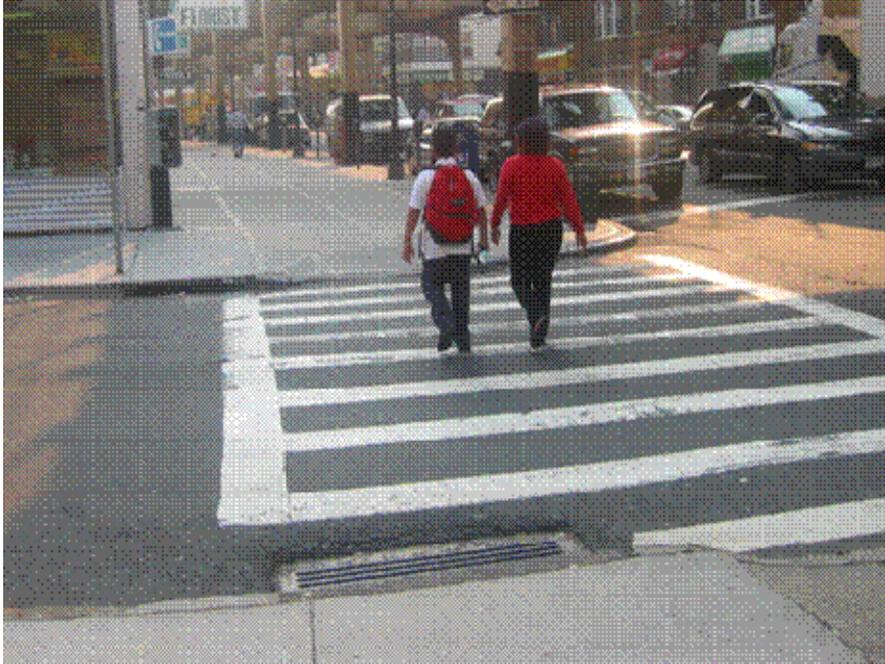
- A pedestrian ramp is missing on the northwest corner, for the school crosswalk across Jamaica Avenue connecting the northwest and southeast corners of the intersection.
- A pedestrian ramp is missing on the north side of Jamaica Avenue, west of 108th Street, for the school crosswalk located across the west leg of the intersection.
- A pedestrian ramp is missing on the southwest corner of the intersection for the school crosswalk located across the south leg of 108th Street.
- A drainage inlet is located in the crosswalk across the north leg of the intersection near the northeast corner (see Figure 10).

Figure 10: Looking east across the north leg of the Jamaica Avenue and 108th Street intersection at the existing drainage inlet located within the school crosswalk.

- Construct a pedestrian ramp on the northwest corner where the pedestrian ramp is missing for the school crosswalk connecting with the southeast corner of the intersection.
- Construct a pedestrian ramp on the north side of Jamaica Avenue, west of 108th Street, where the pedestrian ramp is missing for the school crosswalk located across the west leg of the intersection.
- Construct a pedestrian ramp on the southwest corner of the intersection where the pedestrian ramp is missing for the school crosswalk located across the south leg of 108th Street.
- Relocate the drainage inlet near the northwest corner of the intersection for the crosswalk located across the north leg of 108th Street.

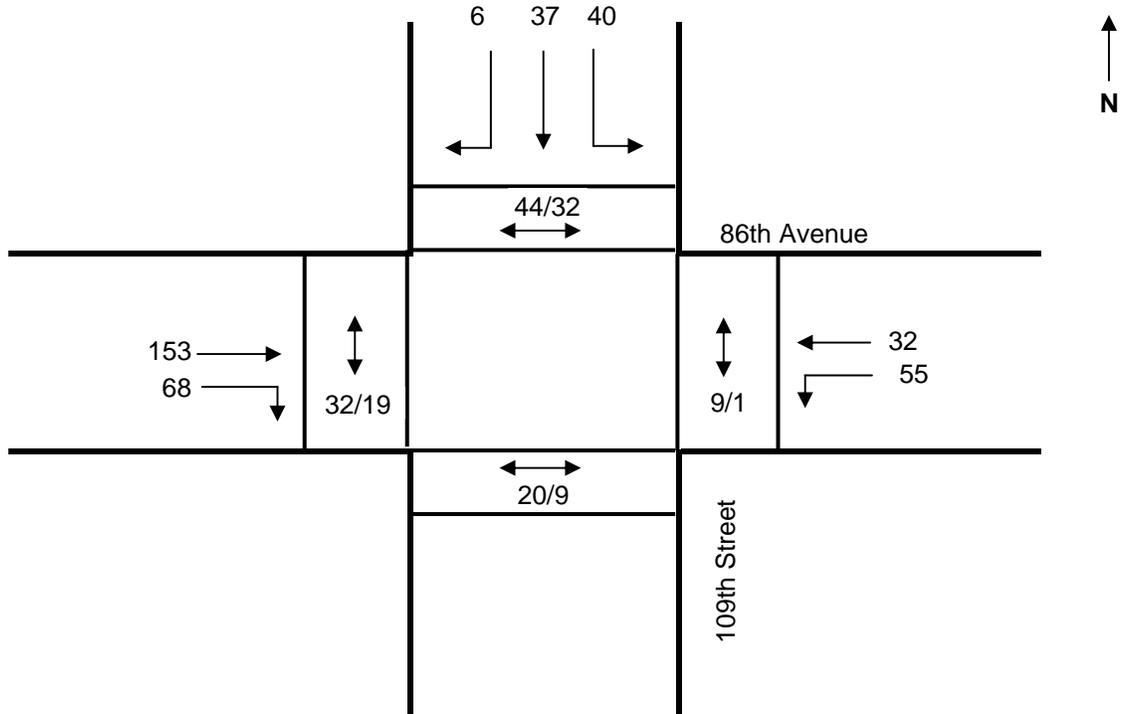
EXHIBIT 7
P.S. 90 QUEENS HORACE MANN SCHOOL
TRAFFIC AND PEDESTRIAN COUNTS

The traffic volume count showed a total of 51 pedestrians (32 adults and 19 students) utilizing the school crosswalk located across the west leg of 86th Avenue, and ten pedestrians (nine adults and one student) were utilizing the east leg of 86th Avenue where no marked crosswalk exists. This results in a total of 61 pedestrians crossing 86th Avenue at its intersection with 109th Street (41 adults and 20 students) during the 7:30 to 8:30 am peak hour.

One Hour Traffic Volumes
Wednesday, November 2nd, 2005 7:30am - 8:30am

Intersection of 86th Avenue and 109th Street

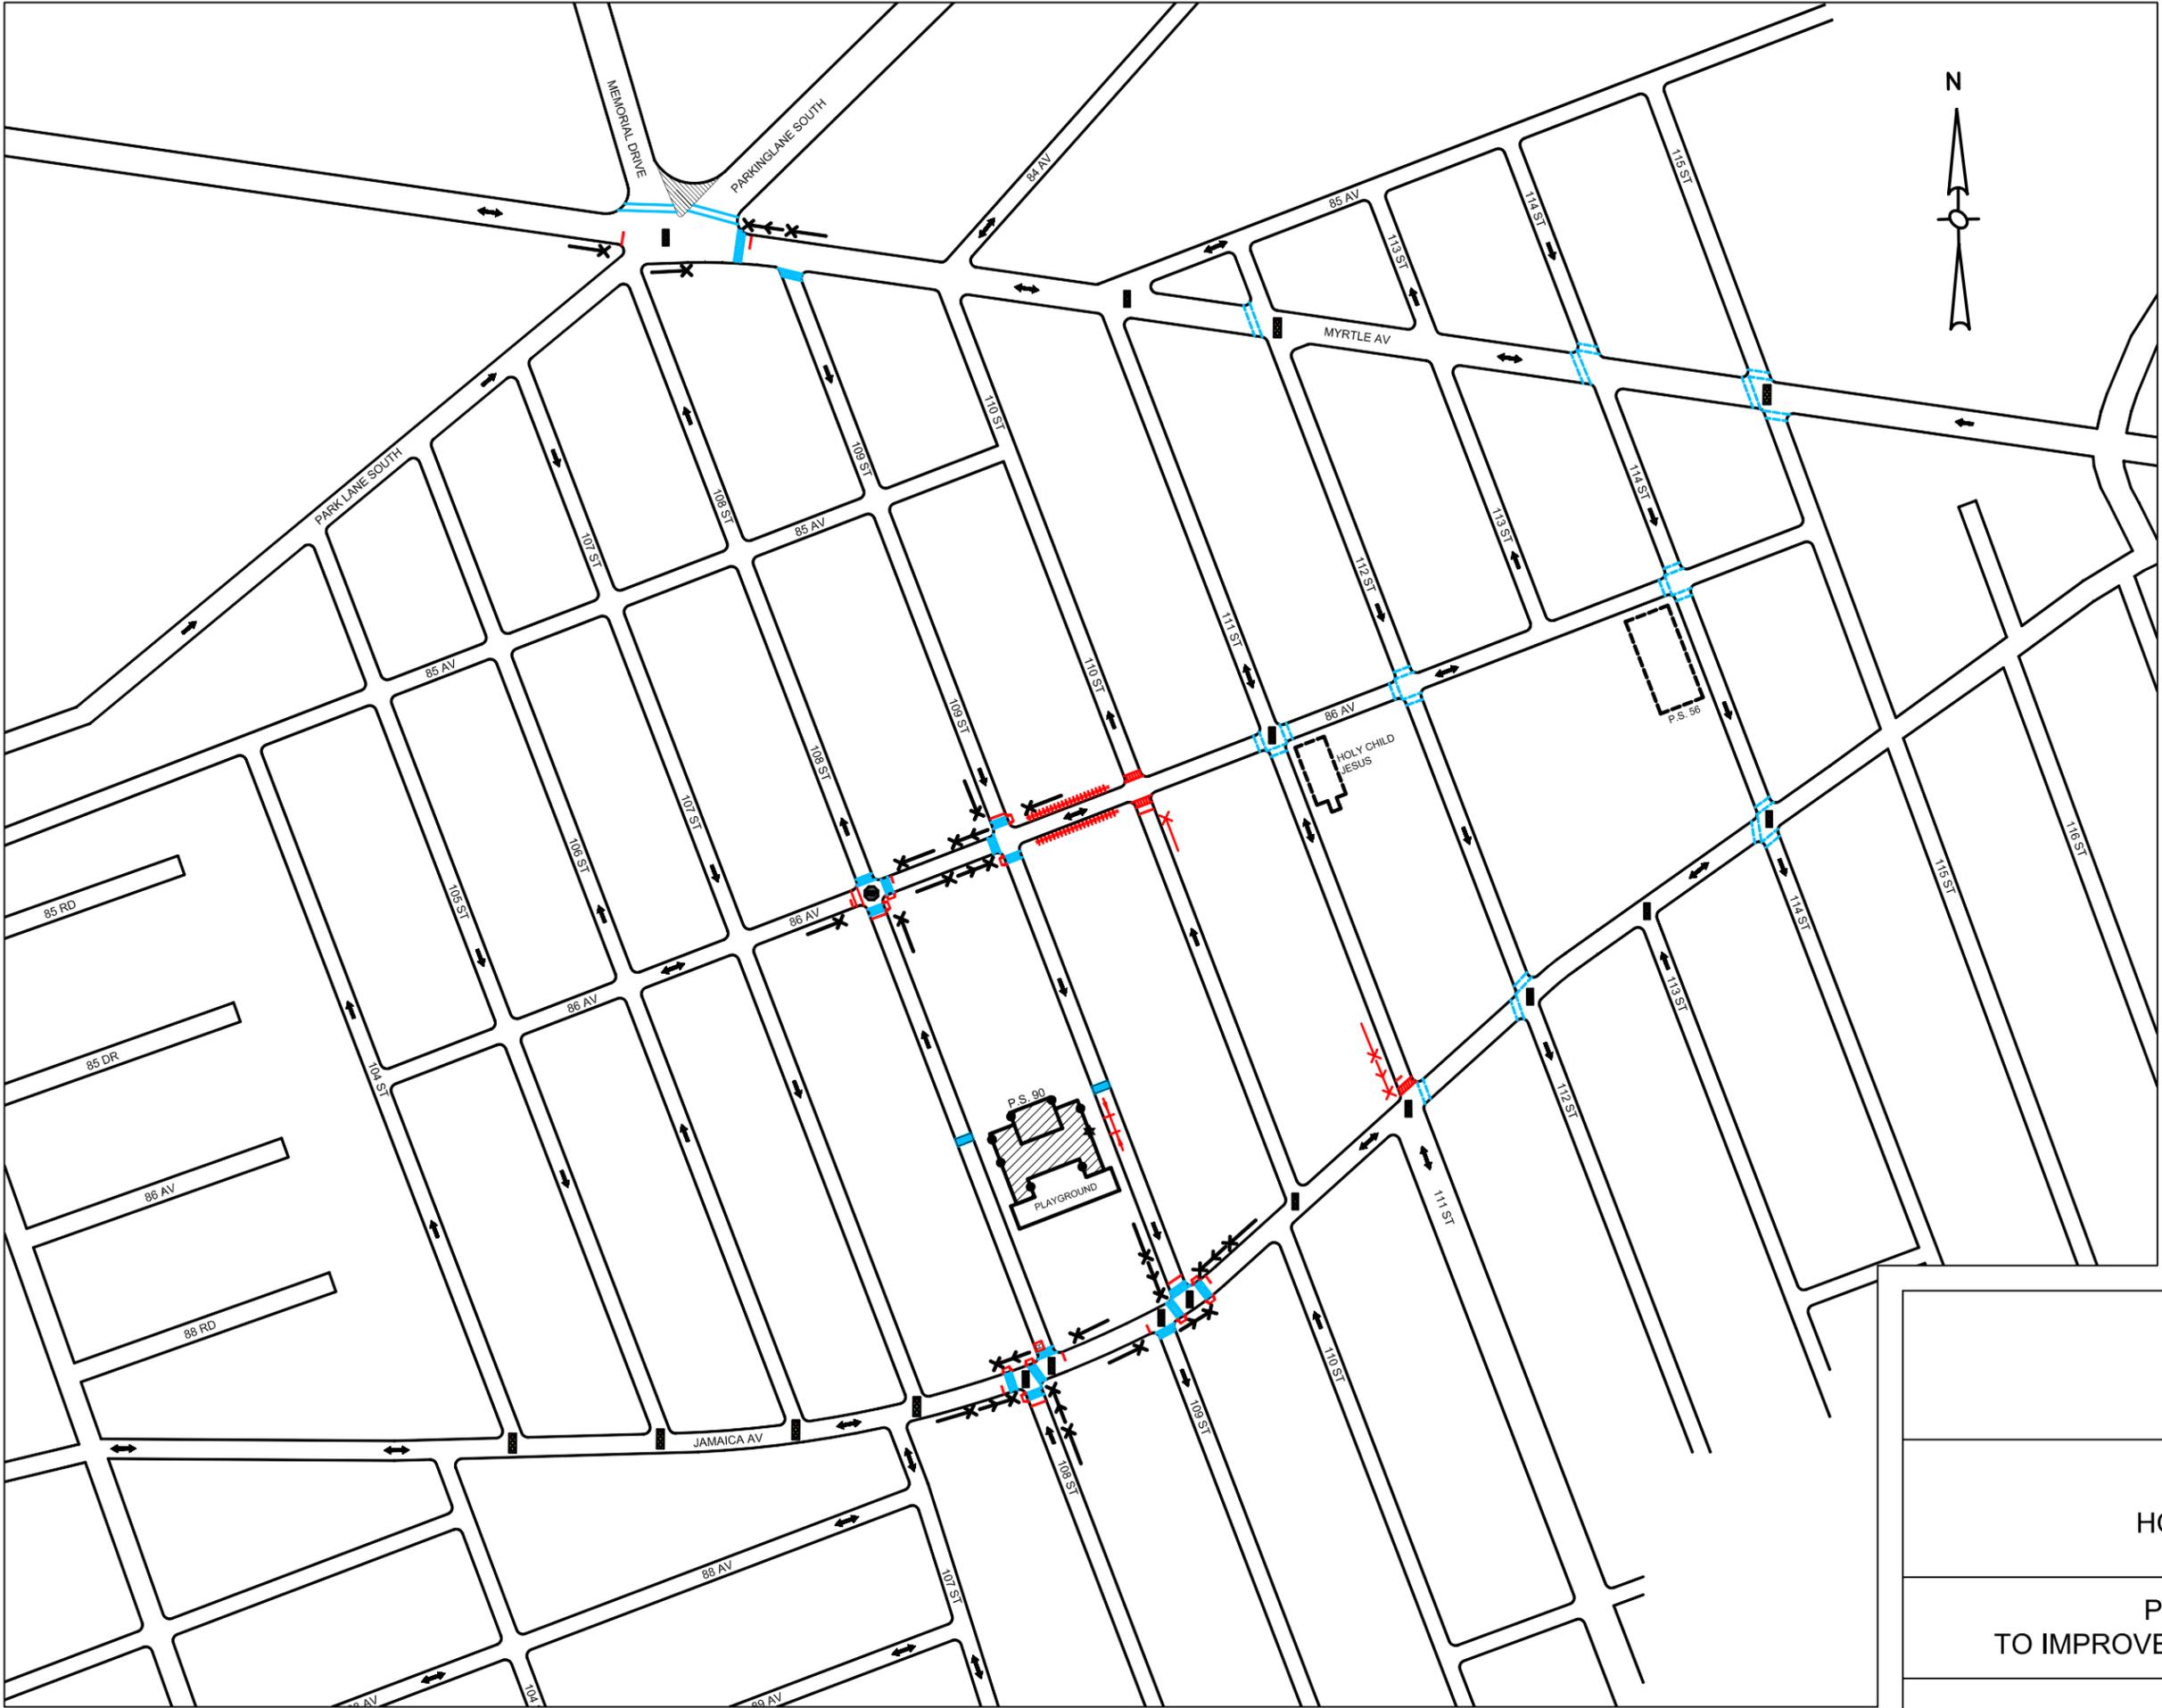
POTENTIAL MEASURES
TO IMPROVE STUDENT PEDESTRIAN SAFETY

This section describes proposed measures to improve school pedestrian safety around P.S. 90. The proposed recommendations are divided into short-term and long-term measures. Short-term measures are those that potentially can be performed in-house. Long-term measures involve capital improvements. Each of the short- and long-term measures recommended for P.S. 90 is discussed as follows, and is shown in more detail in Exhibit 8 at the end of this section.

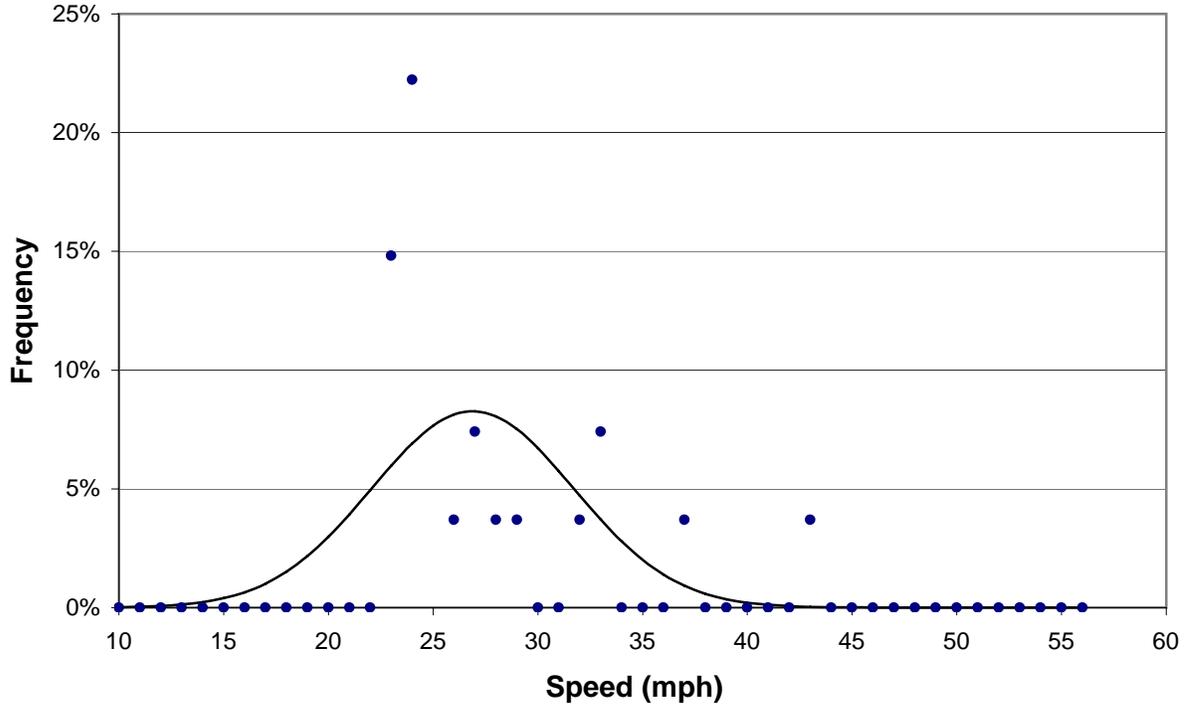
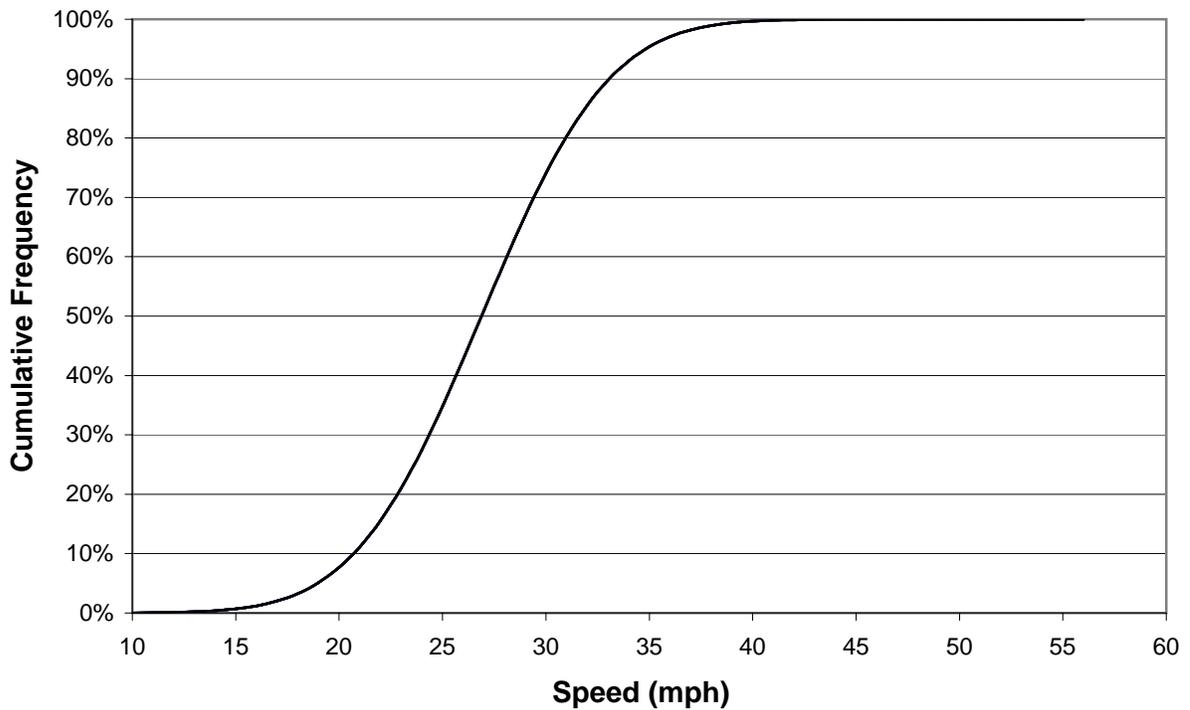
SPOT SPEED STUDY

Mean Speed = 26.9 mph
Standard Deviation = 4.8 mph
Margin of Error (95% Confidence) = ± 1.8 mph

Median Speed = 26.9 mph
15th Percentile Speed = 21.9 mph
85th Percentile Speed = 31.9 mph

The 85th percentile speed for northbound vehicles on 108th Street between Jamaica Avenue and 86th Avenue was found to be 32 mph. The 85th percentile speed is considered to be the representative speed for the street segment. Speeds above the 30 mph threshold indicate a speeding problem that may require appropriate traffic calming measures.
