**Amendment to Application for 28-30 East 92nd Street:
Change in Brownstone Repair and Replacement Scope
Due to Field Conditions**

Nightingale-Bamford School
 Facade of 28-30 East 92nd Street, New York

BRB Architects

October 20, 2015

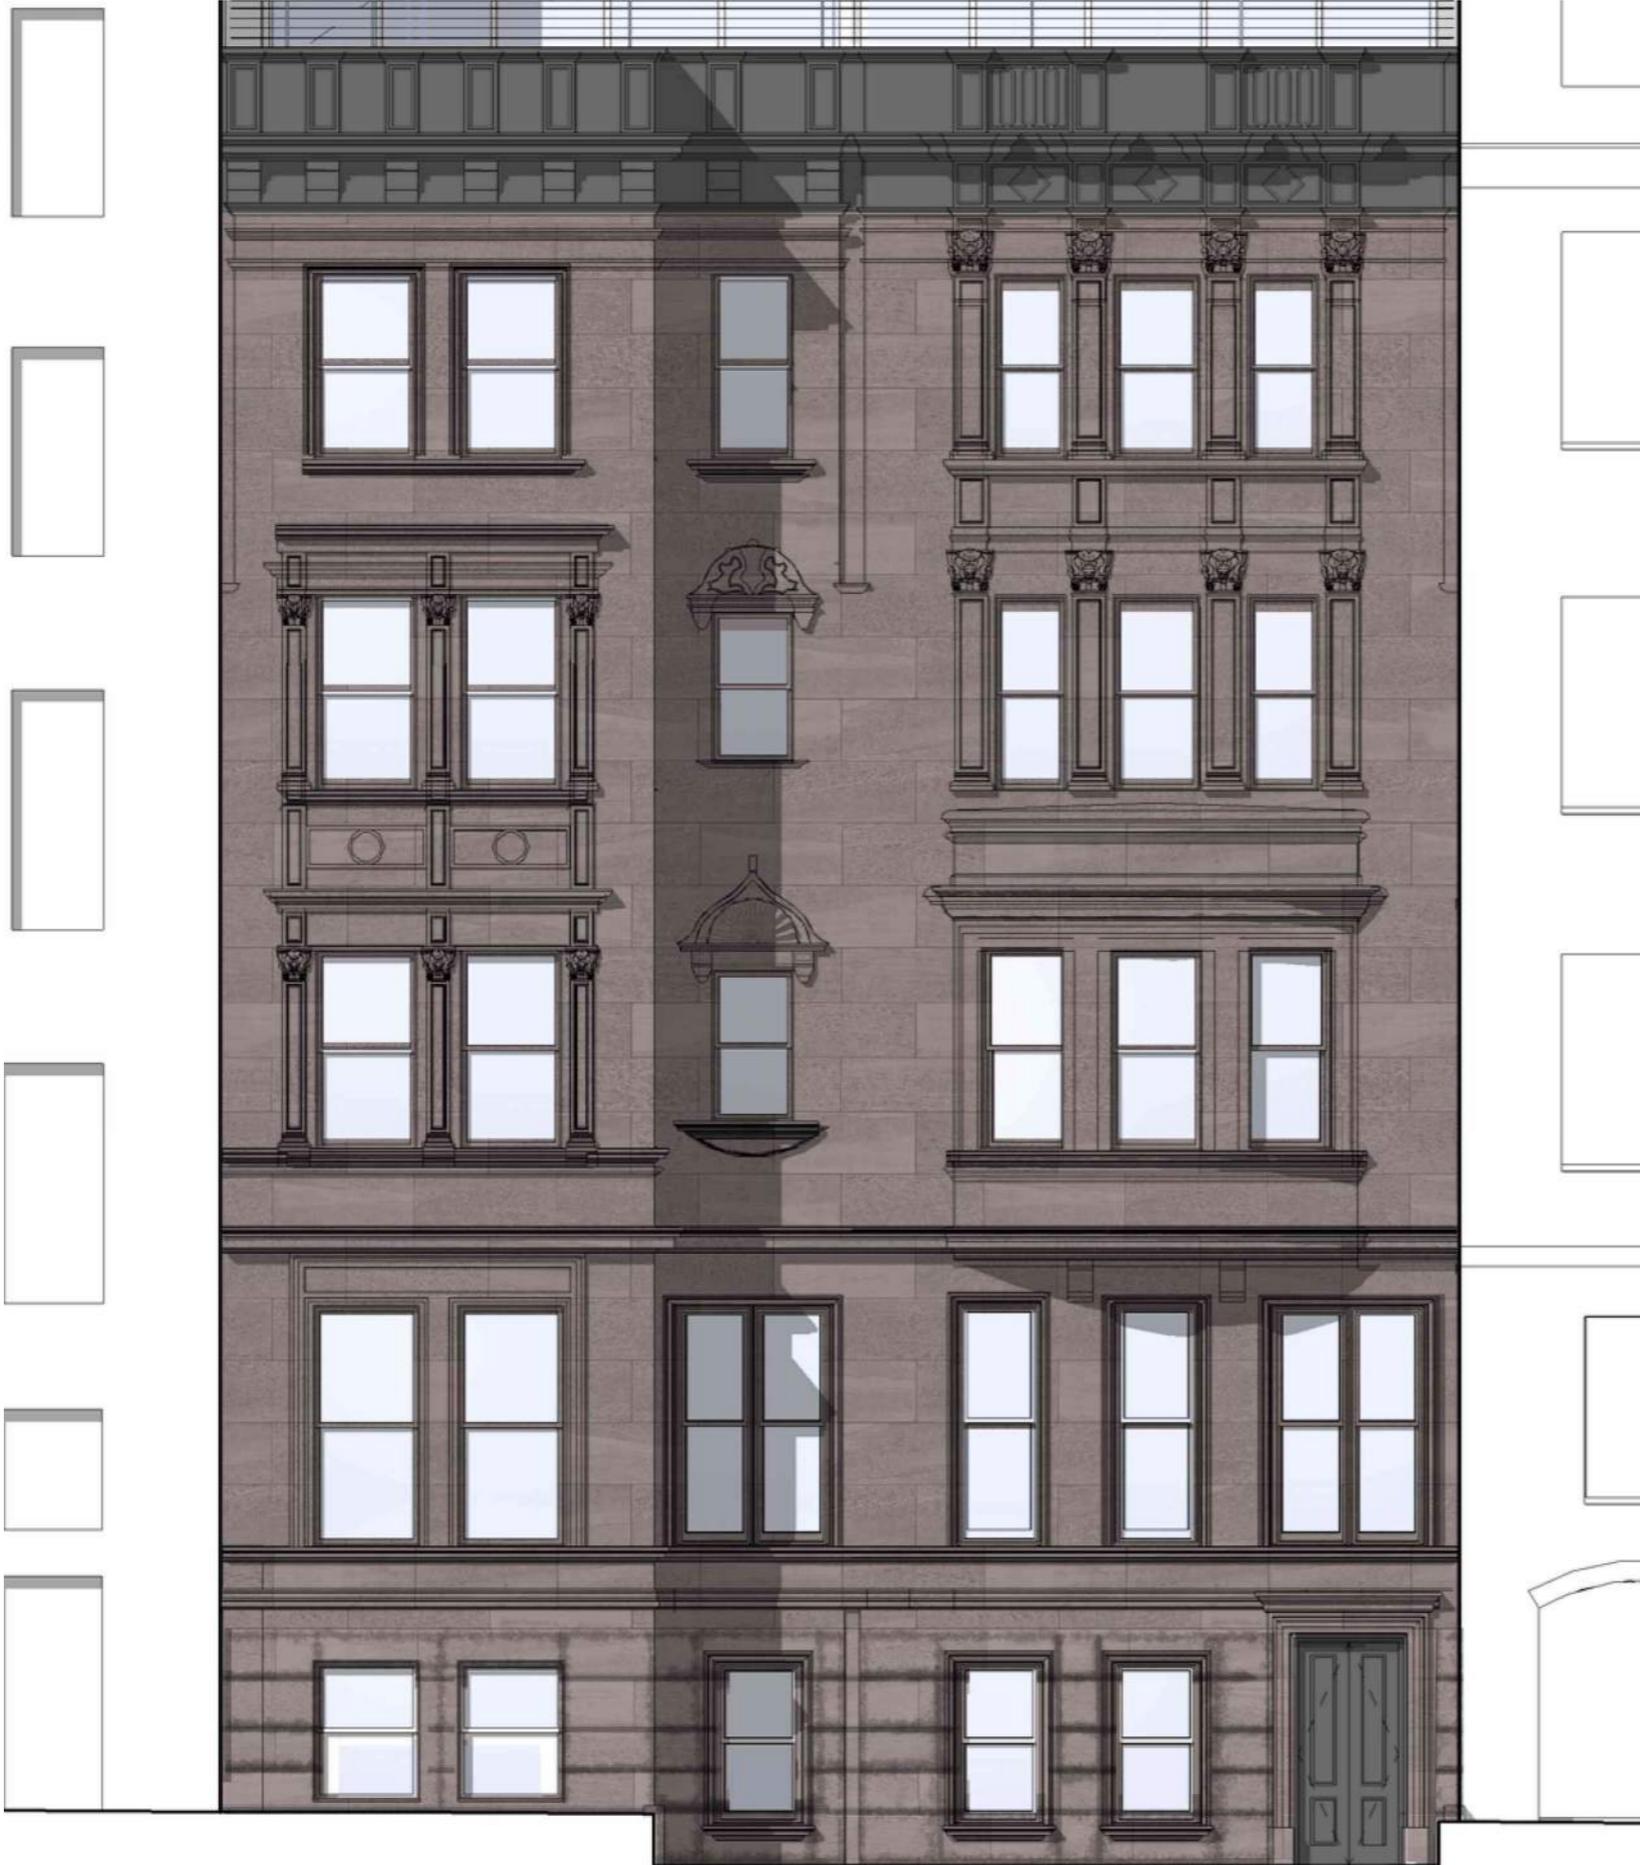
Proposed Front Elevation

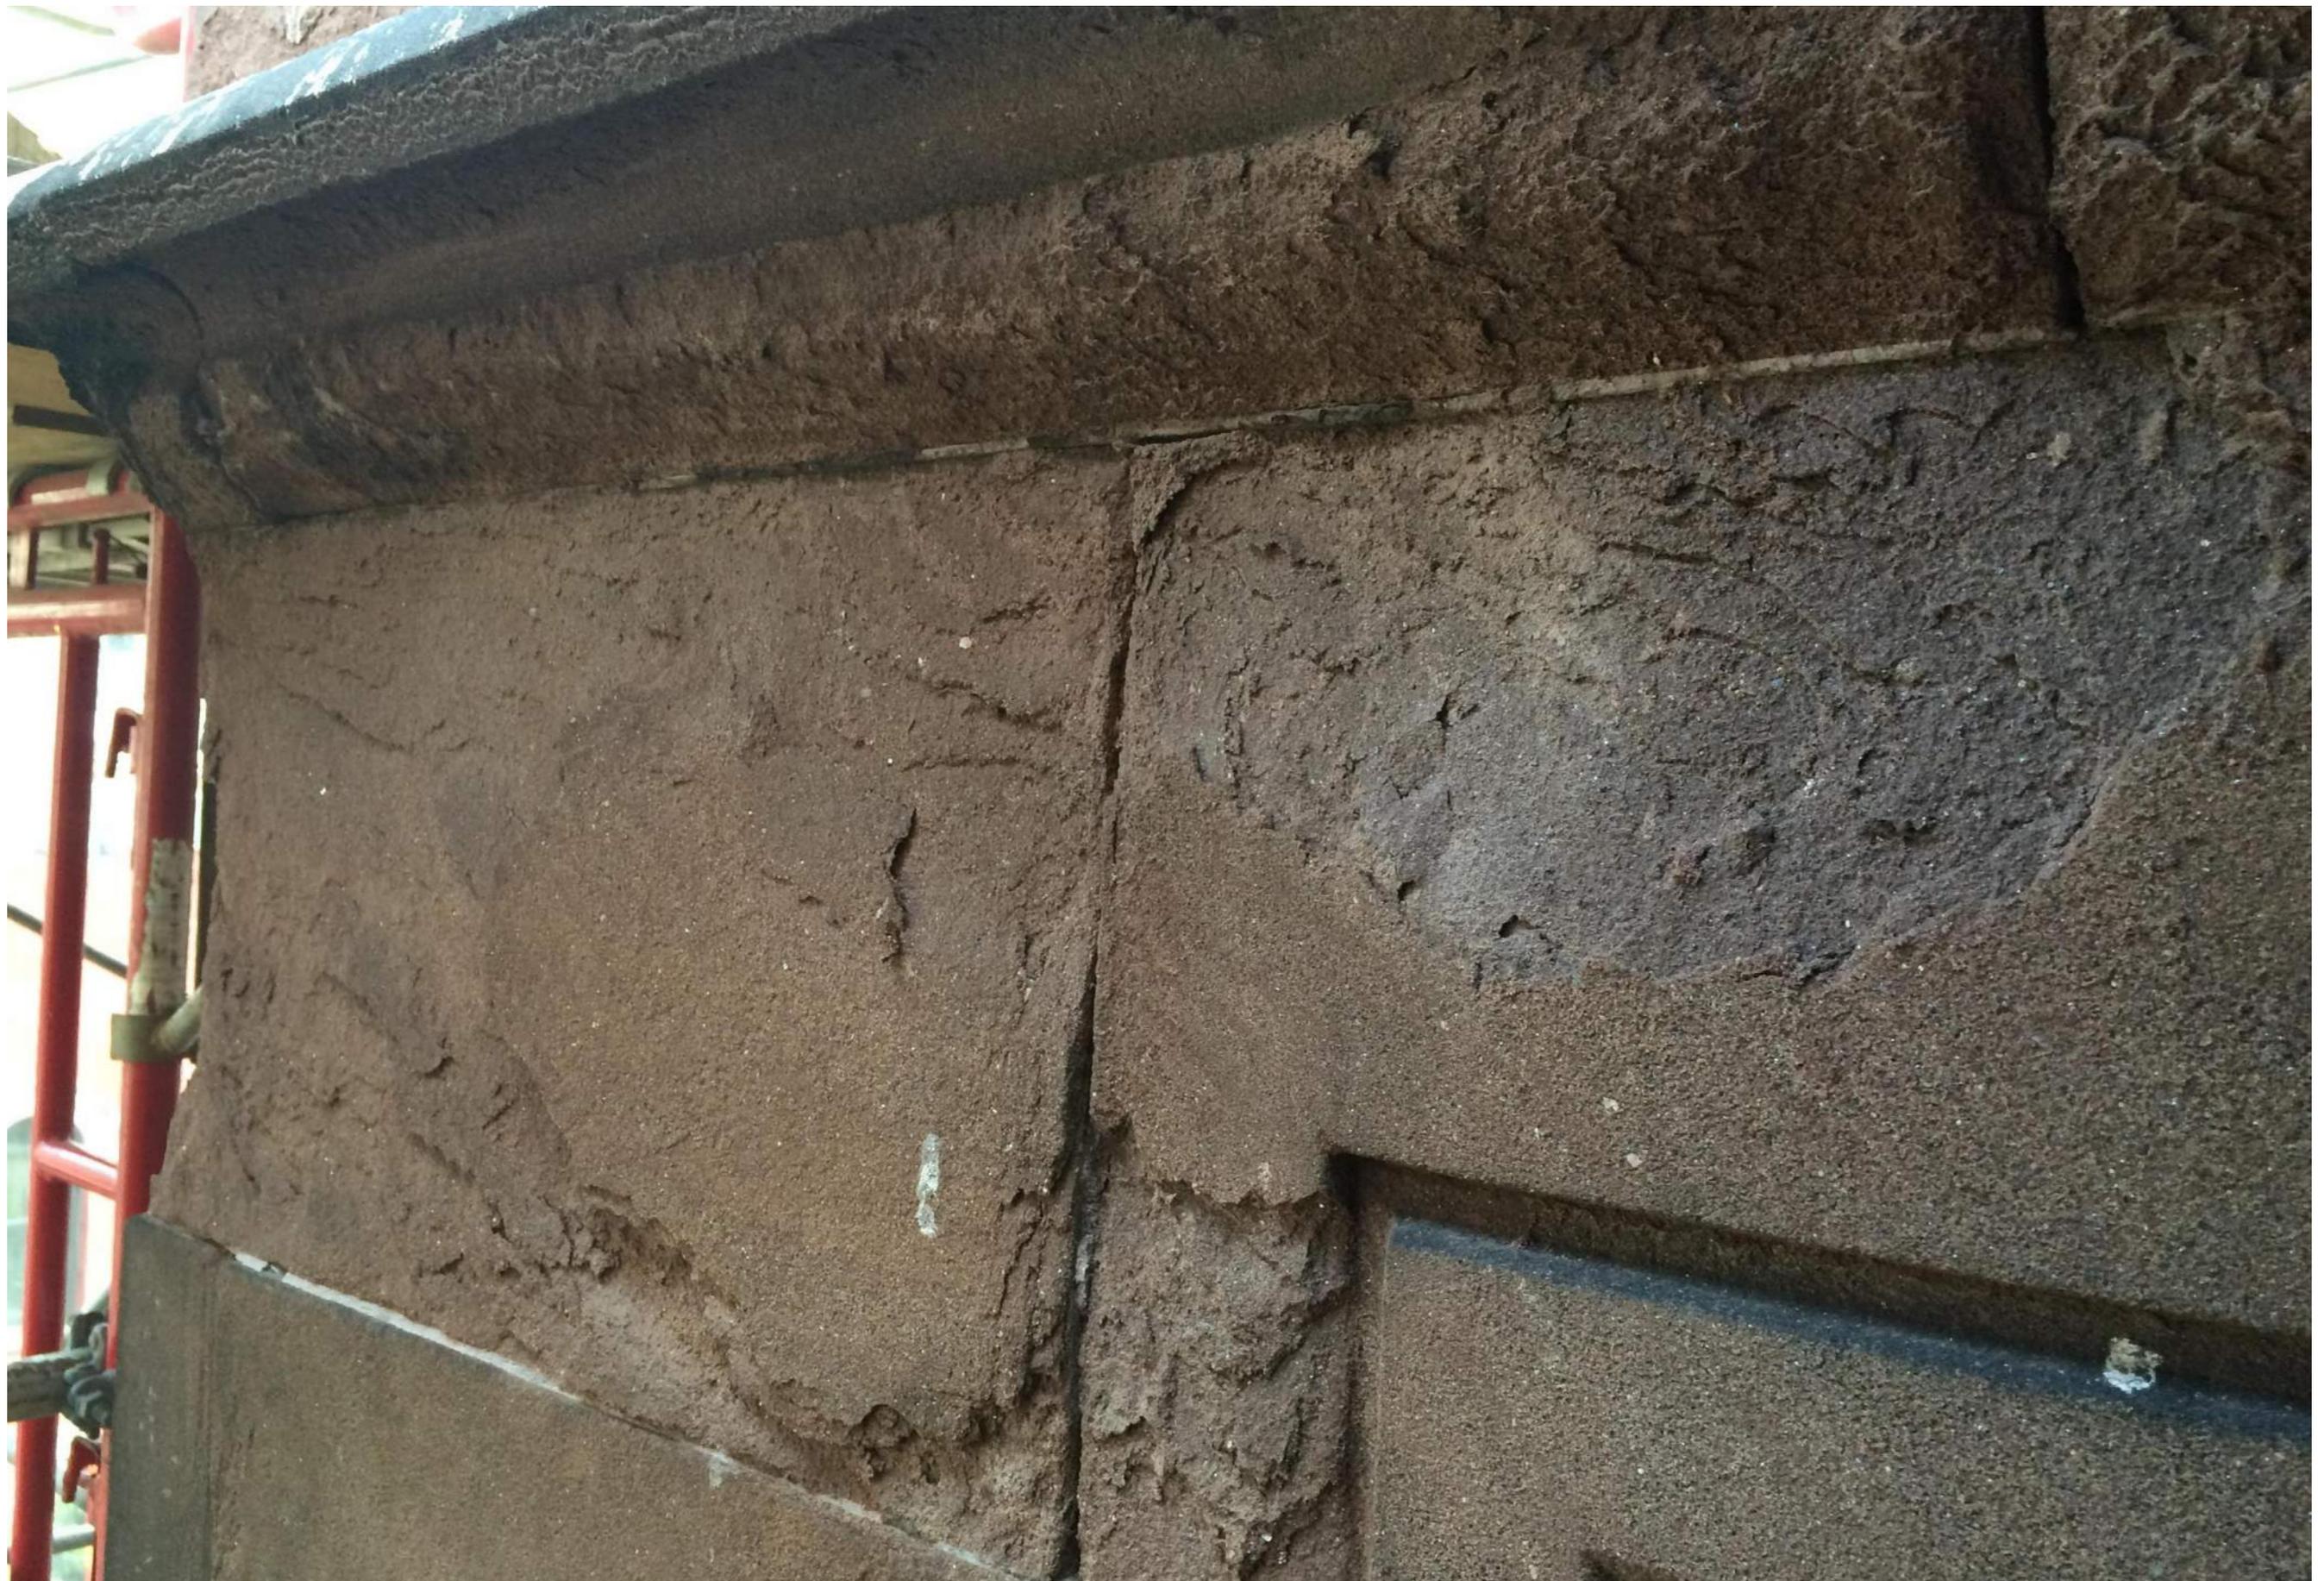
Brownstone Field Conditions

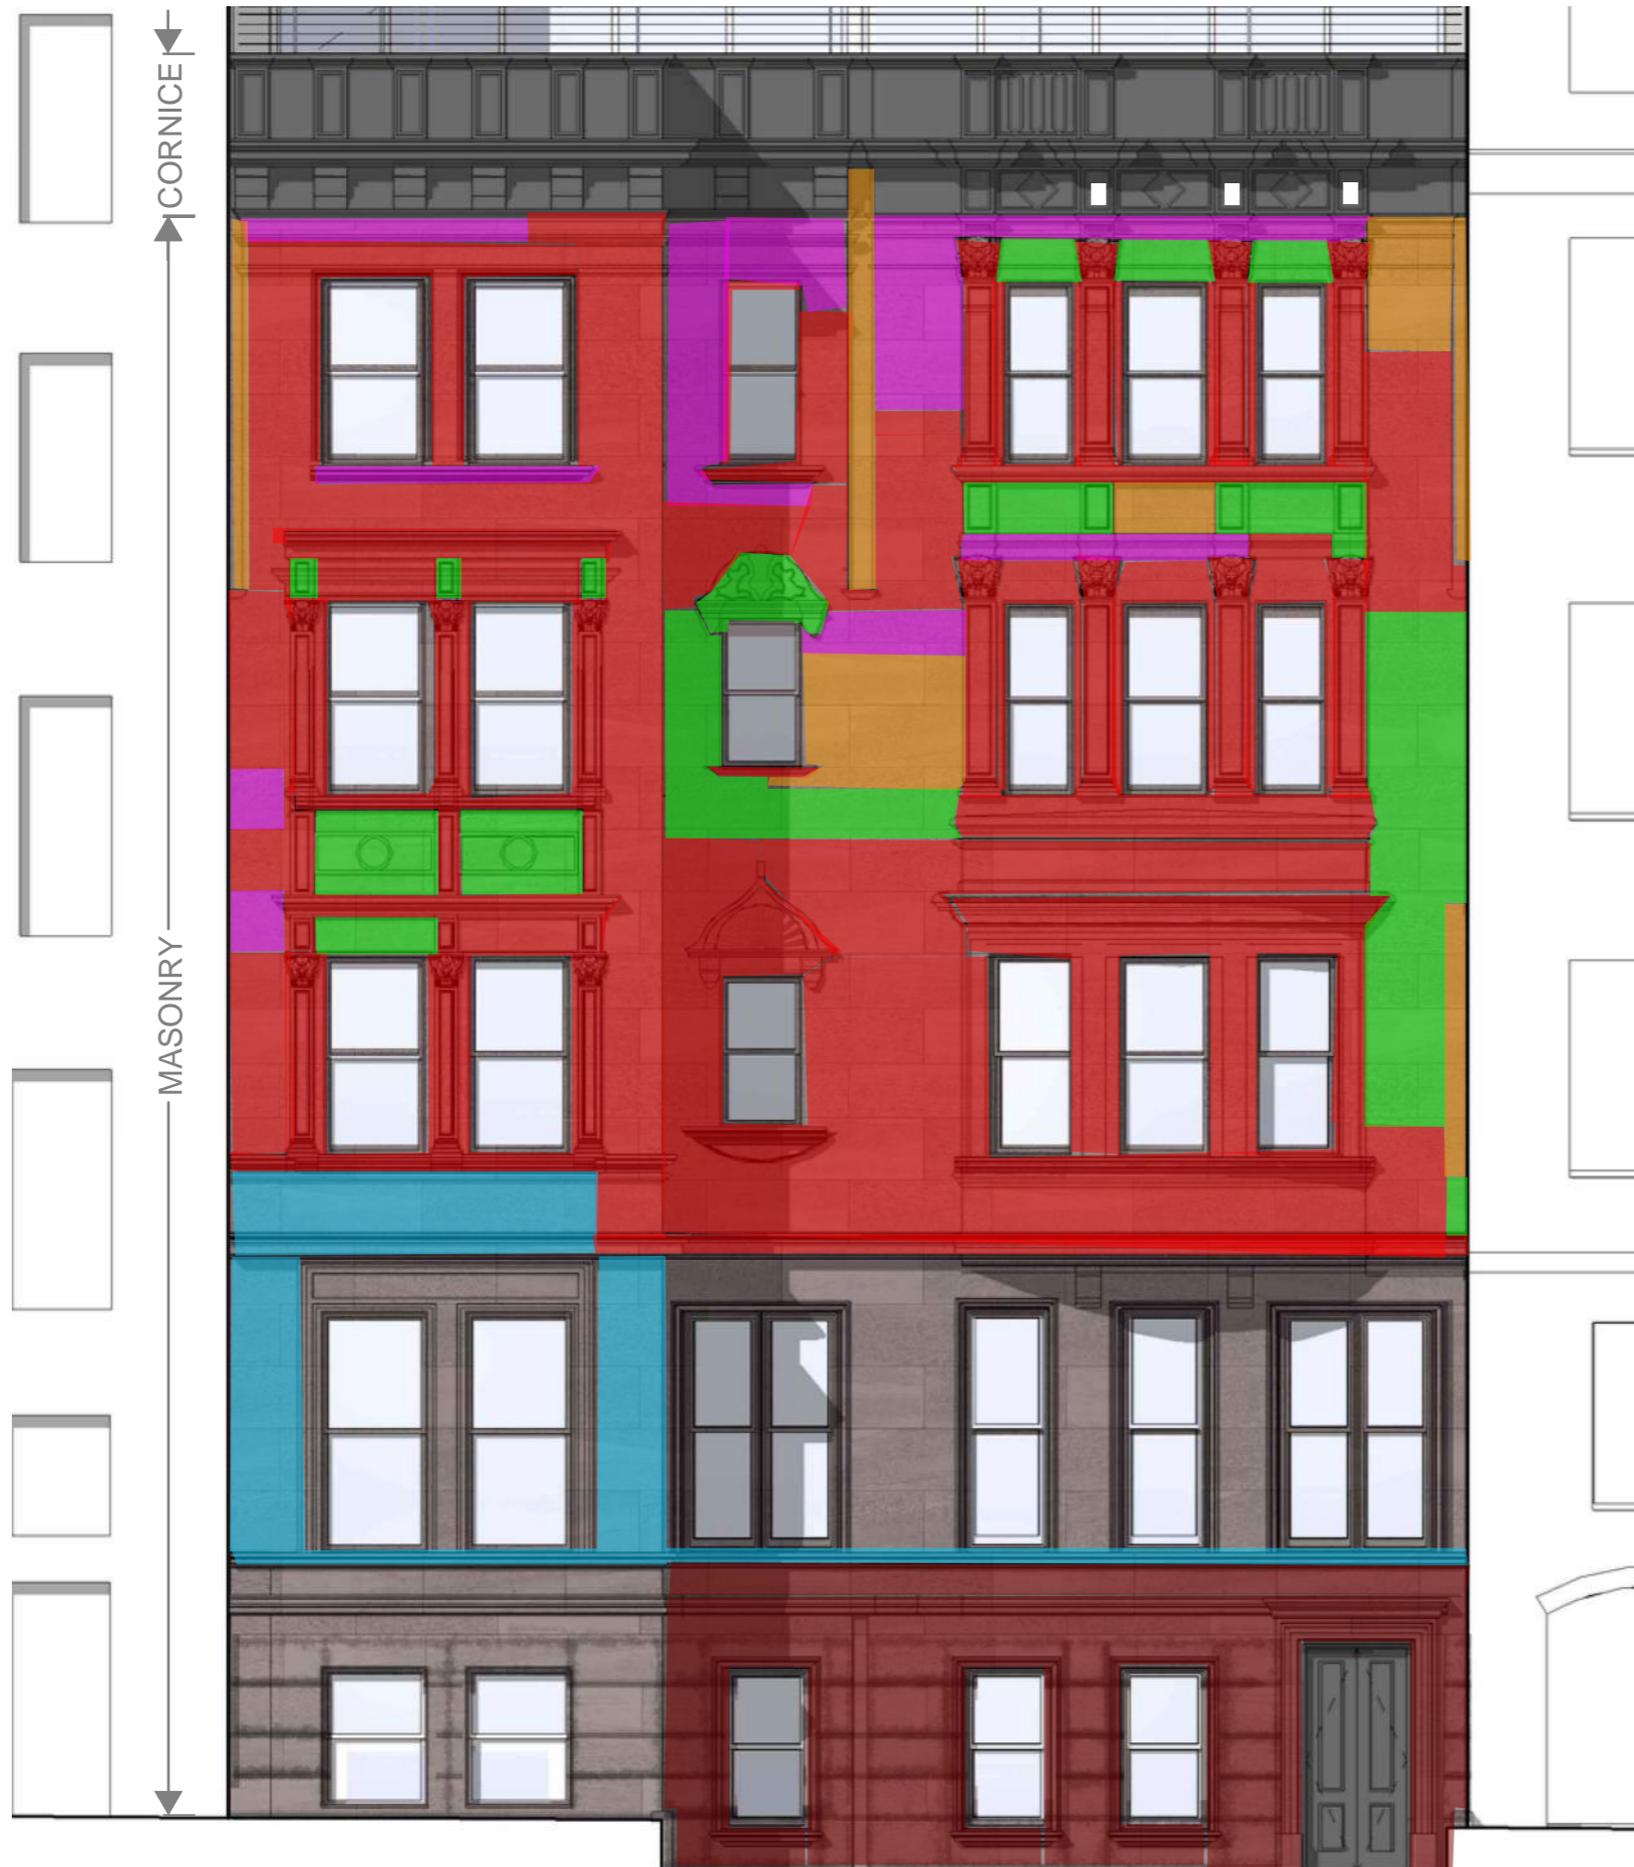
B Scope of Brownstone Repair & Replacement Maximizing Retention of Original Material and Substrates

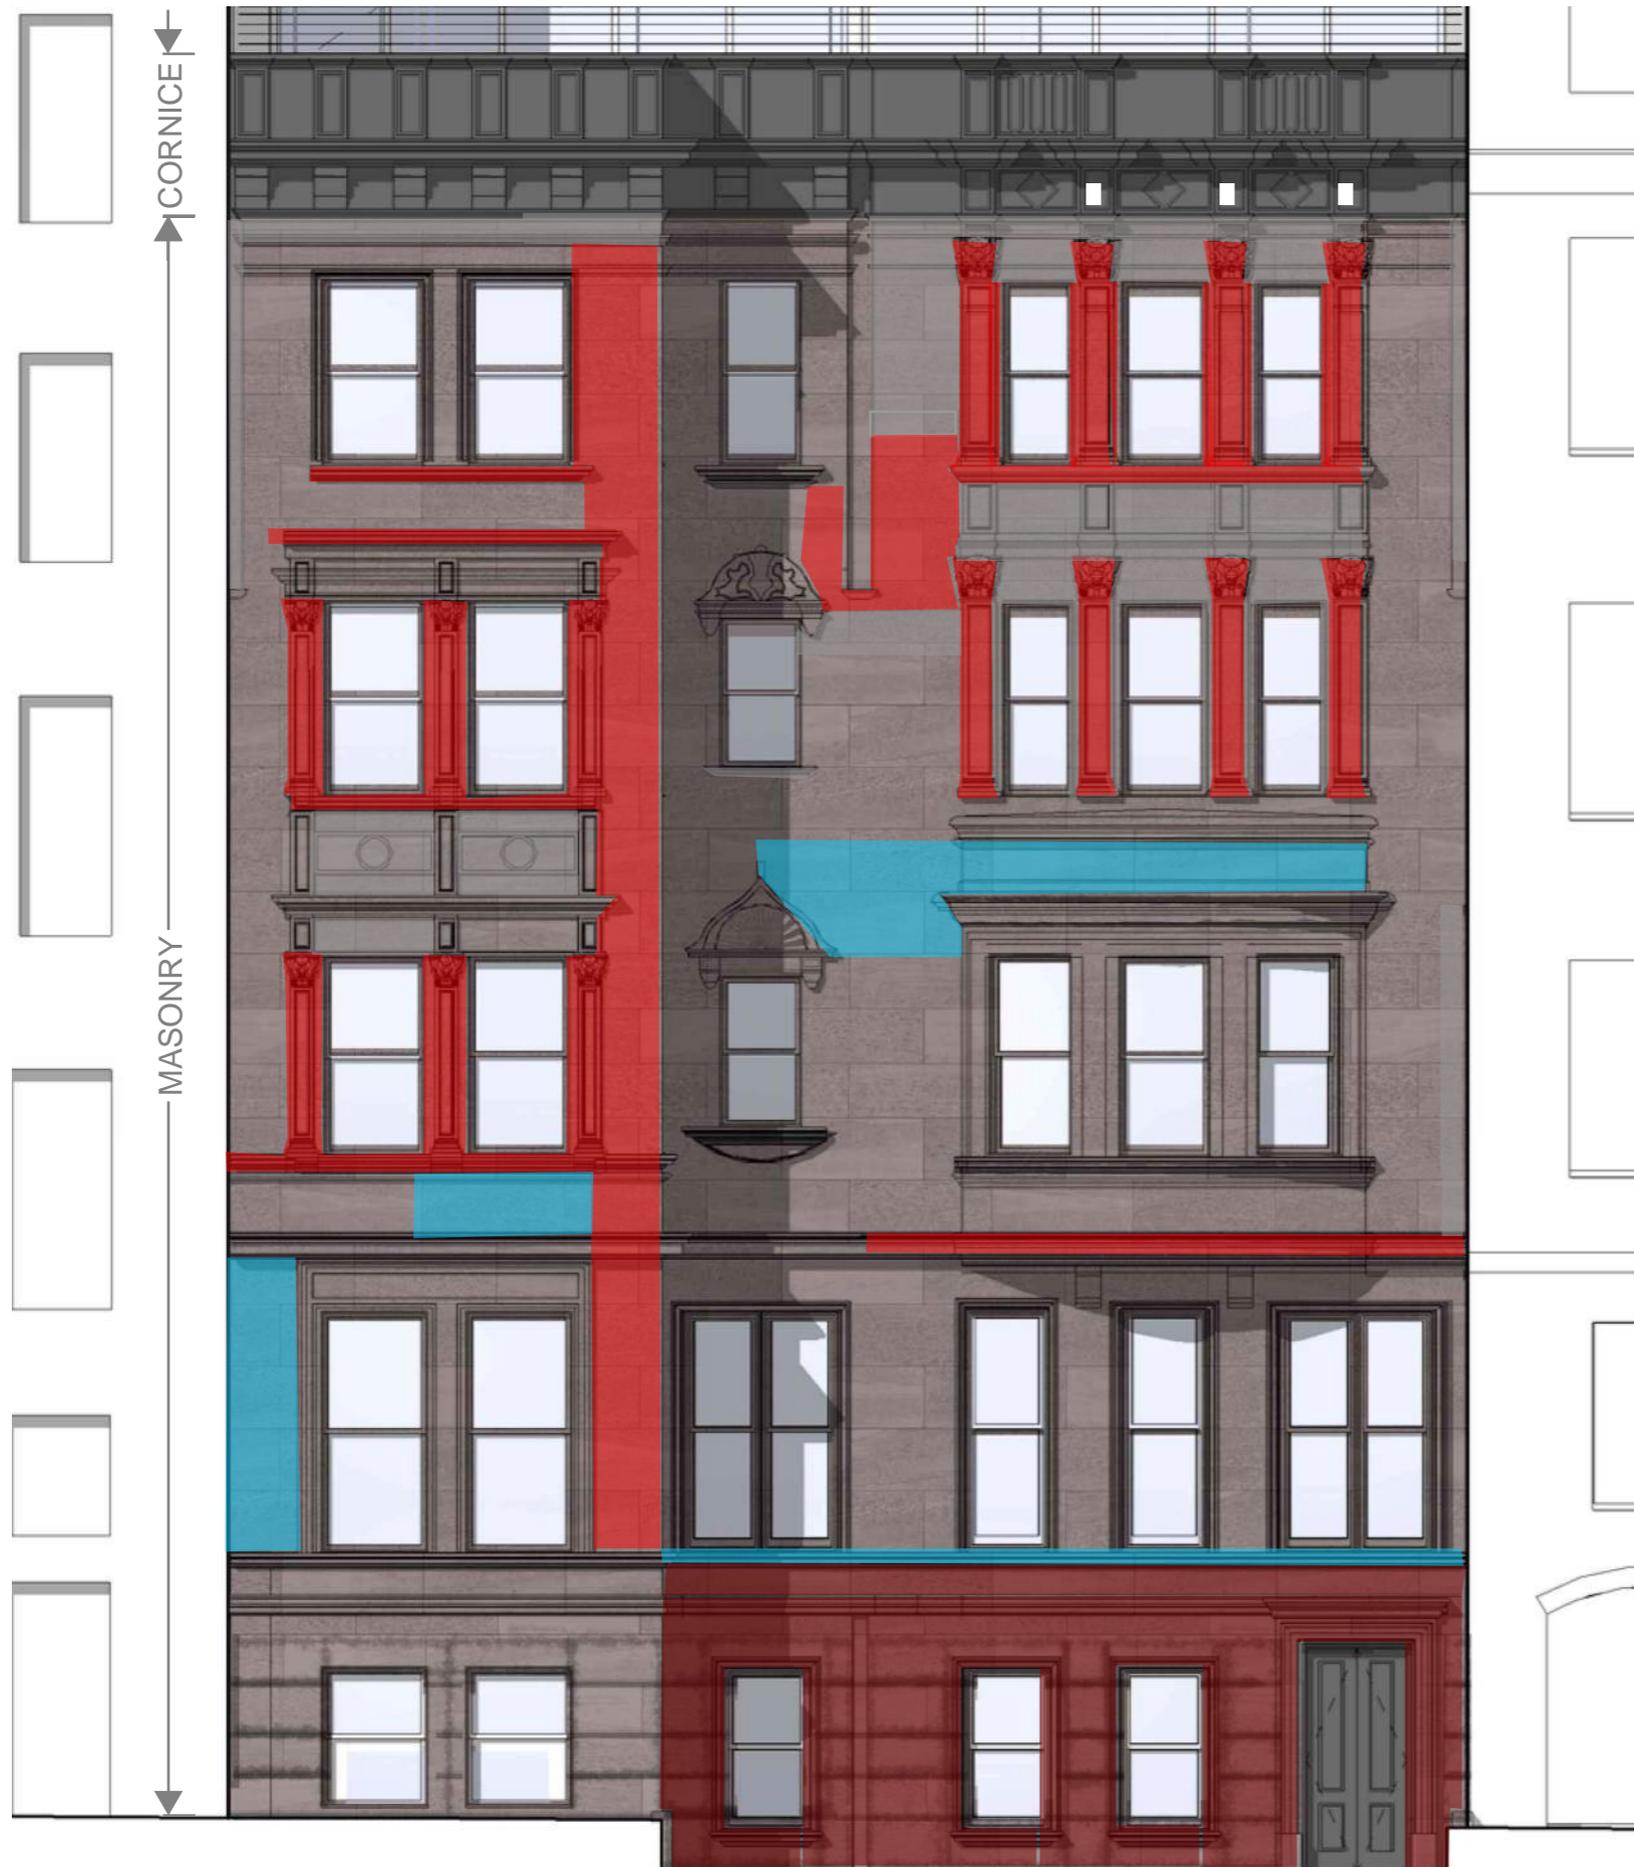
A Scope of Brownstone Repair & Replacement per Original Application

A Scope of Brownstone Repair & Replacement per Original Application

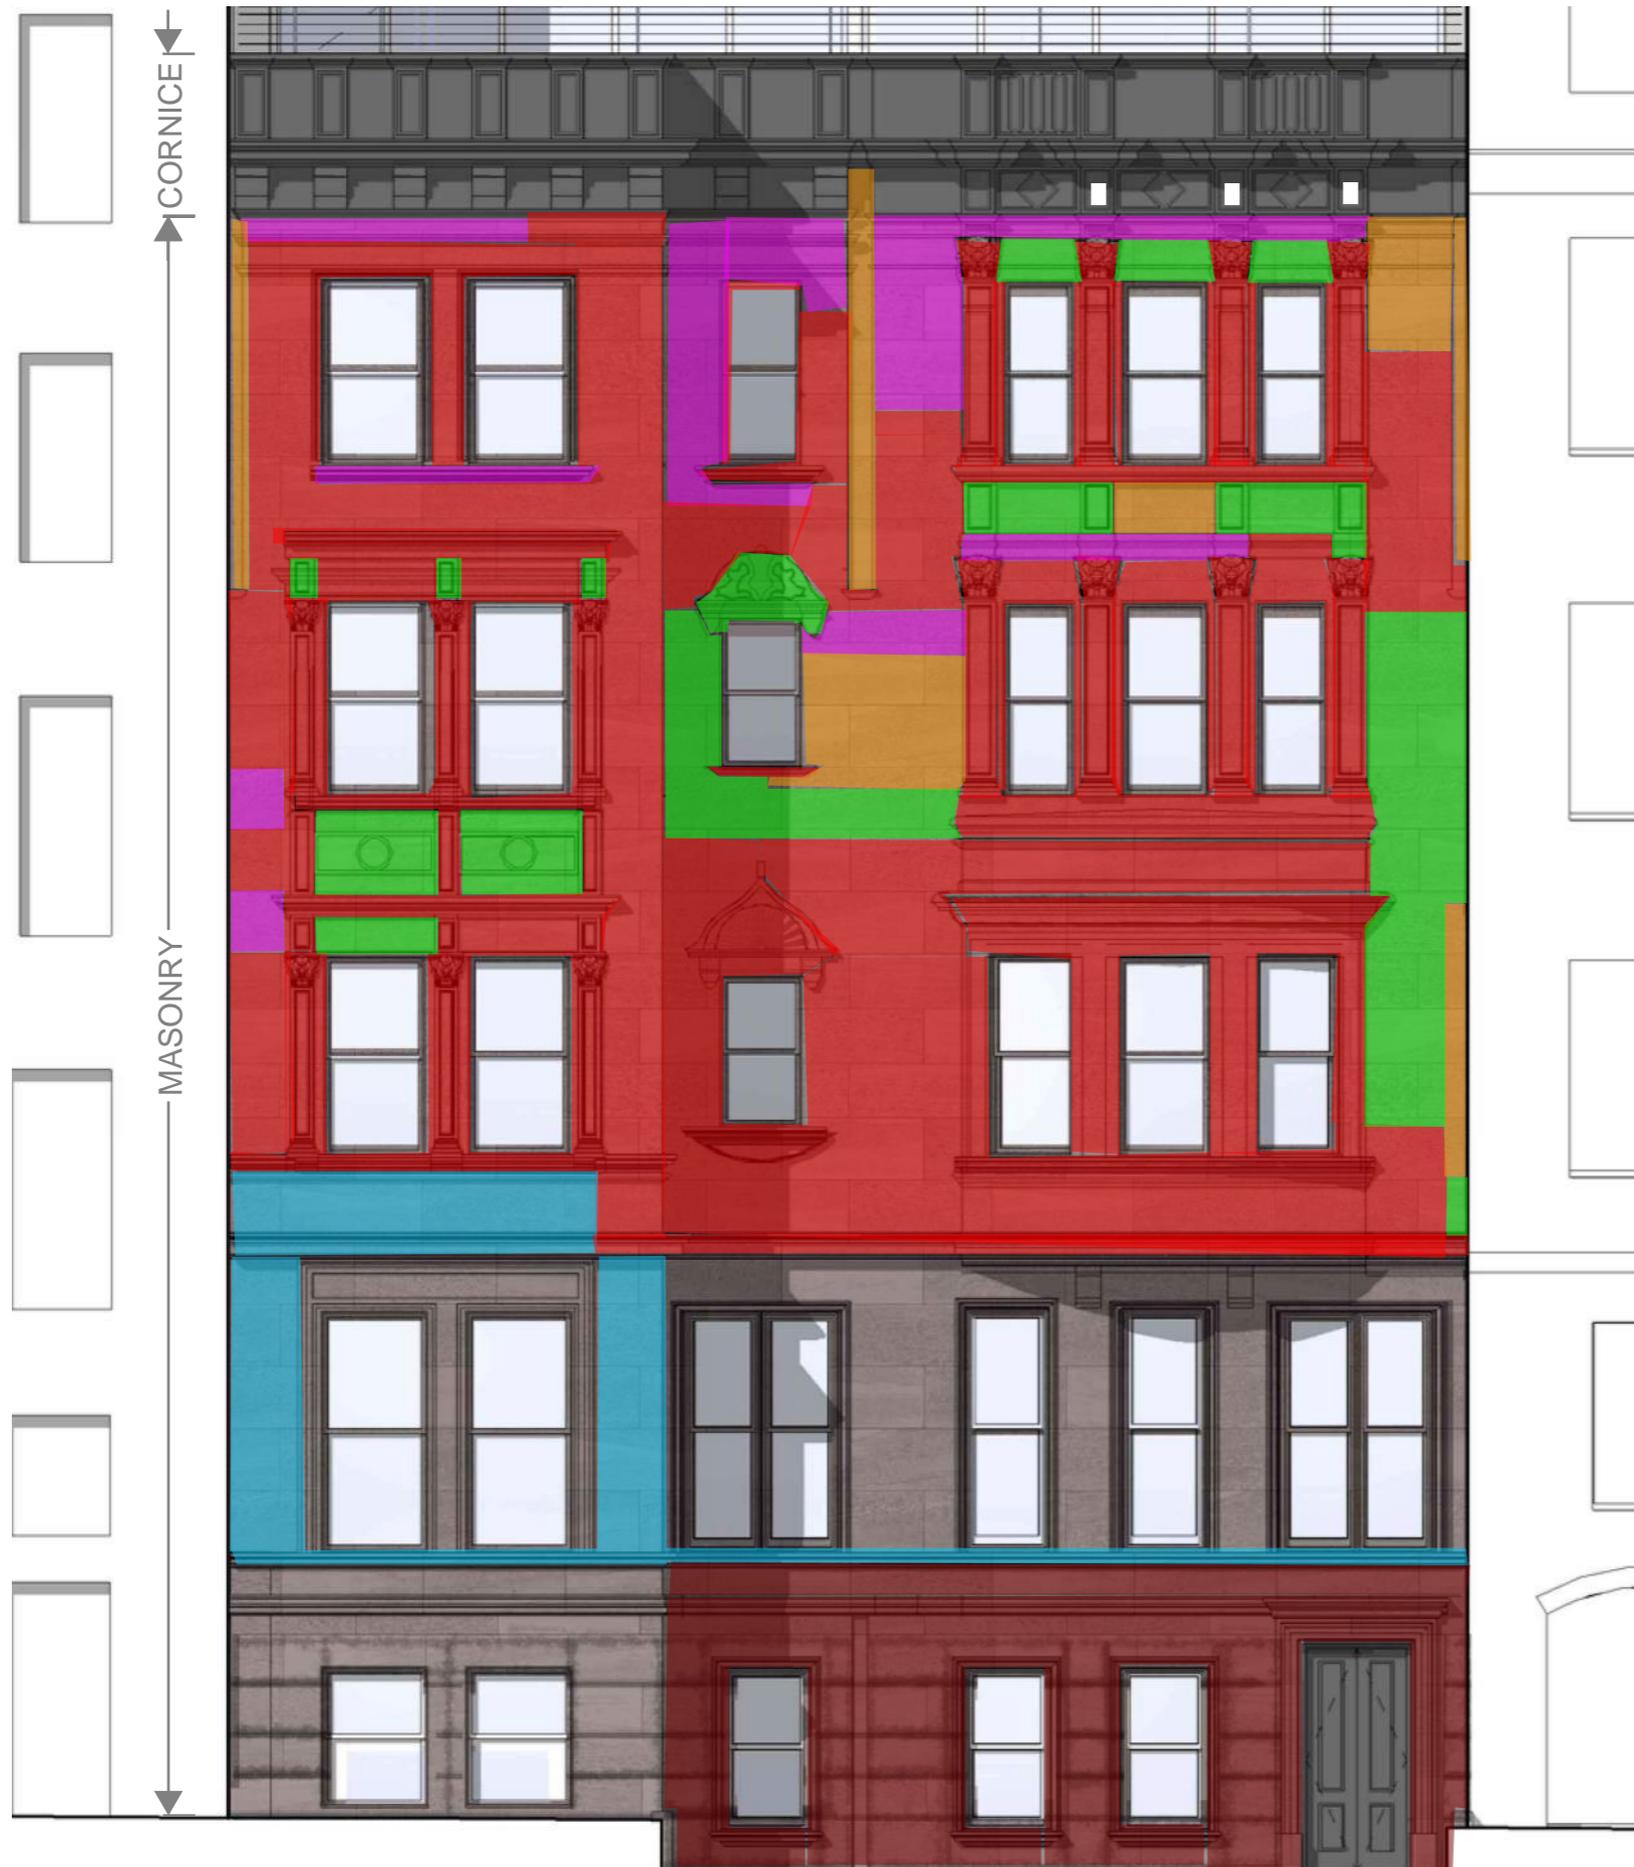
B Scope of Brownstone Repair & Replacement Maximizing Retention of Original Material and Substrates

B Scope of Brownstone Repair & Replacement Maximizing Retention of Original Material and Substrates

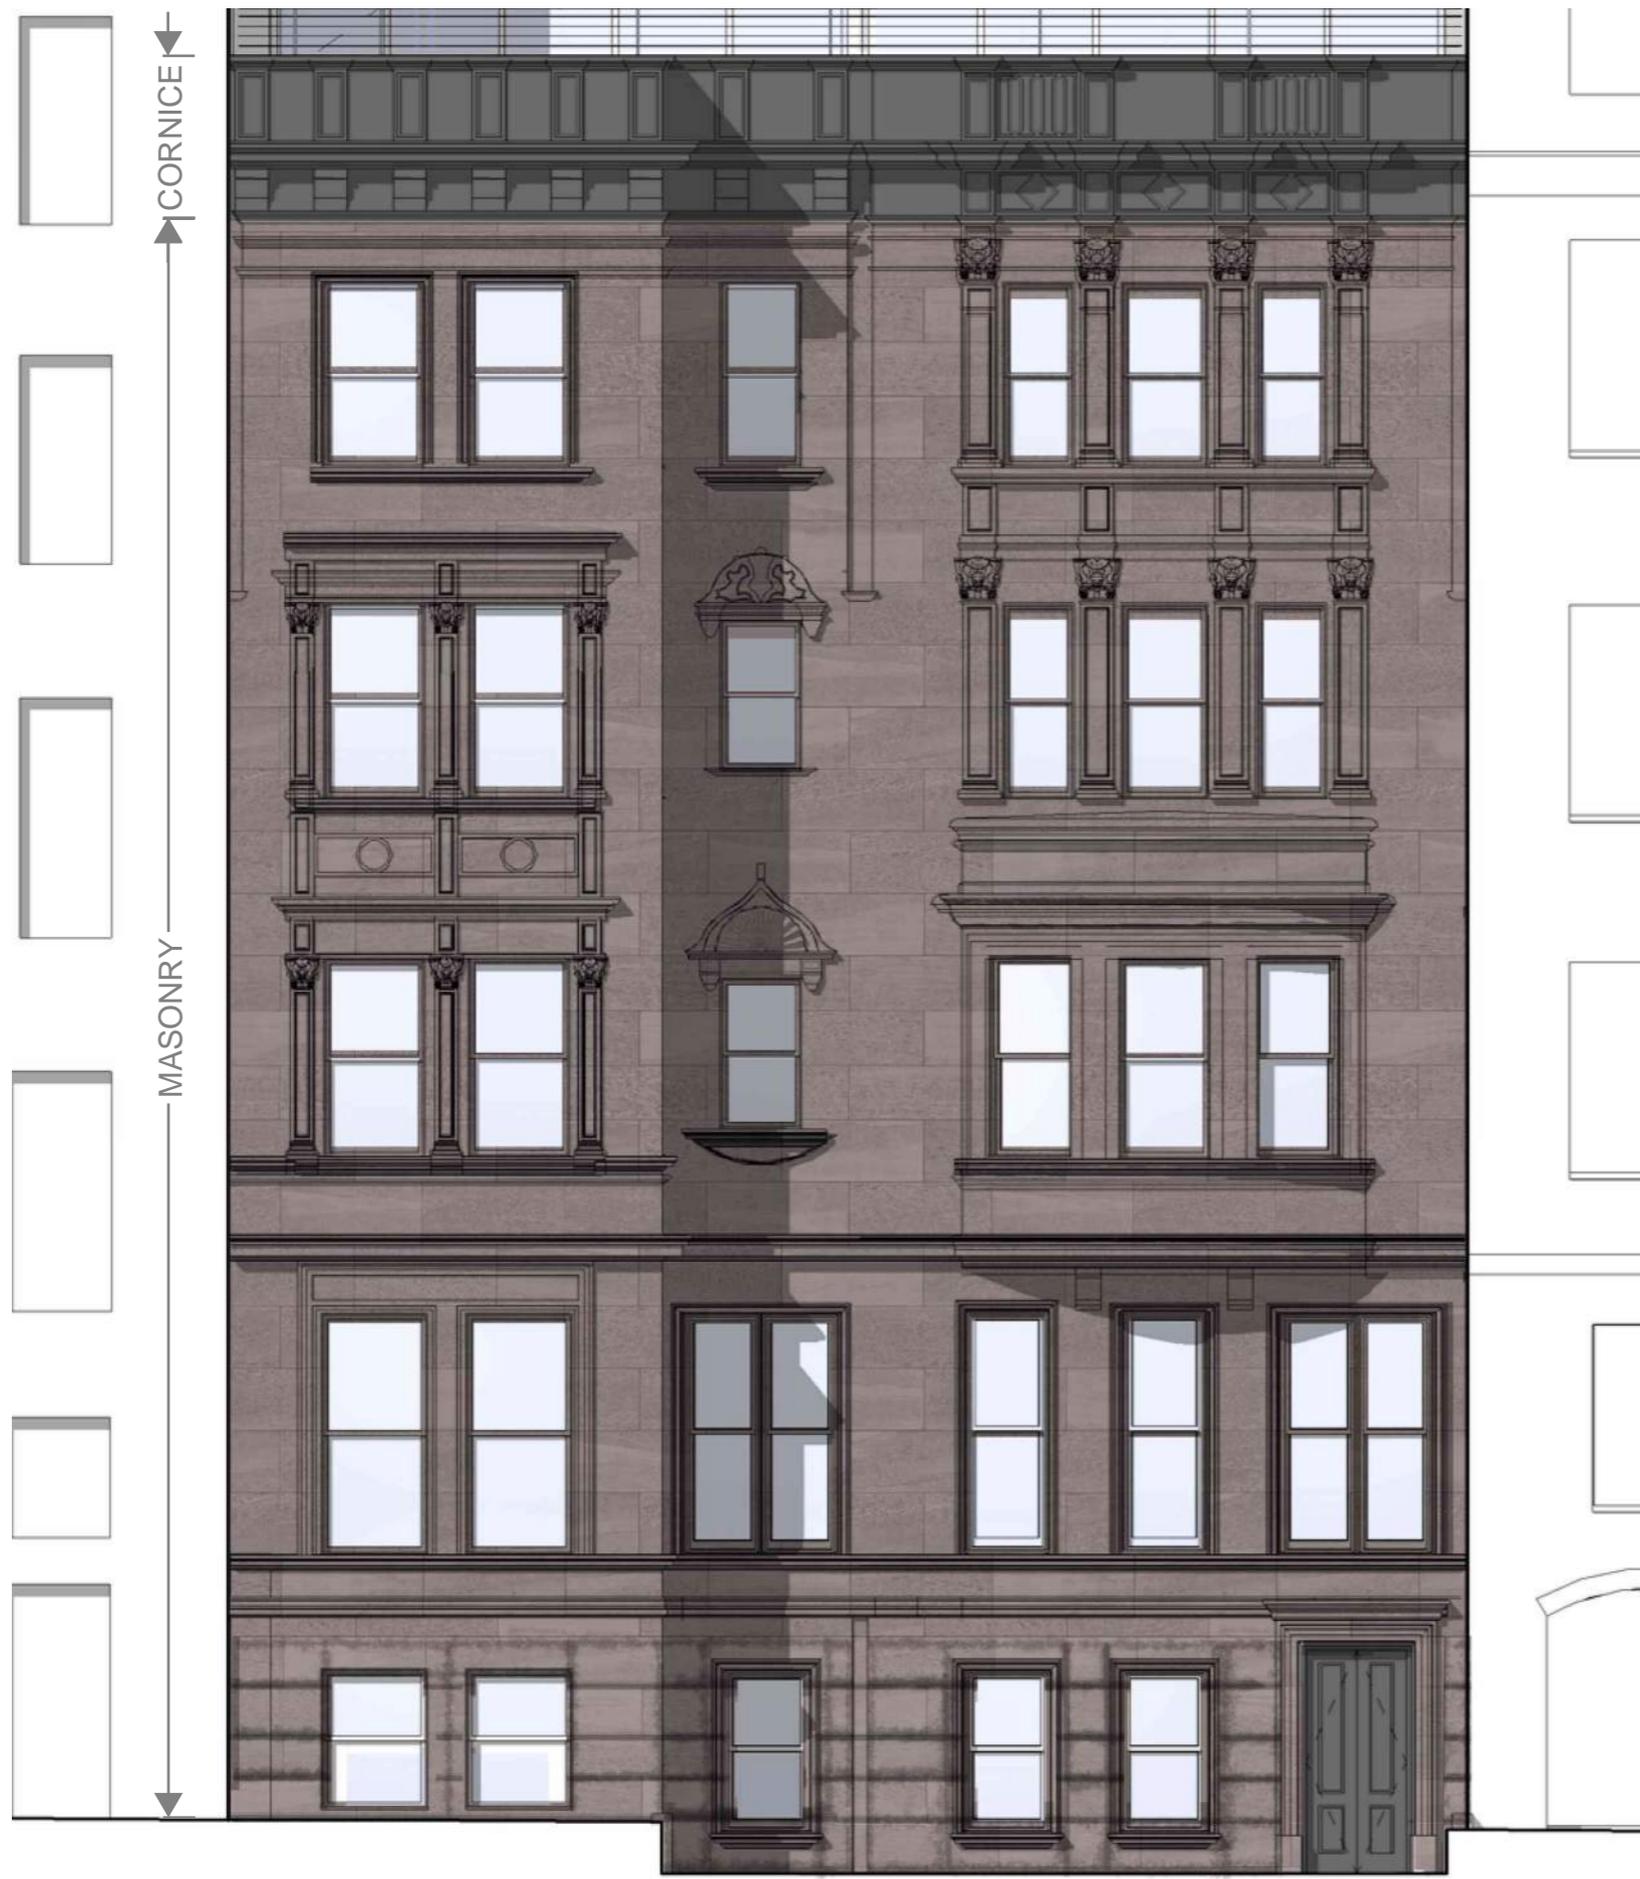
**C Proposed Scope of 100%
Brownstone Replacement
with Cast Stone
(See Samples)**
