SYDNEY HOUSE
839-843 Tilden Street
BRONX, NEW YORK

Remedial Action Work Plan
& STIP List (2/26/2016)

NYC VCP Project Number 16CVCP038X
OER Project Number 15EH-A543X

February 2016

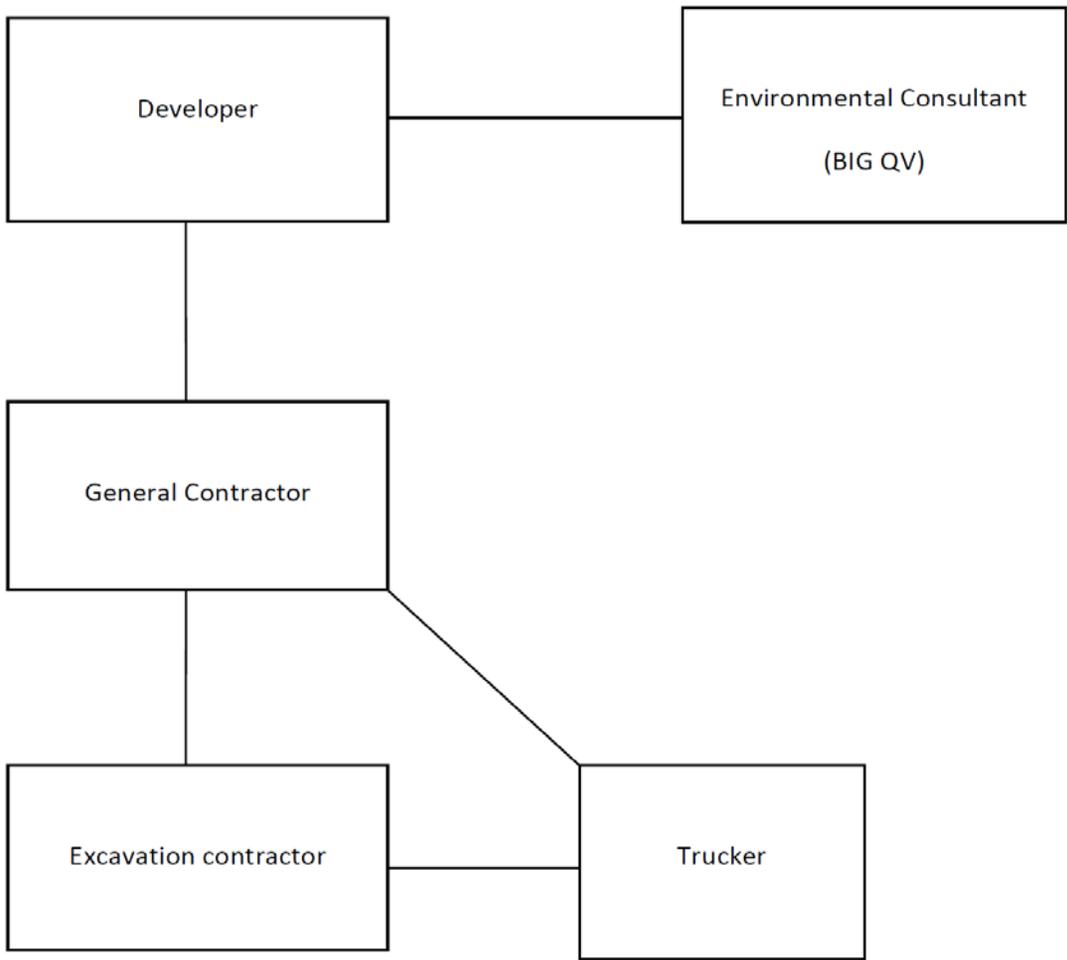
The chart above shows contractual relationships that typically exist for projects that are enrolled in the Voluntary Cleanup Program.

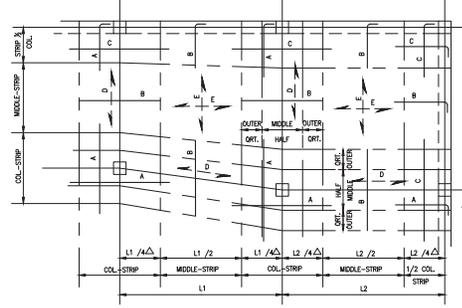
PLAN & ARRANGEMENT OF REINFORCING IN FLAT SLAB

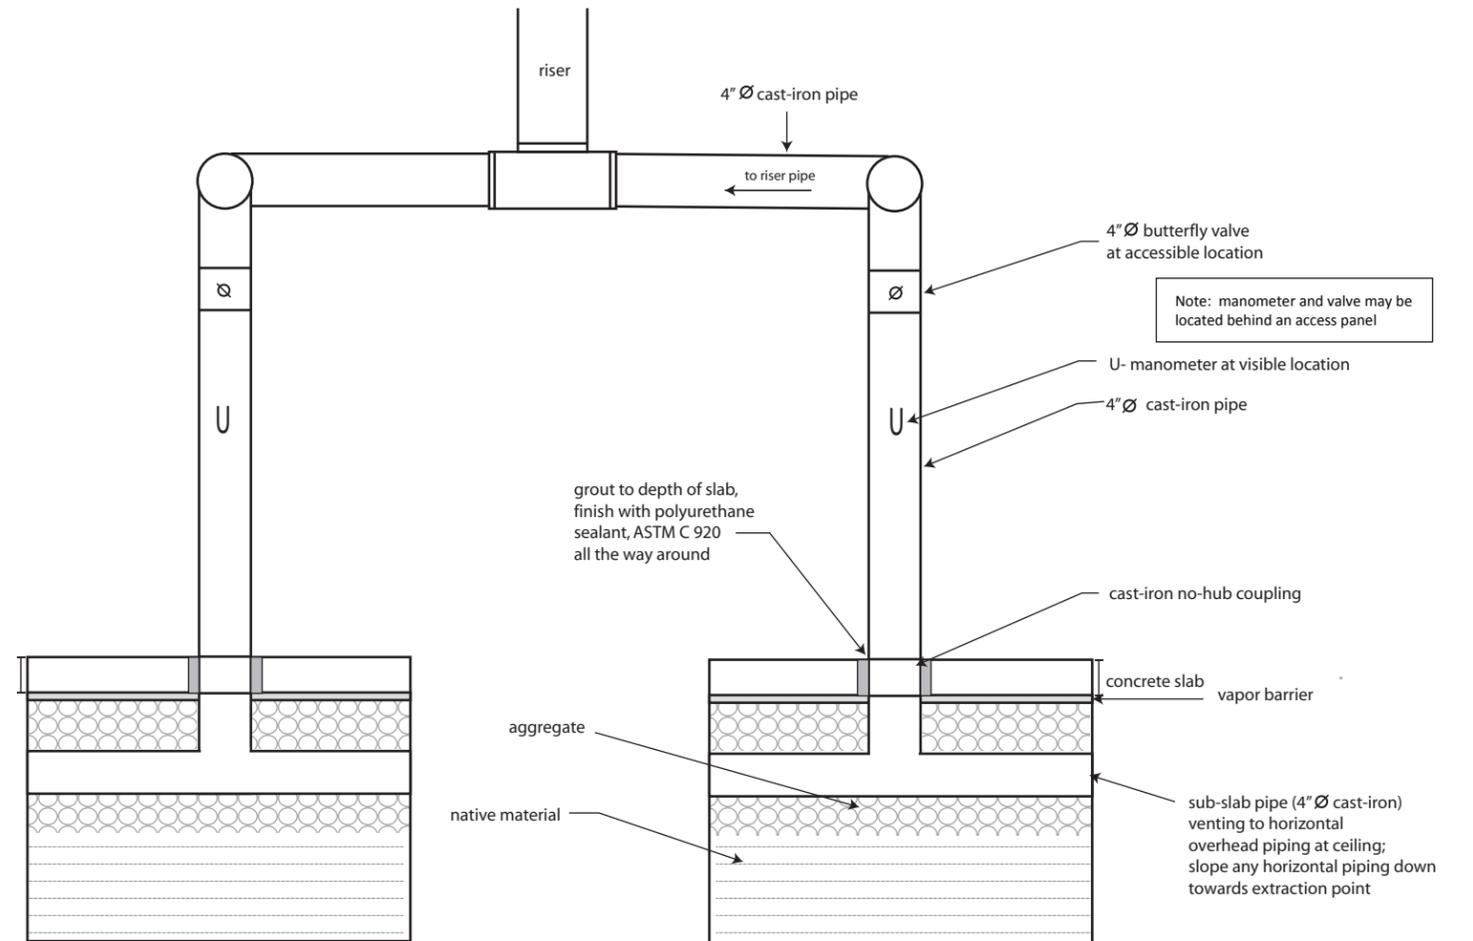
Note:
Cast-iron pipe may be substituted with PVC Schedule 40 pipe if a variance is secured from NYC DOB. If PVC piping is permitted, appropriate fire stop details shall be installed at any location in which the riser pipe penetrates a fire rated wall and all joints shall be sealed with plumber's cement (or similar product) to be applied according to the manufacturer's specifications.

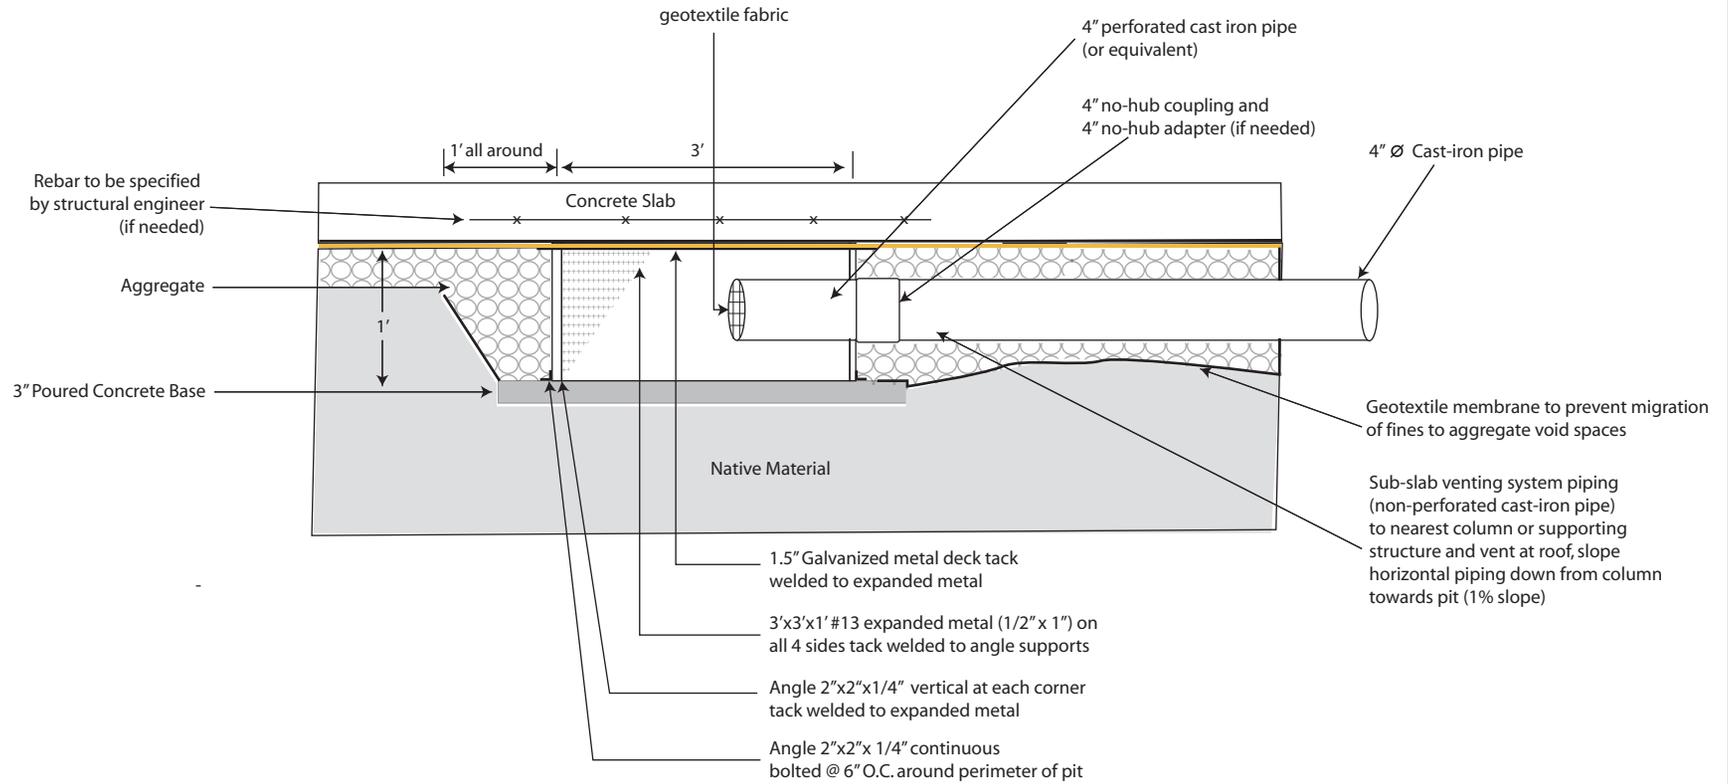
Note: Sub-slab cast-iron pipe may be substituted with PVC Schedule 40 if a variance is secured from NYC DOB (MC Section 512 and PC Section 702)

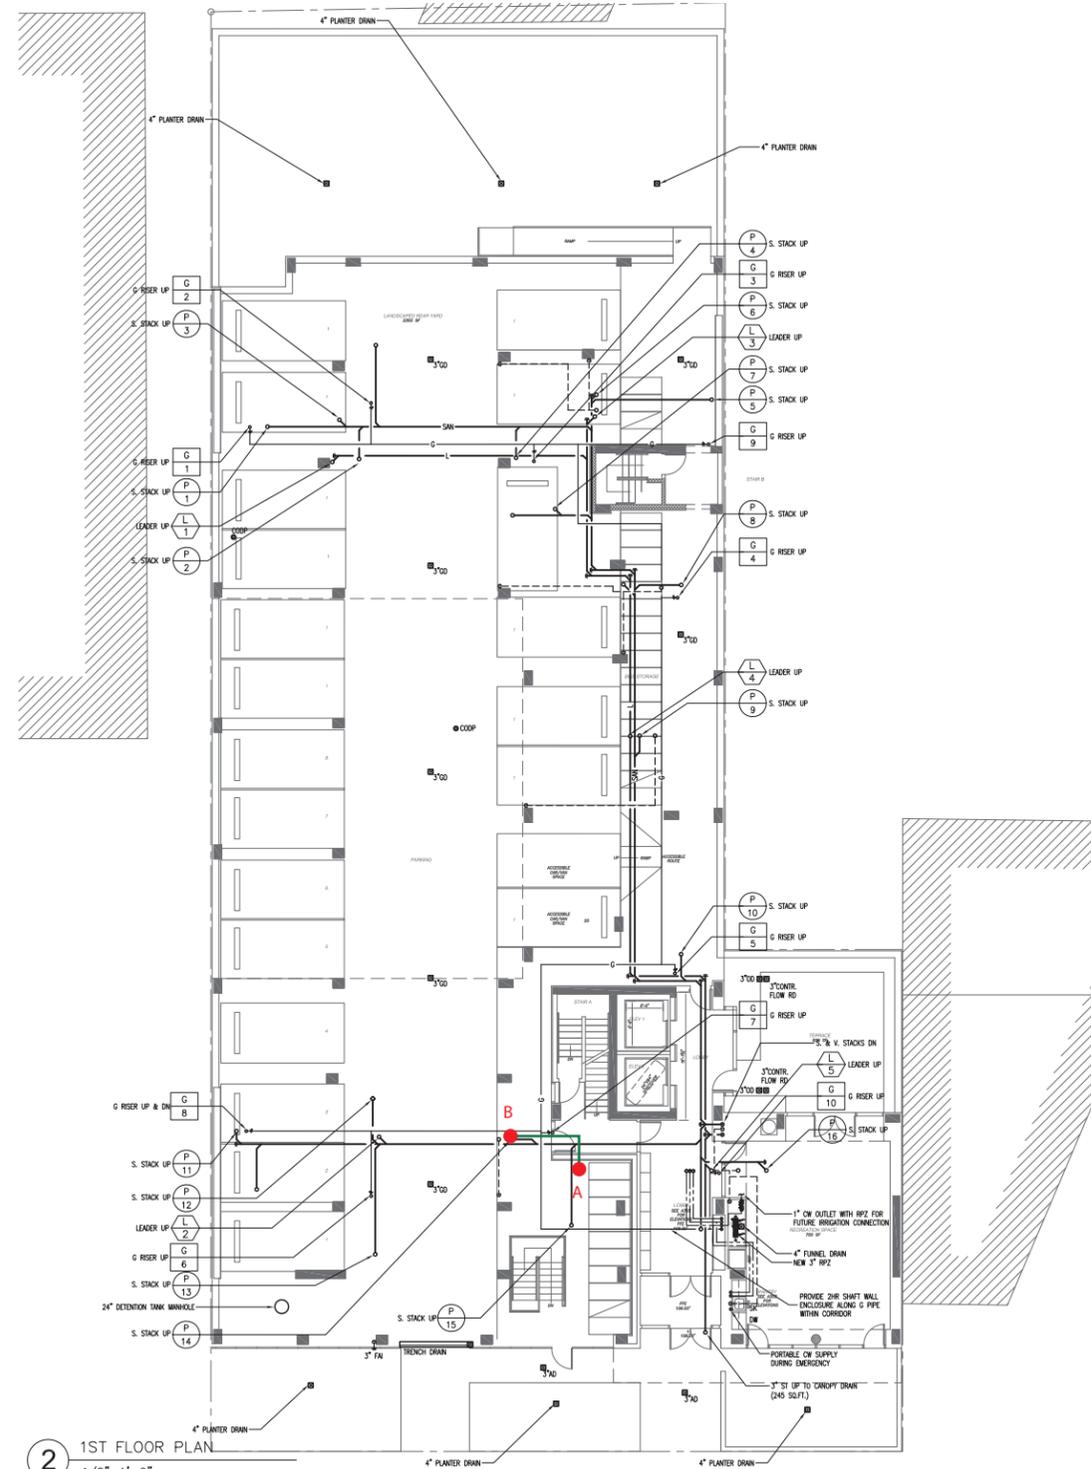
Note:
The riser centering from the cellar (Riser A) will be connected to the riser extending through the entire structure (Riser B) via piping located at ceiling height.

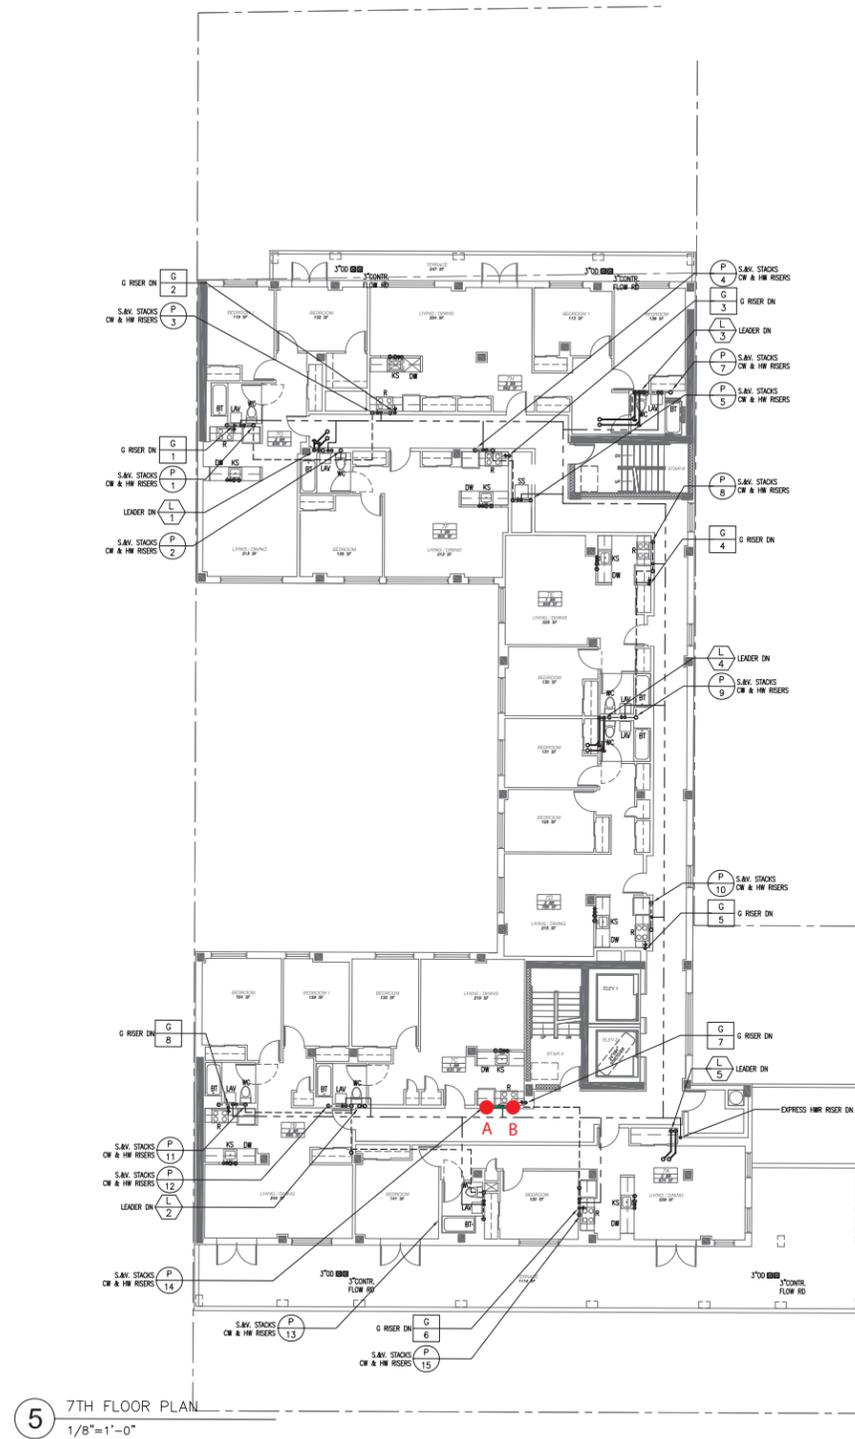
Note:
The riser entering from the sixth floor (Riser A) will be connected to the riser extending through the building's roof (Riser B) via piping located at ceiling height.
