**573 4<sup>TH</sup> AVENUE**

**BROOKLYN, NEW YORK**

# **Remedial Investigation Report**

**NYC VCP Site: 13EH-N282K**

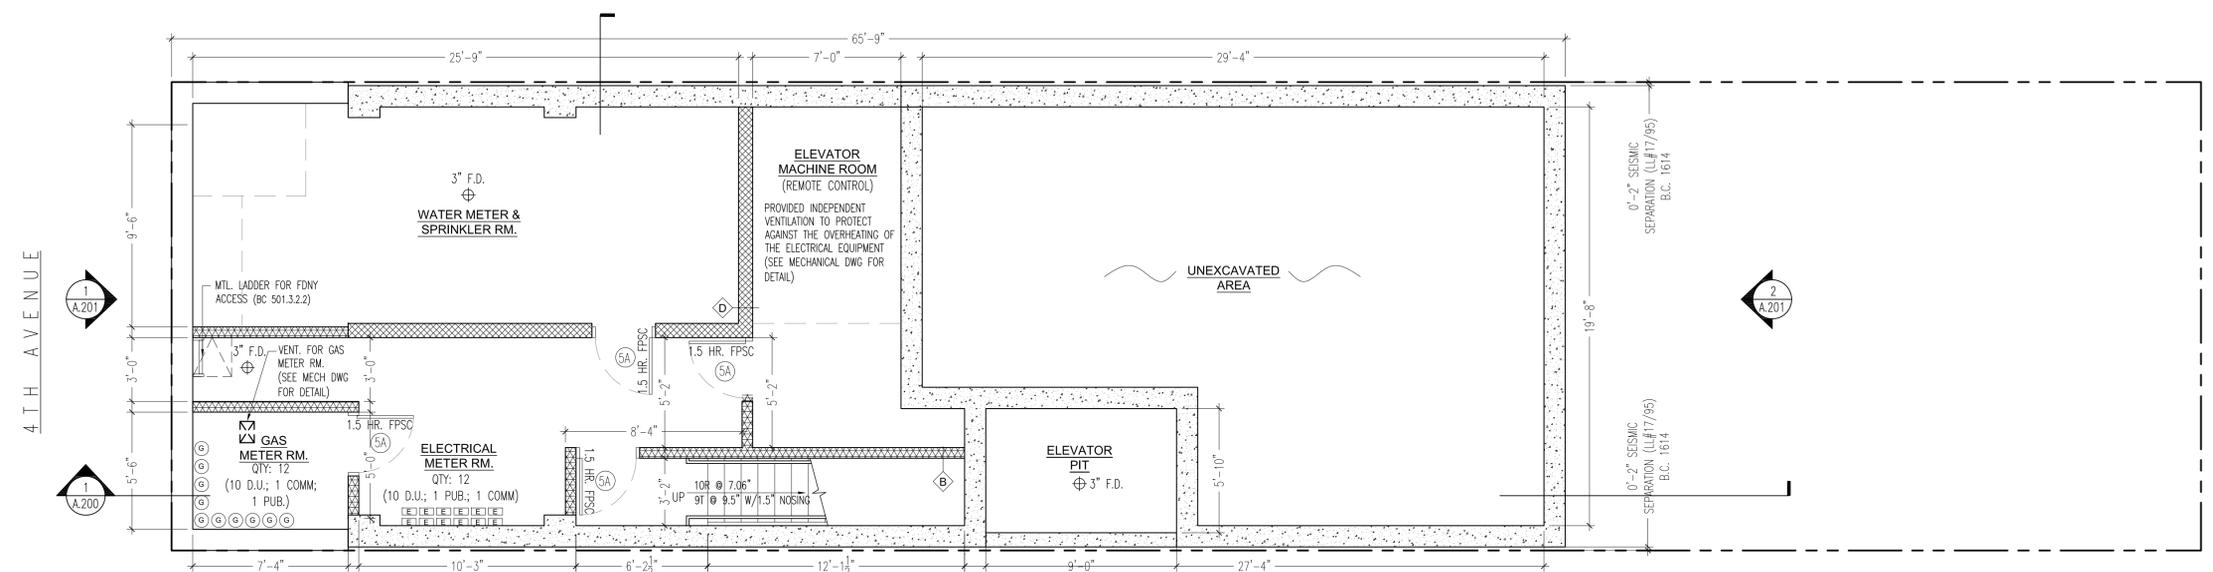
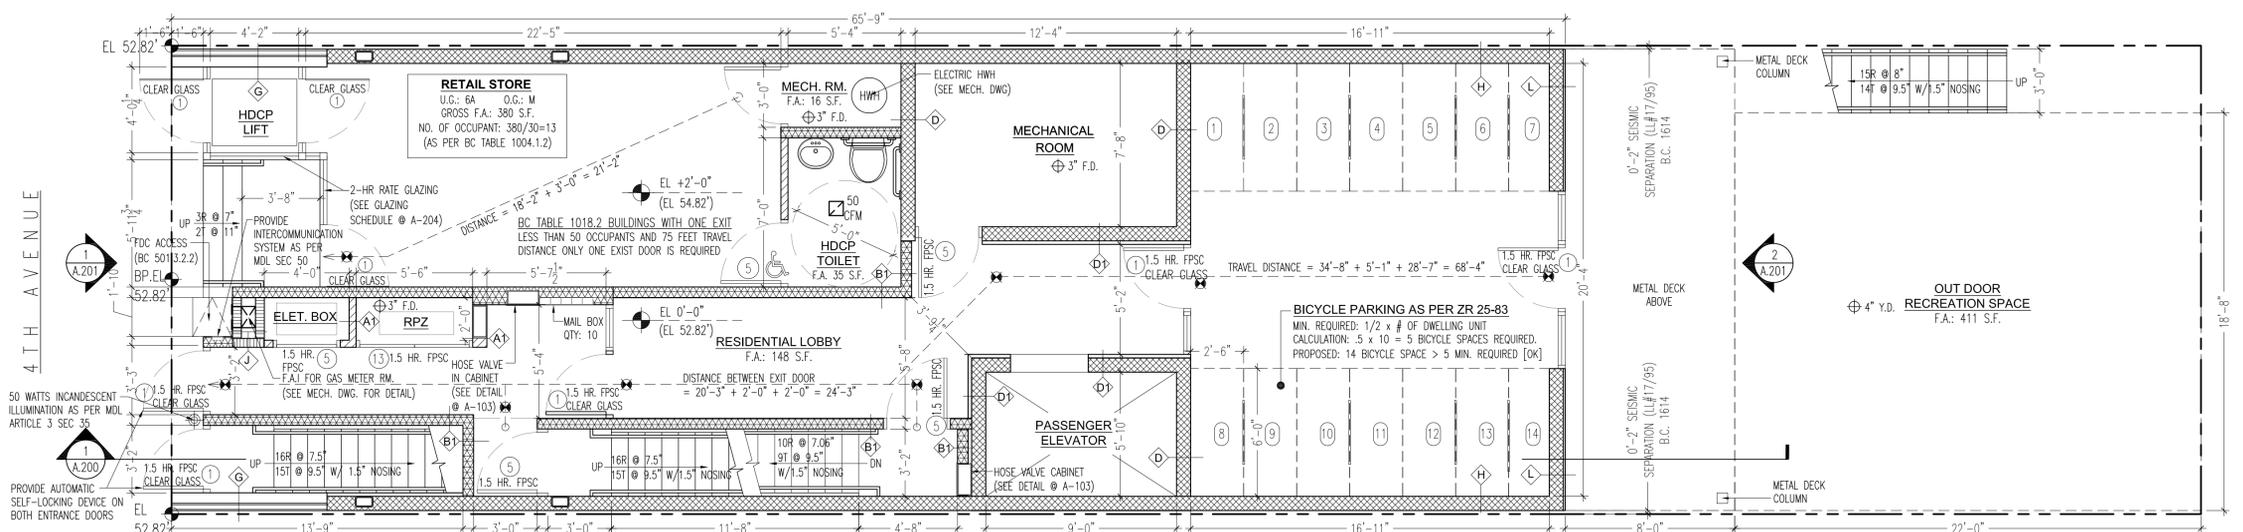
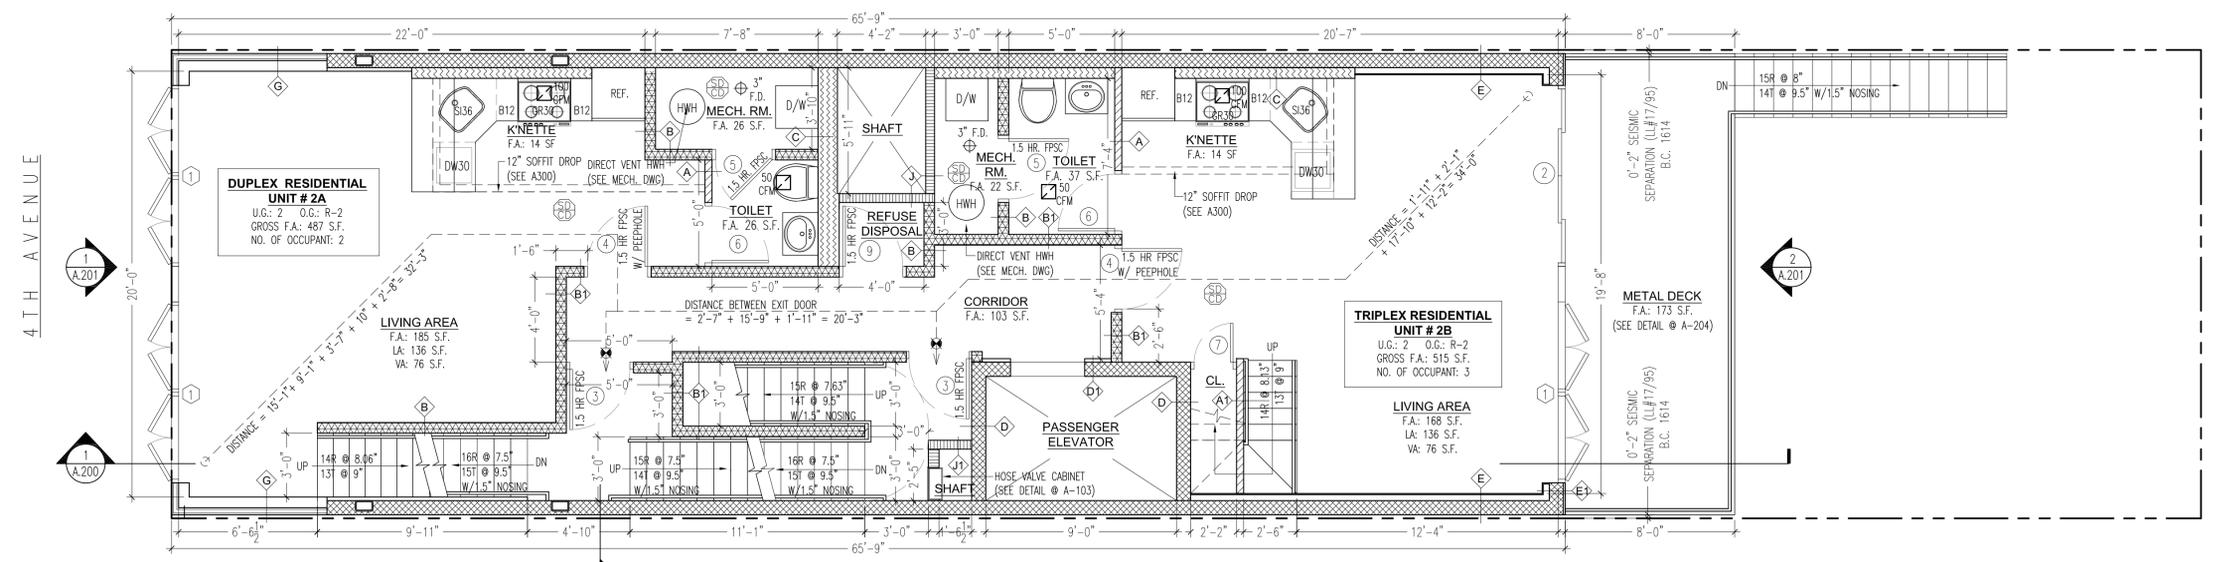
DRAWING TITLE:  
**PROPOSED CELLAR, 1ST & 2ND FLOOR PLAN**

The proposed building for 573 4<sup>th</sup> Avenue will contain a partial 6-foot basement that will cover approximately 40% of the property and will contain utilities and the elevator vault. The foundation for the building, basement and footings will be installed to a final depth of 8' bgs. The first floor will be for commercial usage with residences on the upper 9 floors. As part of development, the referenced lot is expected to remain exclusively on lot 6. The building will be constructed to a height of approximately 95 feet for the 9 floors and be approximately 9,521 gross square feet. There are no areas proposed for landscaping. The water table is expected at approximately 49 feet bgs.

**CELLAR PLAN**  
 SCALE: 1/4" = 1'-0"

**1ST FLOOR PLAN**  
 SCALE: 1/4" = 1'-0"

**2ND FLOOR PLAN**  
 SCALE: 1/4" = 1'-0"

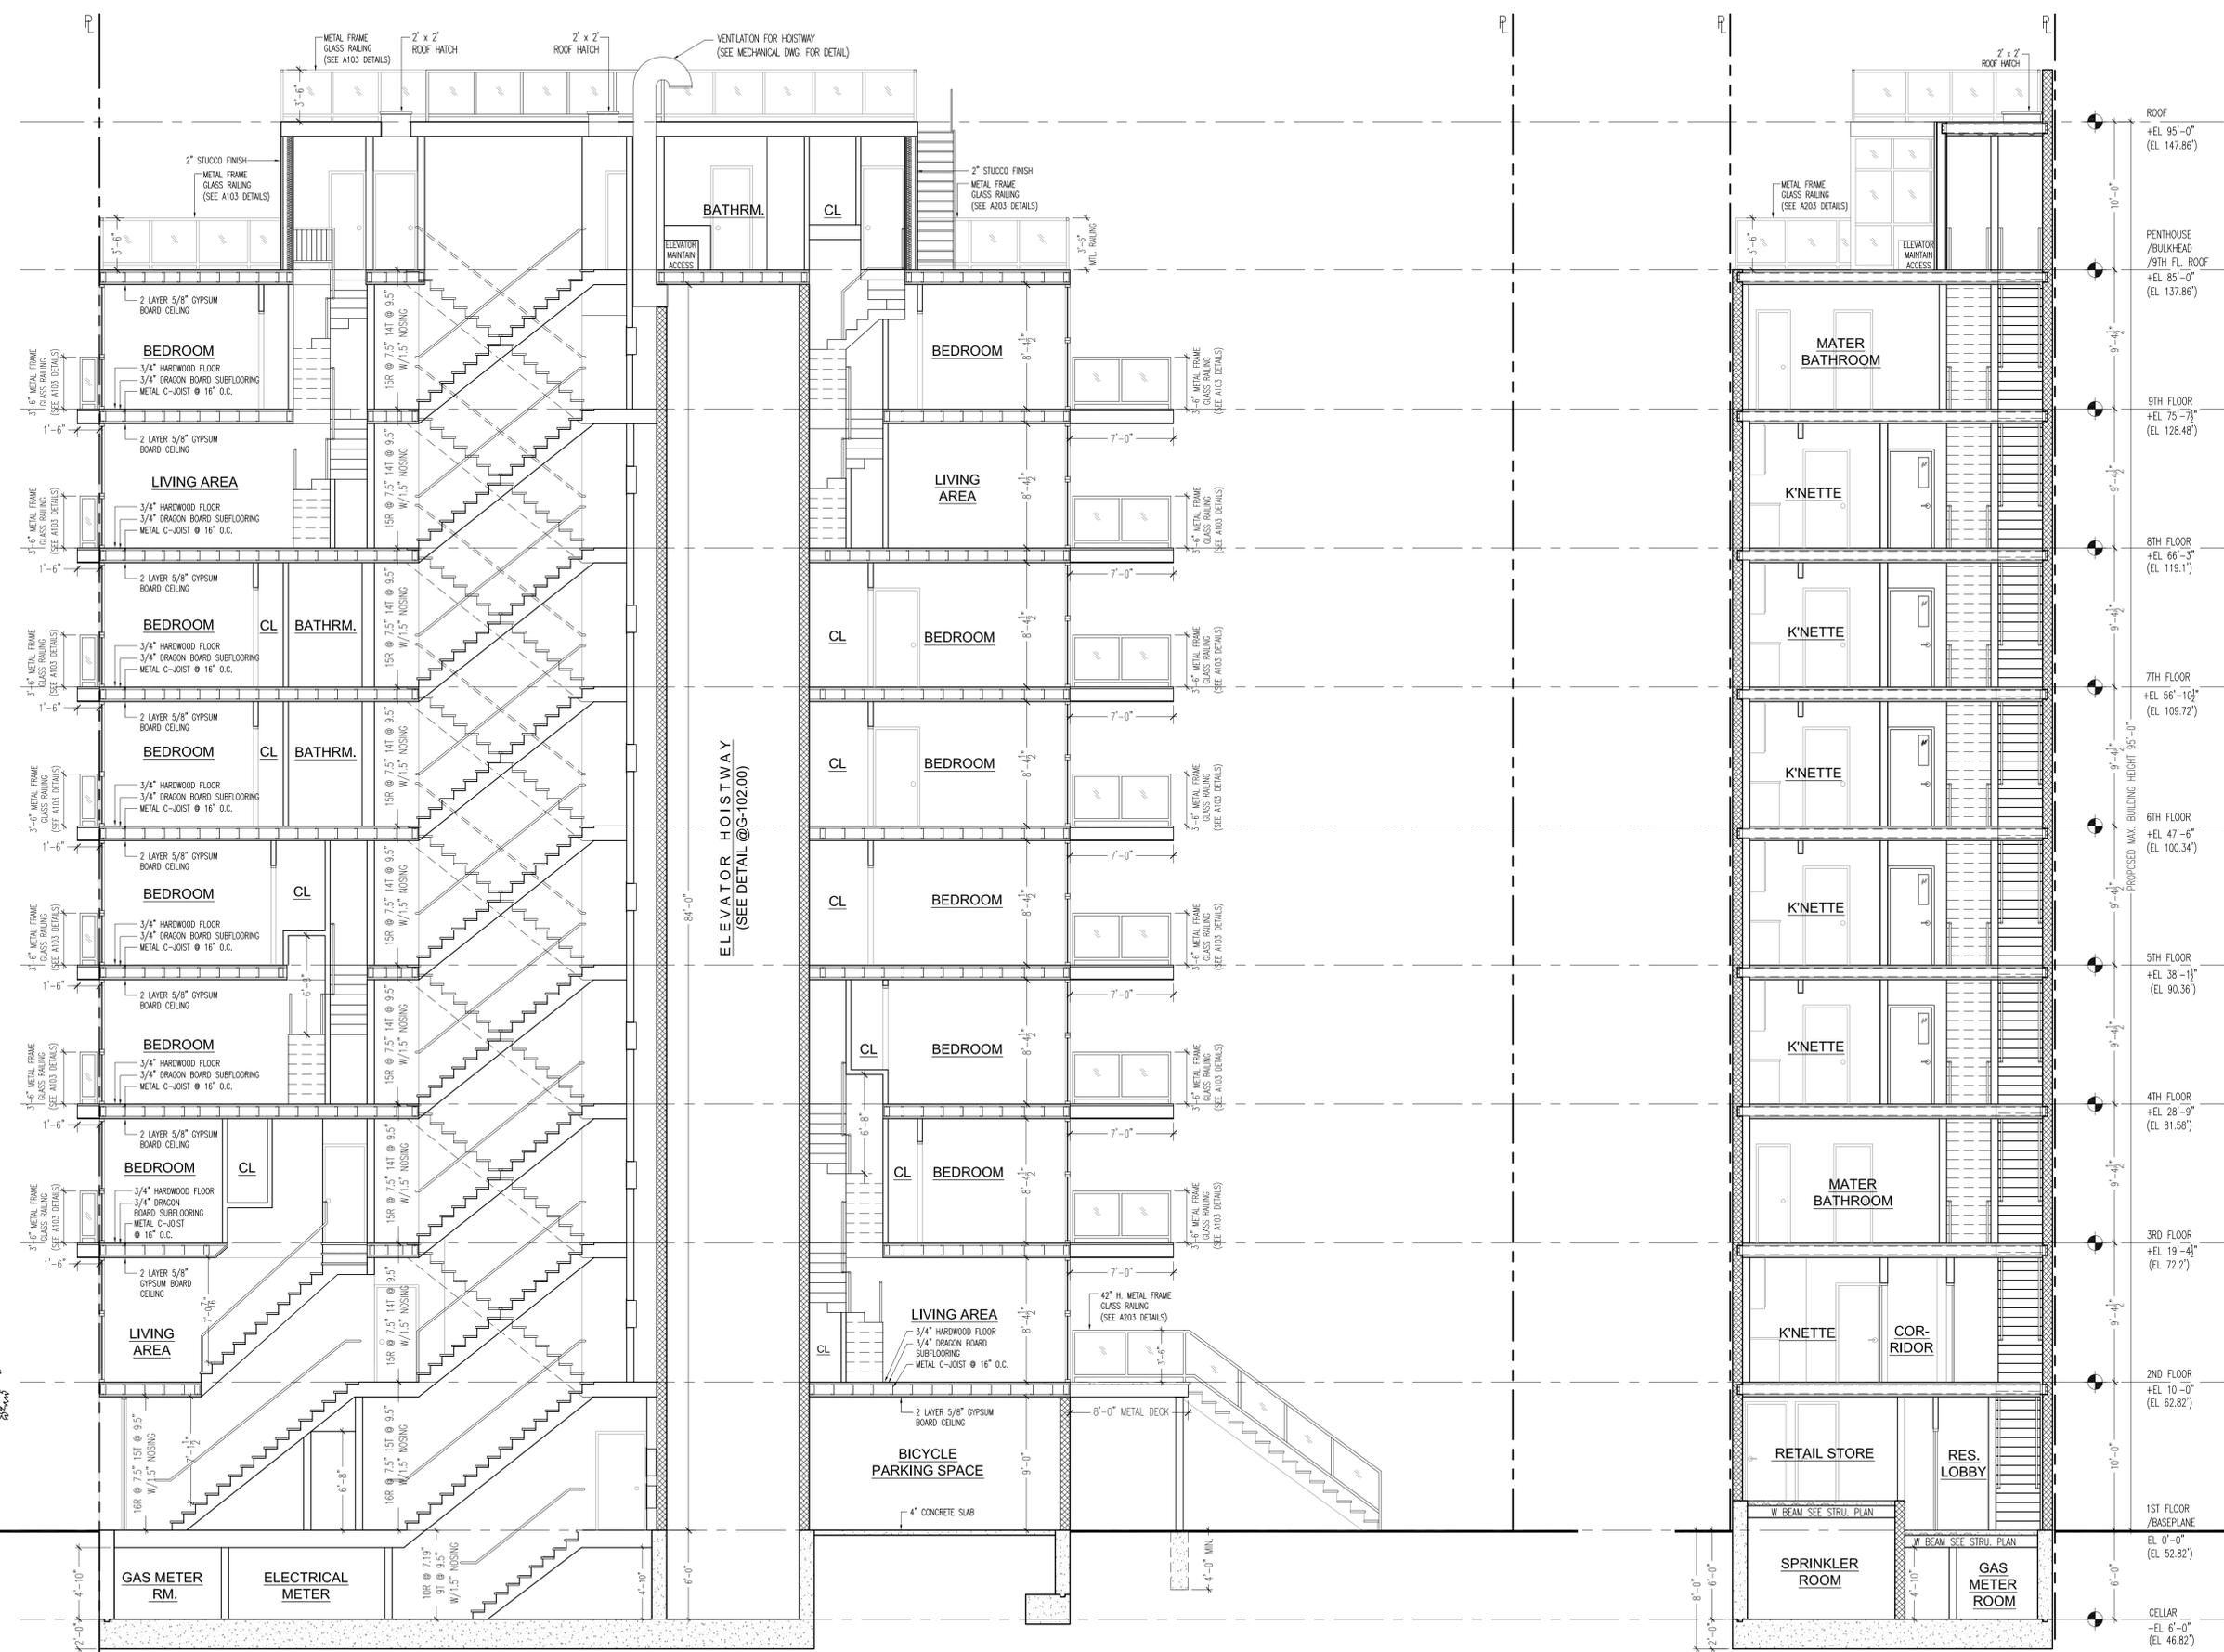
**BUILDING SECTIONS**

**1 LONGITUDINAL SECTION**  
 SCALE: 1/4" = 1'-0"

**2 TRANSVERSAL SECTION**  
 SCALE: 1/4" = 1'-0"

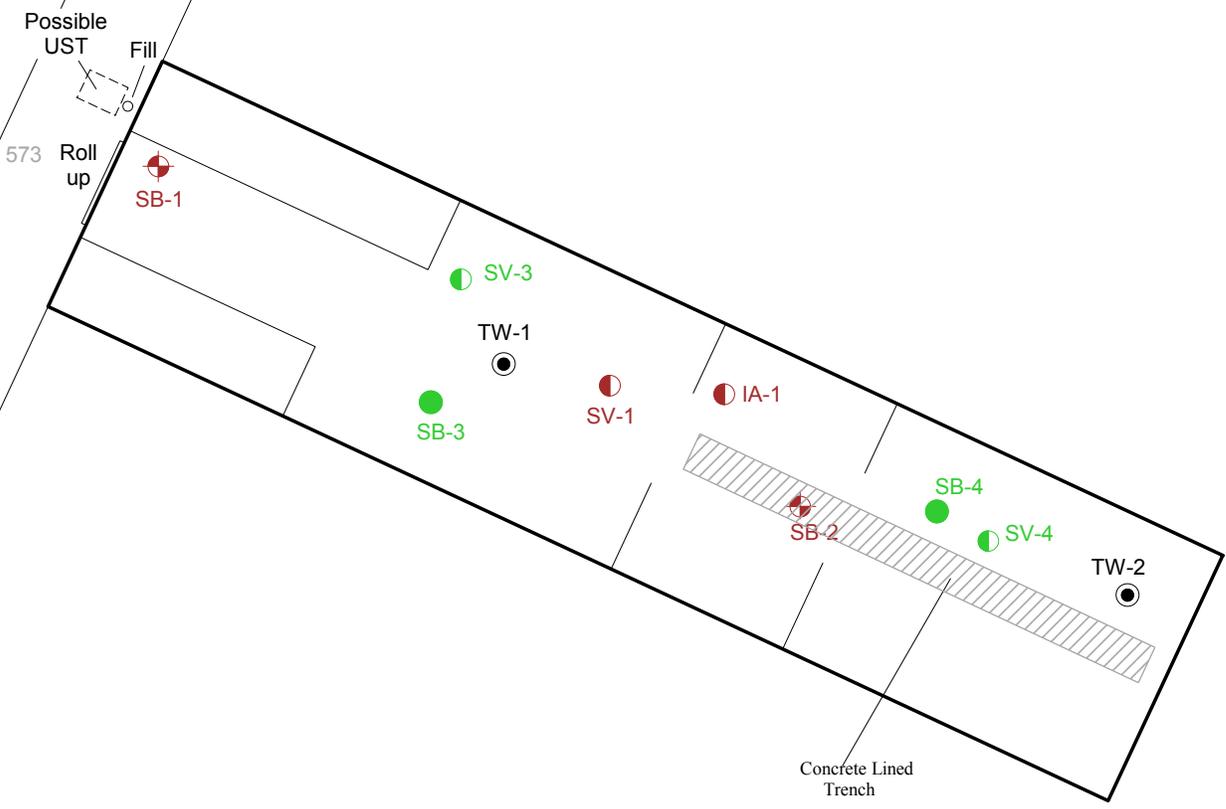
1. Area where a historic underground fuel oil tank is located.
2. Area where there may be potential impacts from former auto repair operations.
3. Concrete lined trench behind the building.

Concrete Lined Trench

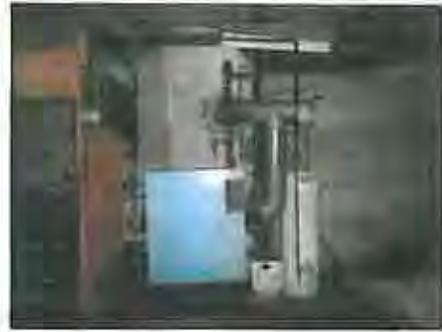
**PHOTO 11:** VIEW OF EQUIPMENT. NATURAL GAS BOILER AND WATER HEATER. BOILER HAS DEDICATED EXHAUST. THE PARTITION TO THE LEFT CONTAINS THE CITY UTILITY CONNECTIONS (GAS, ELECTRICITY, DOM. WATER).

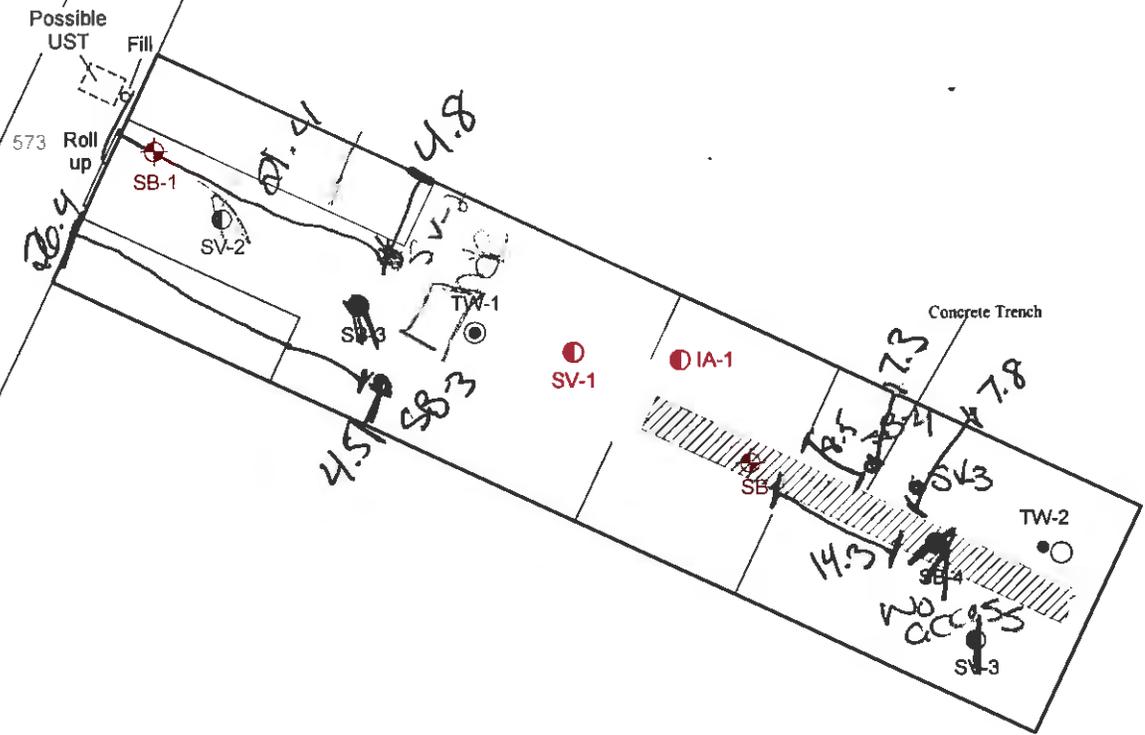
All sampling points in brown were installed on September 25, 2012.

All sampling points in black are proposed for summer 2013.
