533-537 FLUSHING AVENUE

Remedial Investigation Report

OER Site Number: 14EHAN422K

OCTOBER 2014

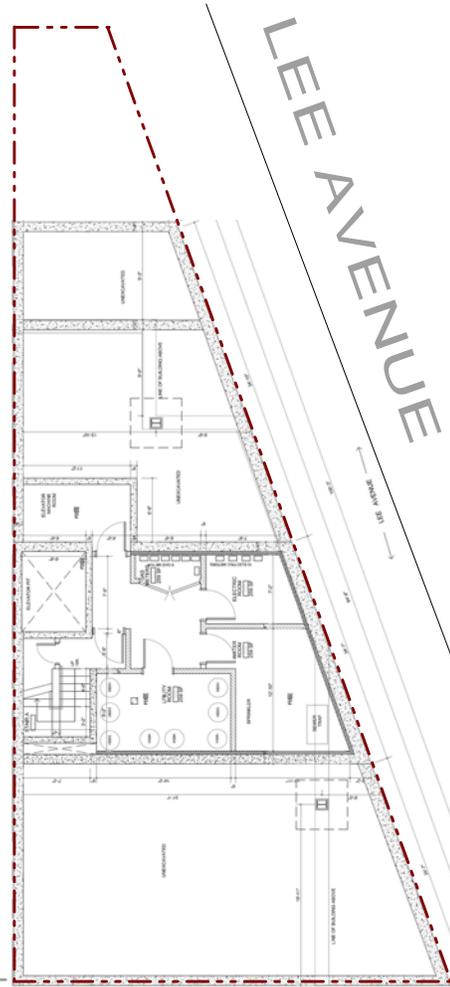
Drawing Title: Redevelopment Plan

CELLAR FLOOR PLAN

The cellar will require excavation across an area of approximately 1,900 ft² to a depth of approximately 10 feet below sidewalk grade, which will generate approximately 700 cubic yards (1,000 tons). Additional excavation of the top 2 to 3 feet would be required across the remainder of the Site for construction of the buildings slab-on grade foundation and concrete capped rear

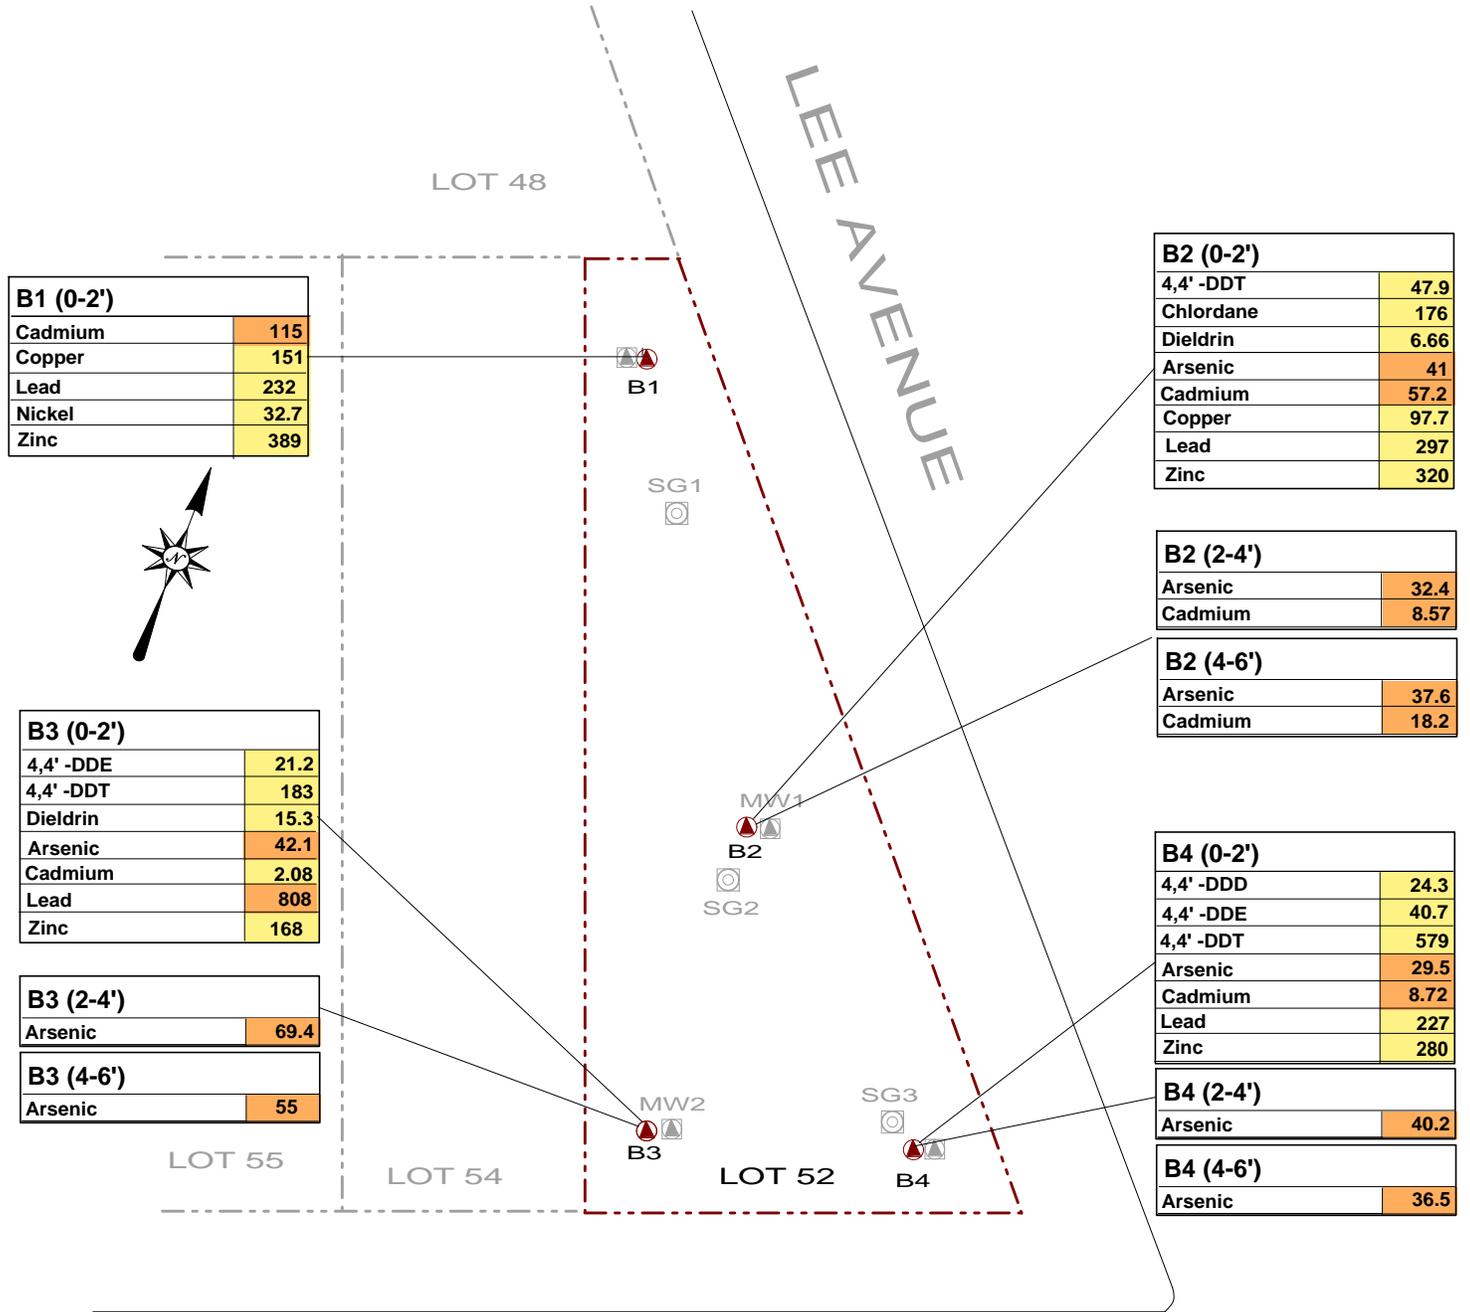
- Property Boundary
- Groundwater Sampling Location
- Soil Boring Location
- Soil Gas Sampling Location

On February 23, 2009, two groundwater samples were collected from soil boring locations B1 and B4 by installing a stainless-steel groundwater sampler, set to intersect the water table. The collection location of the two groundwater samples is shown on Figure 5.

All three soil vapor probes were installed using Geoprobe™ equipment and tooling. The approximate location of each of the soil vapor probes is shown on Figure 5. The vapor probes that were installed were the Geoprobe™ Model AT86 series, which are constructed of a 6-inch length of double woven stainless steel wire. The three soil vapor probes installed on April 1, 2014, were installed to a depth of 8 feet below grade. Each probe was attached to ¼ inch polyethylene tubing which extended approximately 18 inches beyond that needed to reach the surface. The tubing was capped with a ¼ inch plastic end to prevent the infiltration of foreign particles into the tube. Coarse sand was placed around the probe to a height of approximately 1 foot above the bottom of the probe. The remainder of the borehole was sealed with a bentonite slurry to the surface.
