**PROPOSED WAREHOUSE FACILITY  
EXISTING COMMERCIAL PROPERTY  
RALPH AVENUE AND PRESTON COURT  
BROOKLYN, KINGS COUNTY, NEW YORK**

**Remedial Action Work Plan  
& STIP List (9/11/2015)**

**NYC VCP Number: 15CVCP123K**

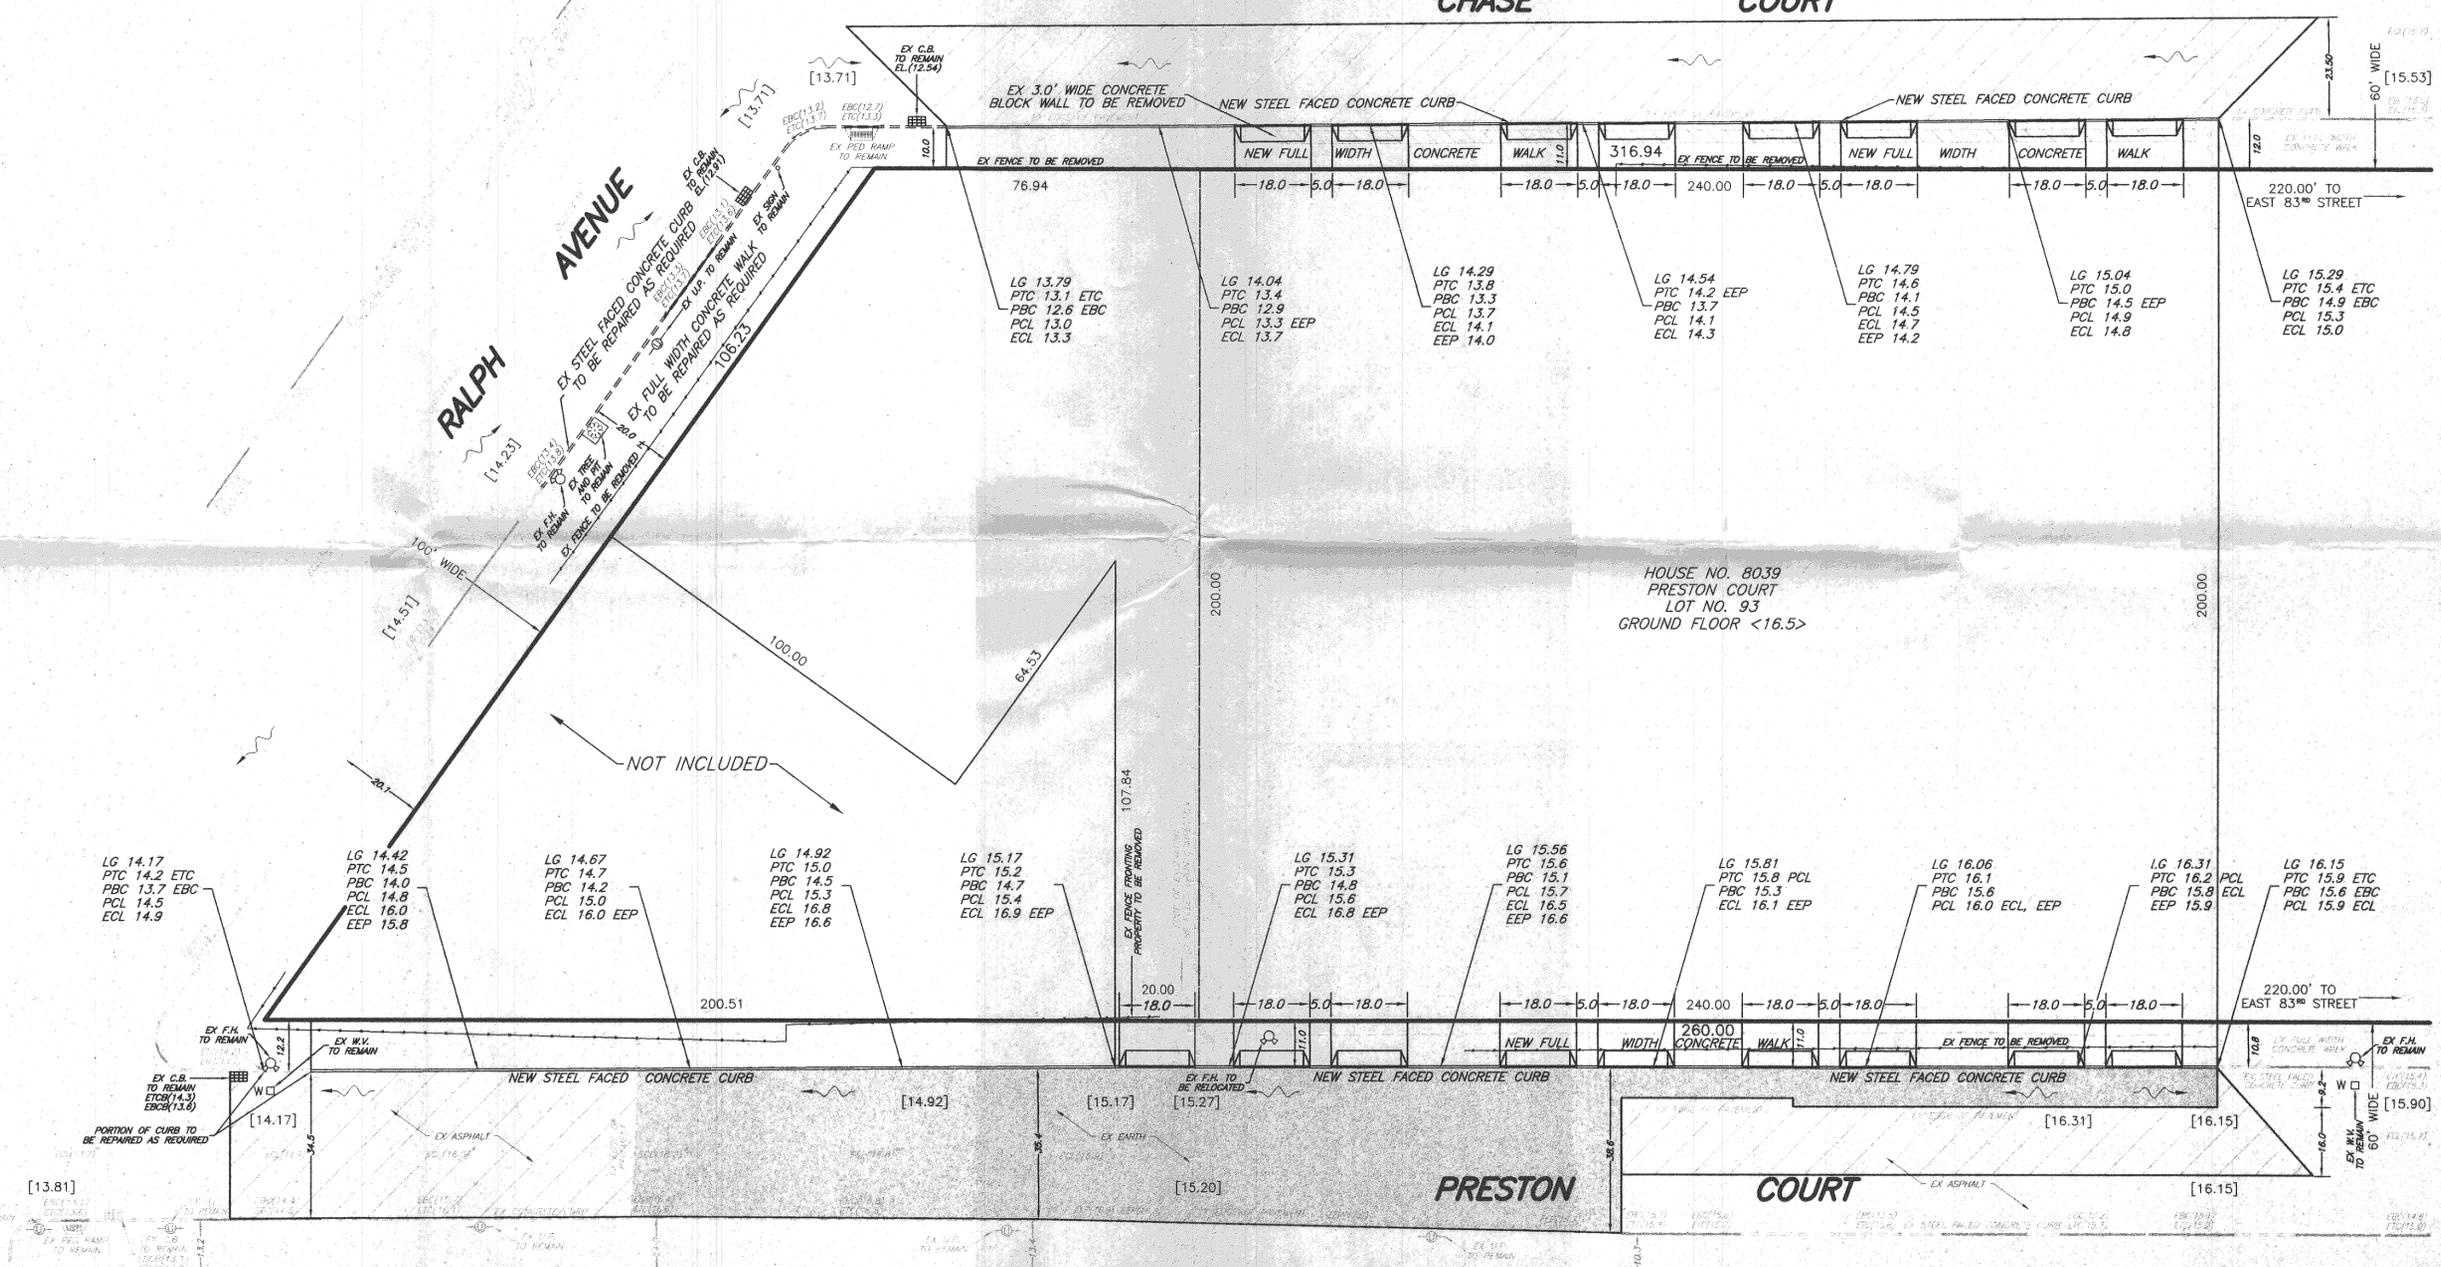
NEW 3" ASPHALTIC CONCRETE ON 8" DENSE GRADED STONE

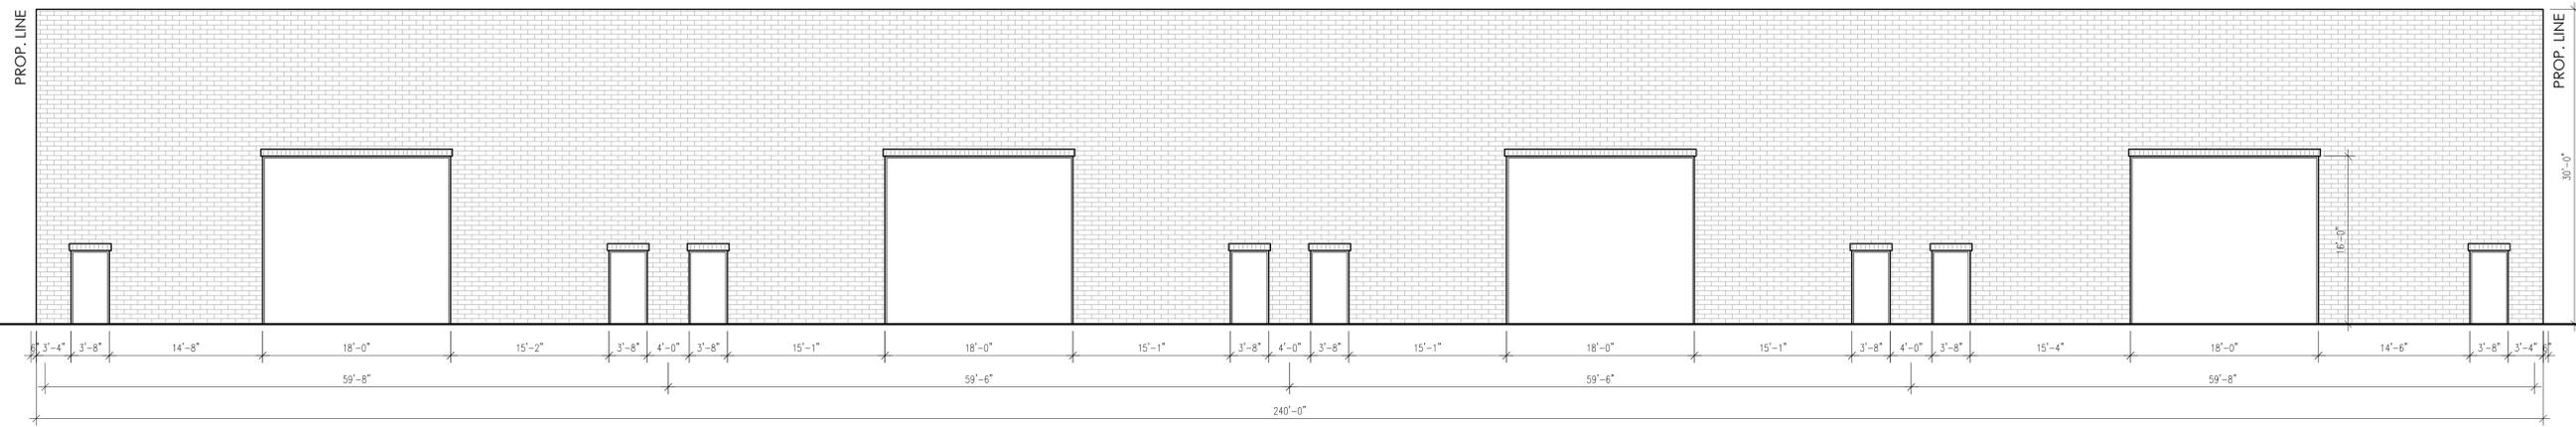
**NORTH (CHASE COURT) / SOUTH (PRESTON COURT) ELEVATION**

SCALE: 1/8" = 1'-0"

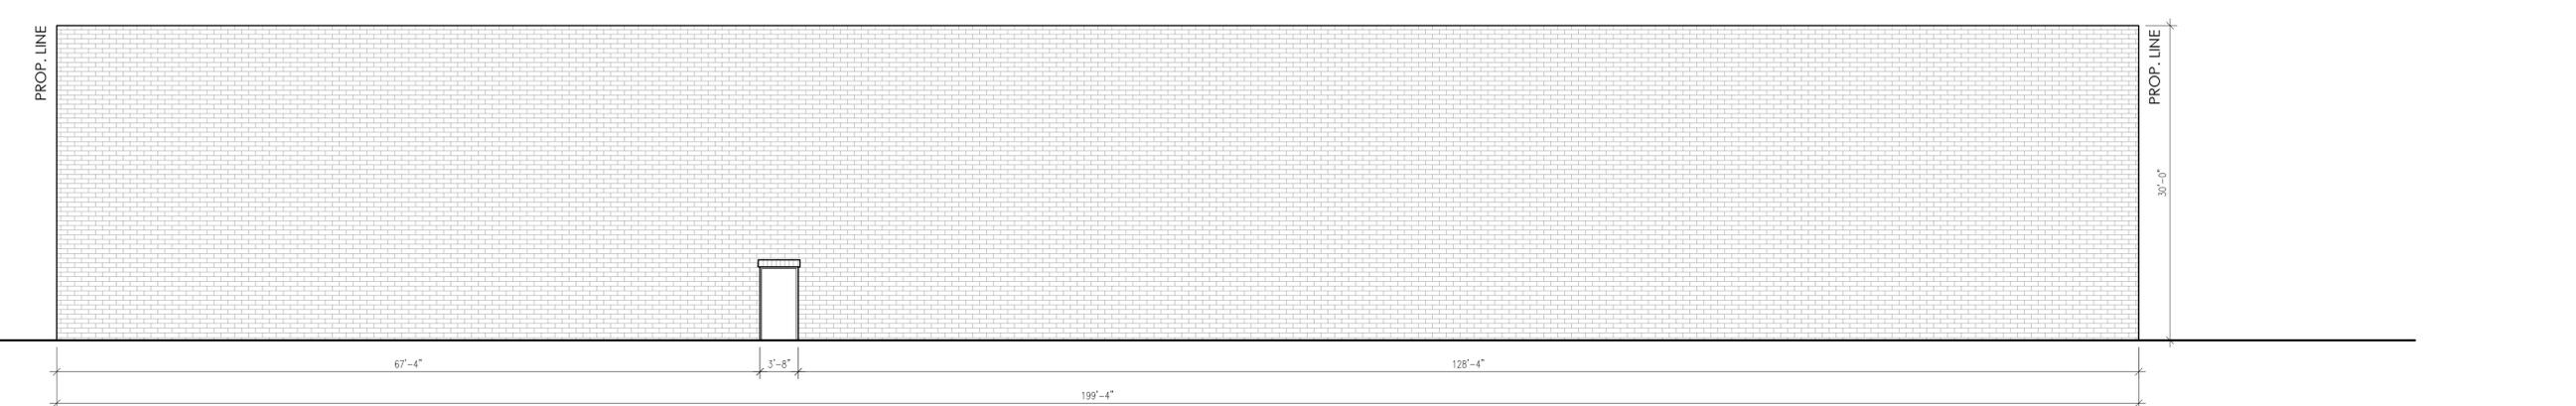
**WEST ELEVATION**

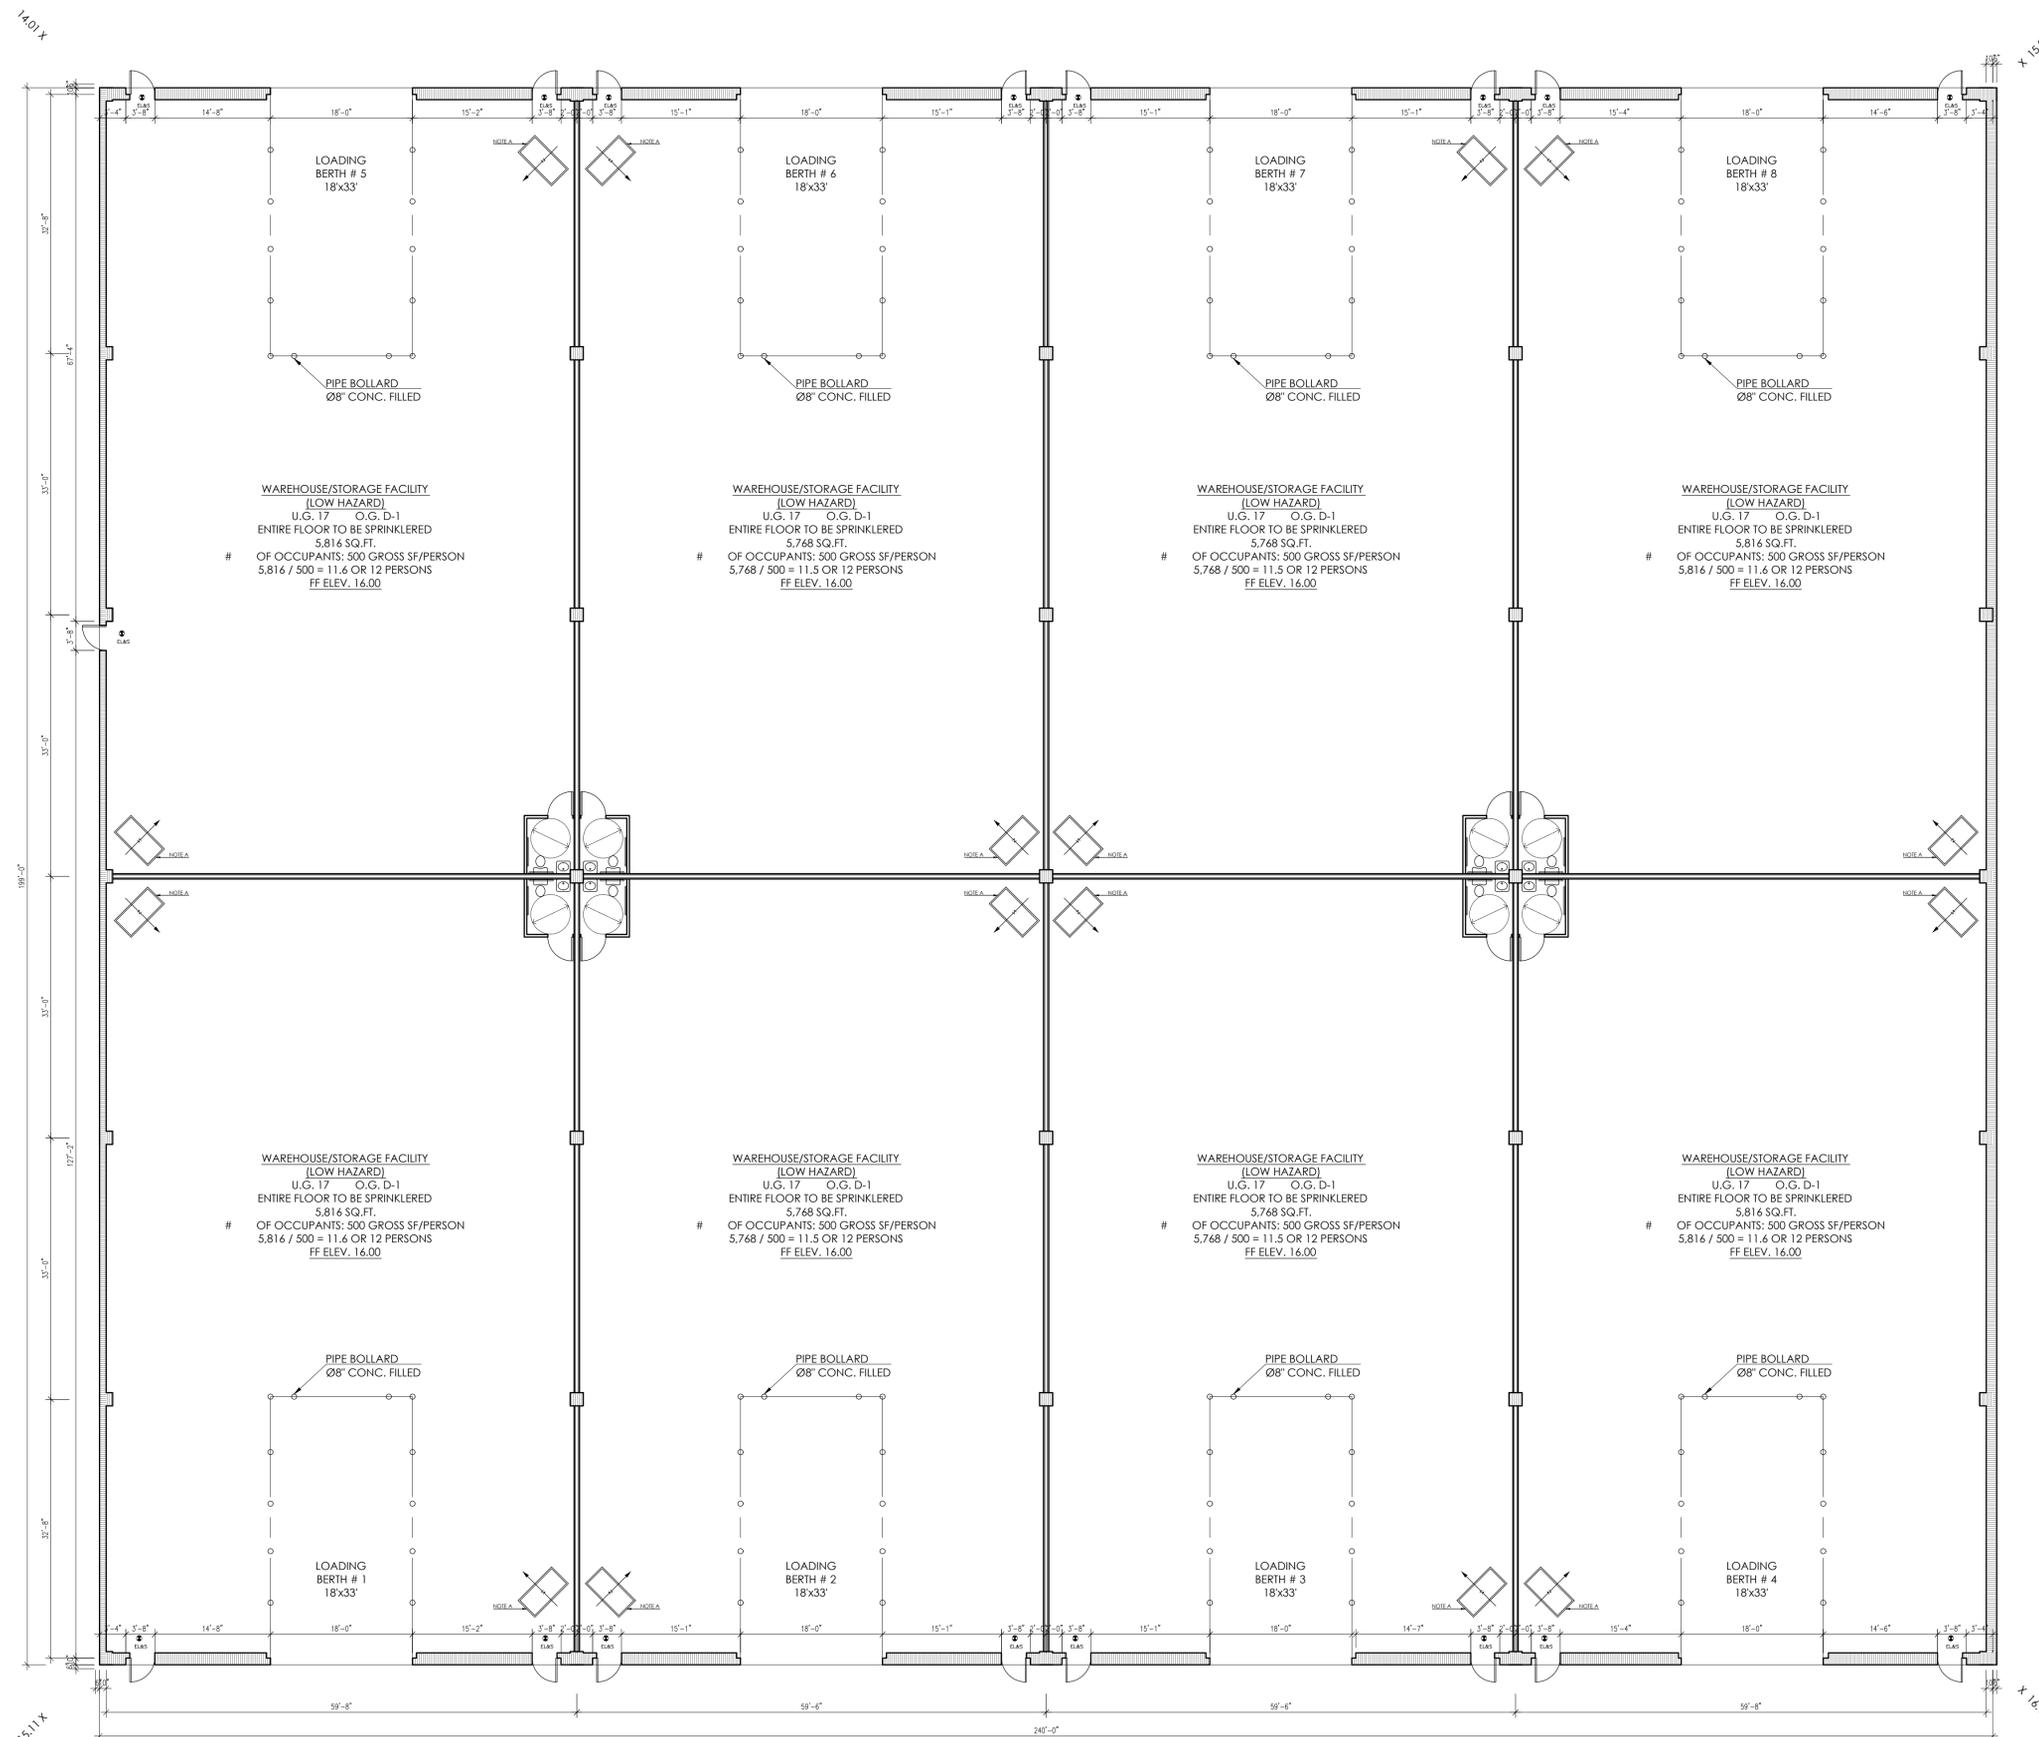
**FIRST FLOOR PLAN**  
SCALE: 3/32" = 1'-0"

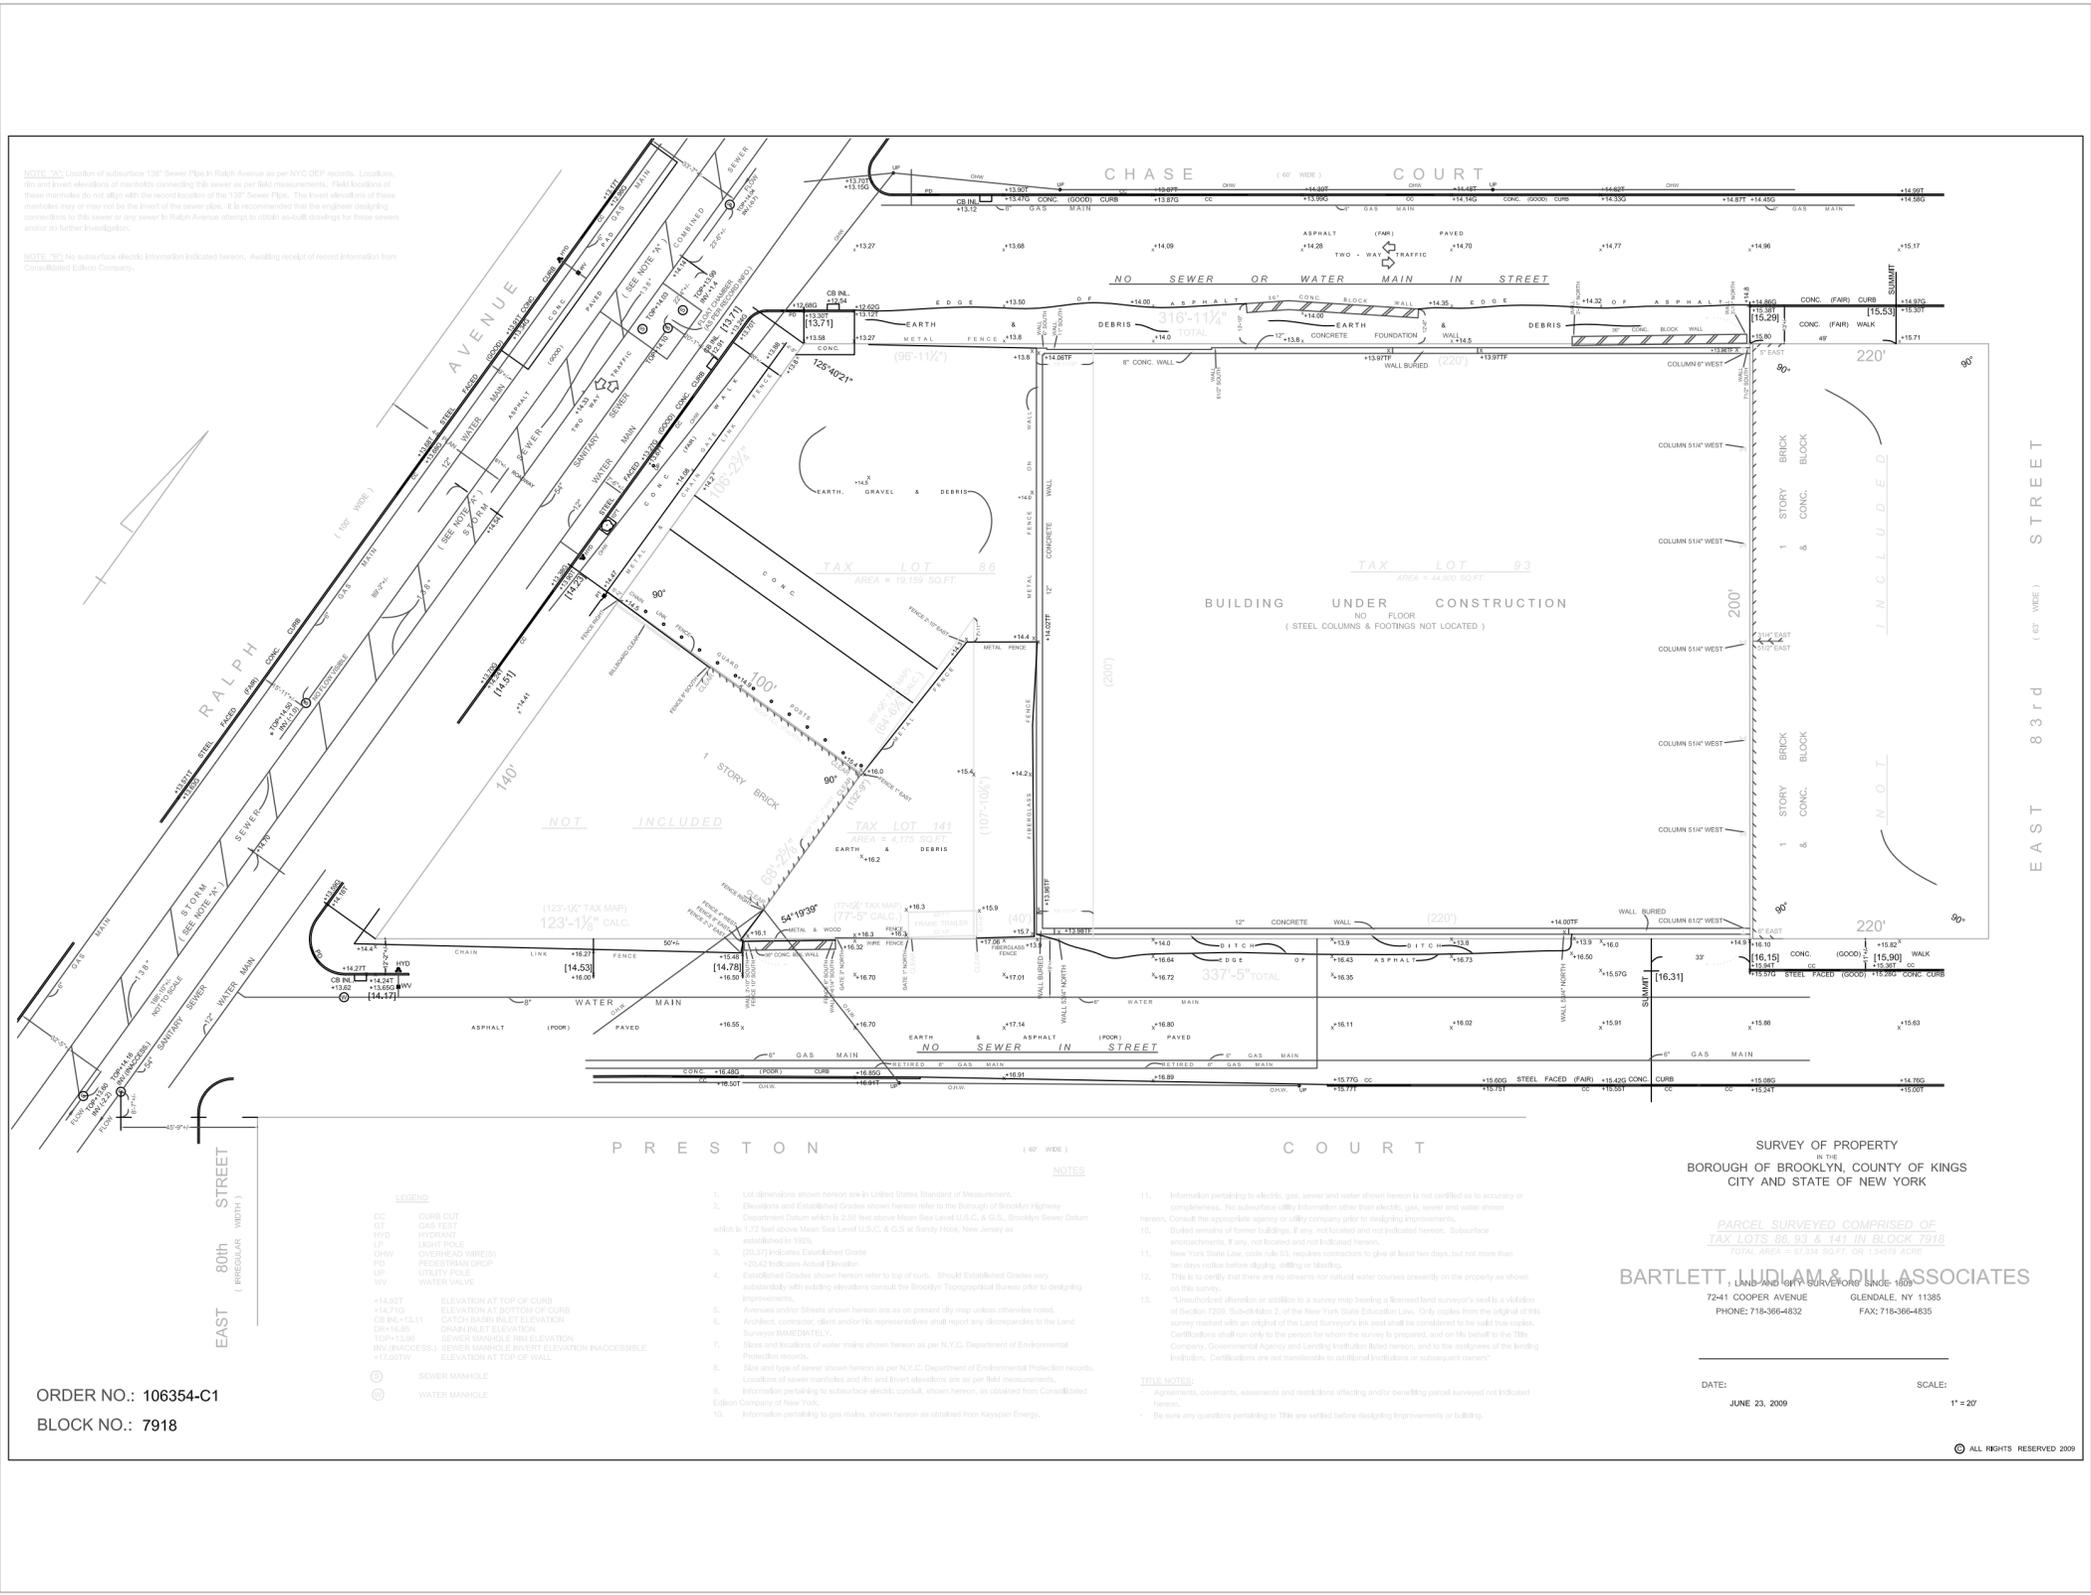
NOTE: 70 Location of subsurface 15" Sewer Pipe in Ralph Avenue as per NYC DEP records. Locations, size and invert elevations of manholes connecting this sewer as per field measurements. Field locations of these manholes may or may not align with the record location of the 15" Sewer Pipe. The invert elevations of these manholes may or may not be the invert of the sewer pipe. It is recommended that the engineer designing connections to this sewer or any sewer in Ralph Avenue attempt to obtain accurate drawings for these sewers and/or do further investigation.

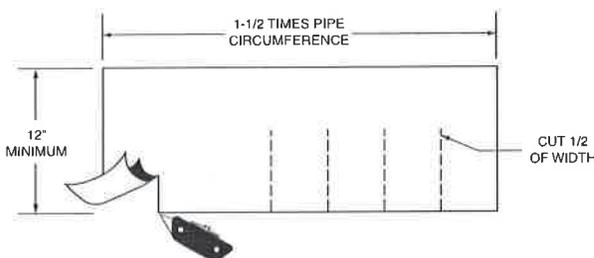
Figure 1 COLLAR

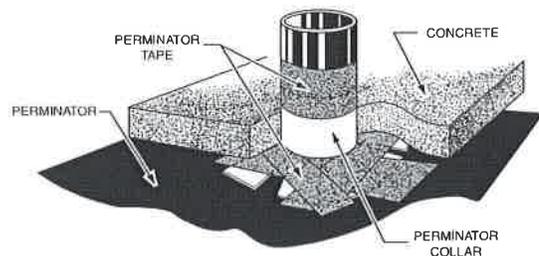
Figure 2: COLLAR INSTALLATION

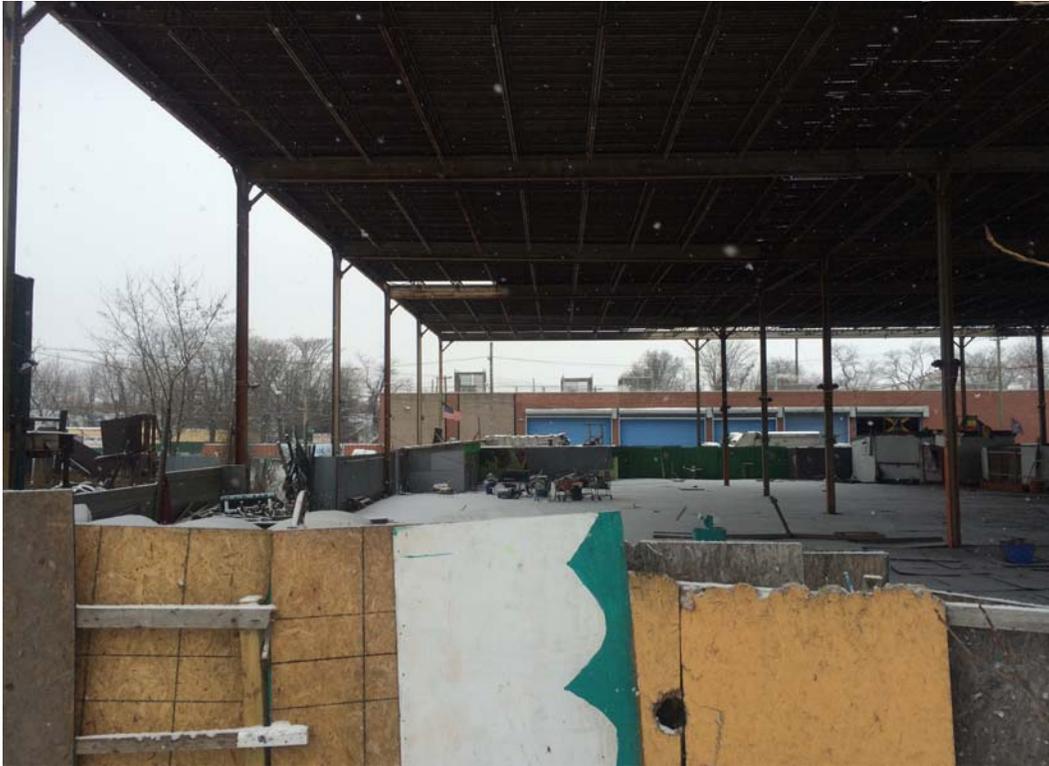
**WESTERN PORTION OF THE SITE; VIEW TO THE NORTH.**

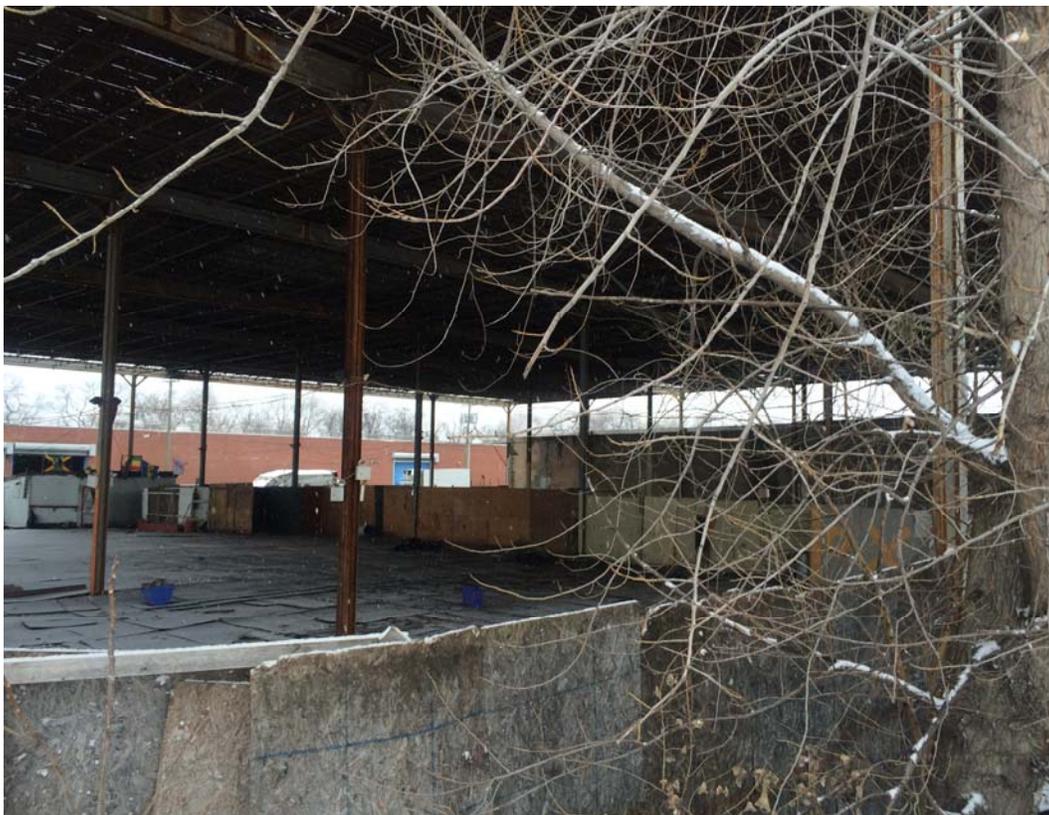
**CENTRAL PORTION OF THE SITE; VIEW TO THE NORTH.**
