27-01 41ST AVENUE
QUEENS, NEW YORK

Remedial Investigation Report

NYC VCP Number: 14CVCP158Q
E- Designation Site Number: 13EHAZZ45Q

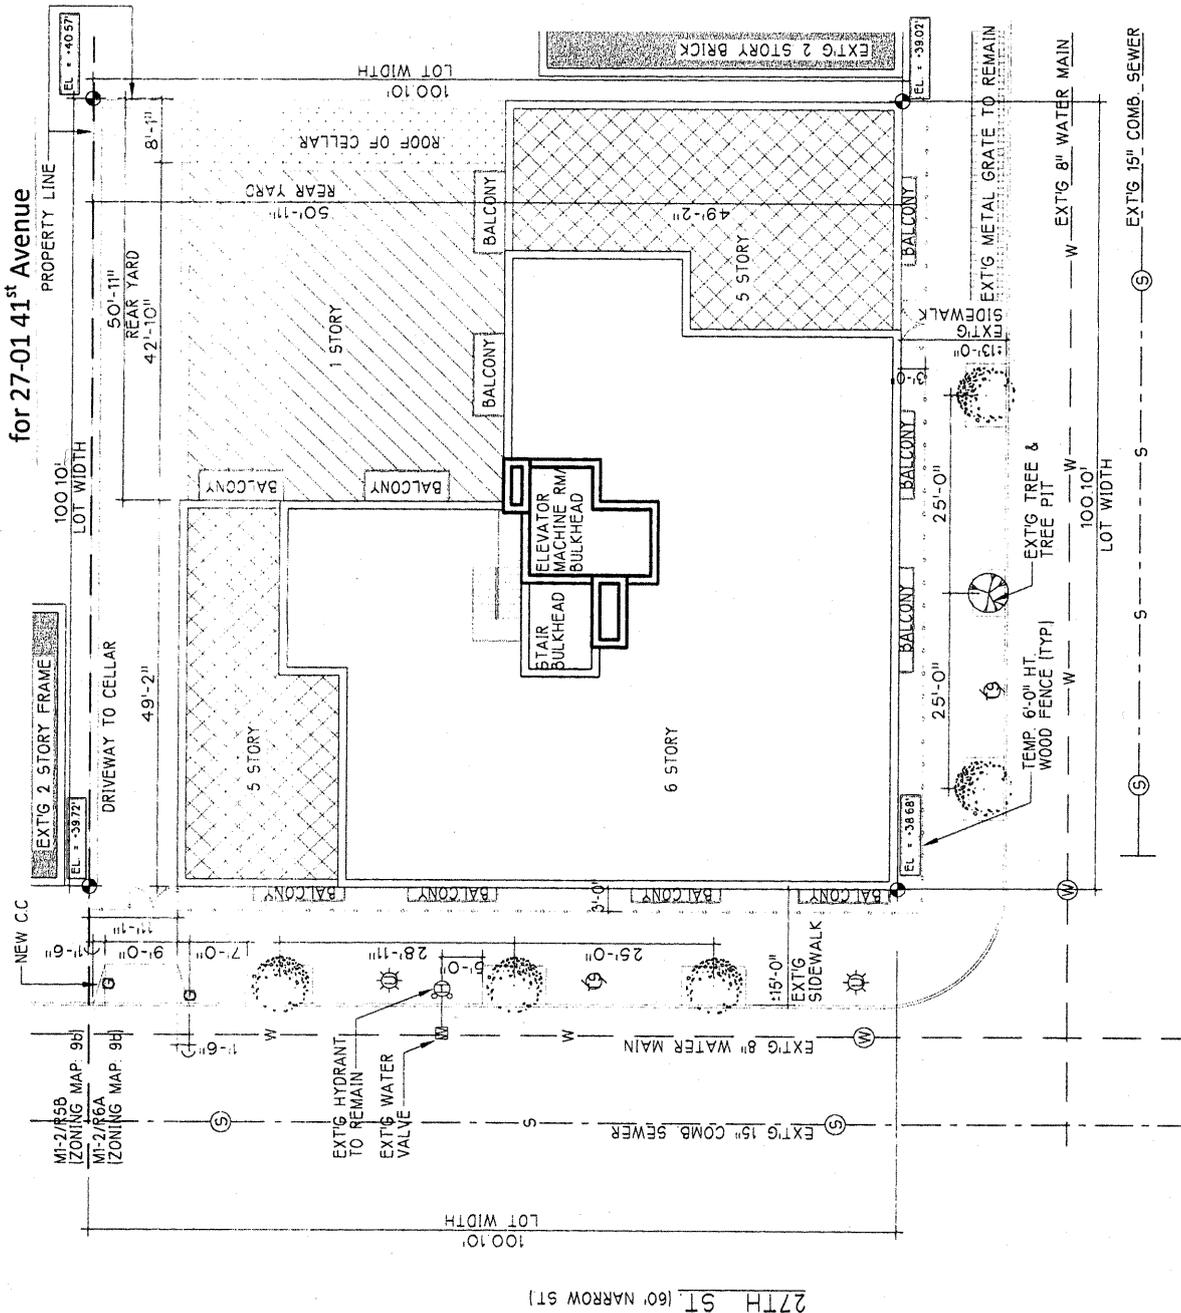
Figure 1 Plot Plan showing the footprint and the property boundary lines

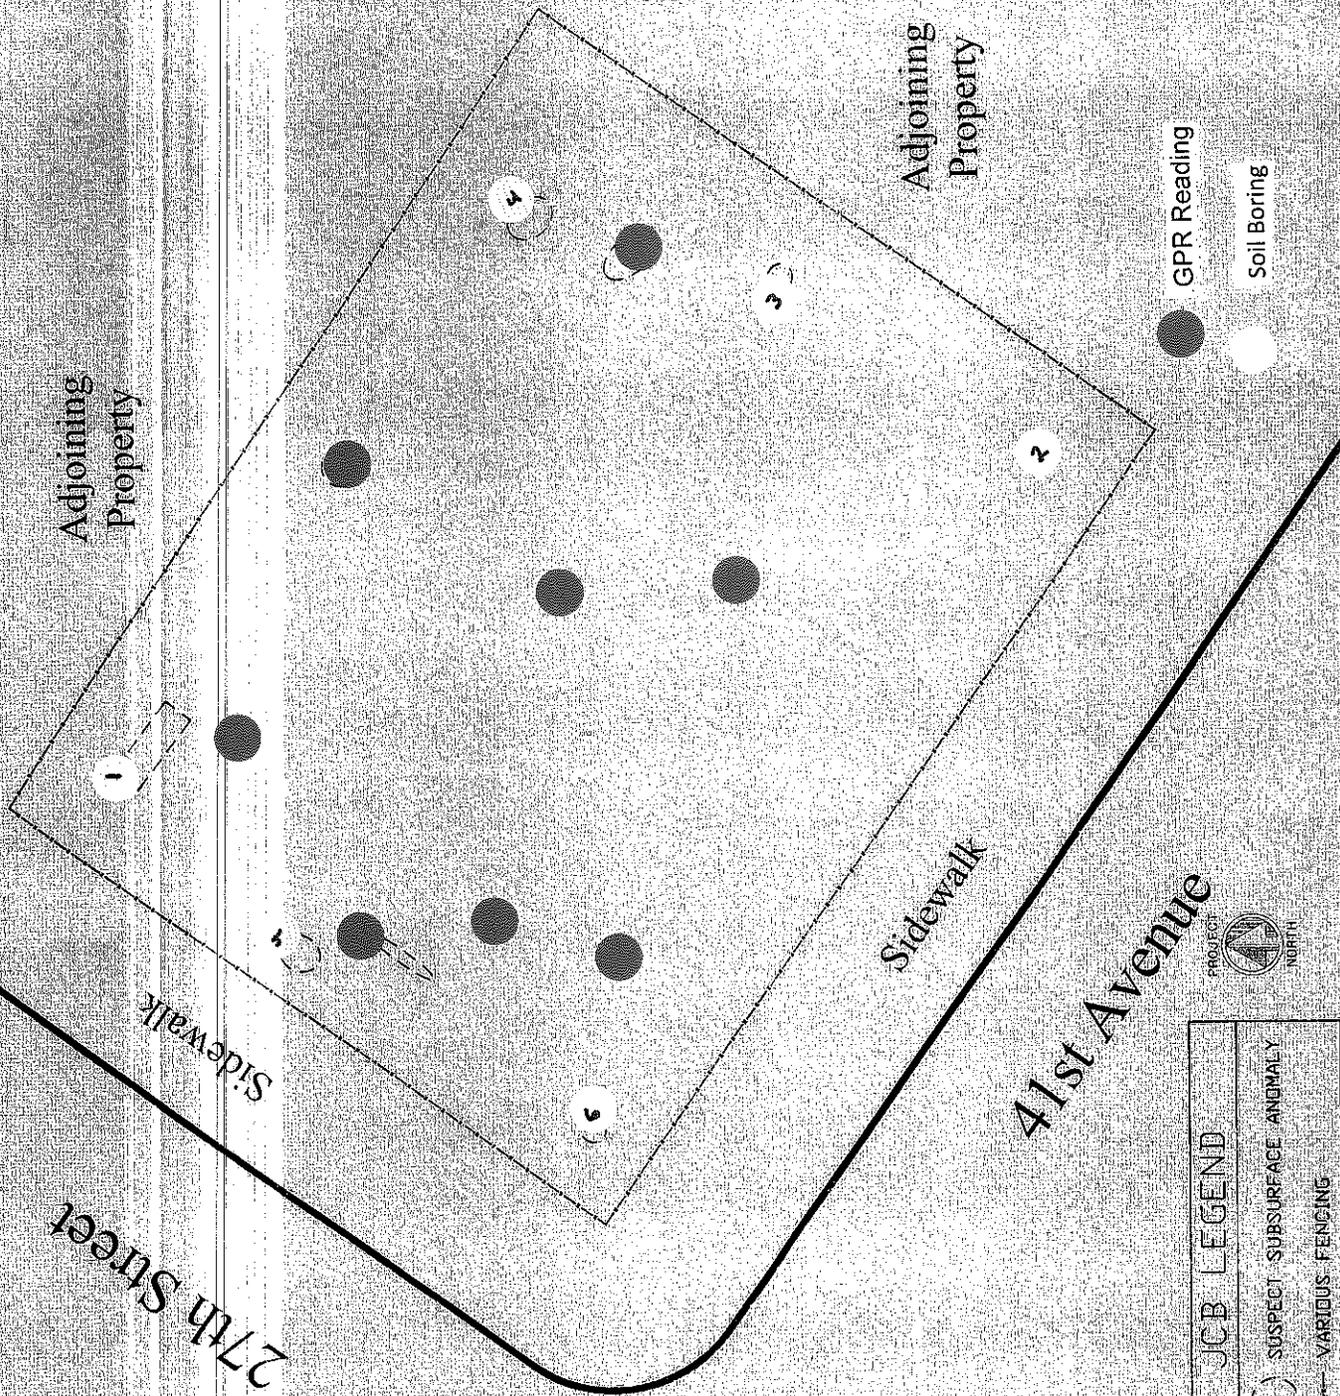
Figure 2 Site map showing the locations of GPR small anomalies together with the locations of six soil borings

The six soil borings were located at points on the property where small anomalies were found by the geophysical surveys. The borings were drilled to a depth of 15 feet in order to reach levels that would correspond to the excavation depths of the proposed underground garage. The entire

found no evidence of staining or odors that would indicate the presence of contamination. The borings were one inch in diameter and were installed and back filled after sampling.

The continuous cores over the 15 foot interval were described in detail and scanned with a PID meter to determine if there were any volatile organic compound exceedances. The cores were scanned visually and at no point did we find anything other than clean well sorted sand. No staining or the presence of organic material anywhere in the drilling results. We encountered no solid objects such as demolition debris in the upper 15 feet or any evidence of buried tanks or drums. All of this confirming that the objects noted in the magnetometer survey and the GPR survey were probably not sources of contamination.

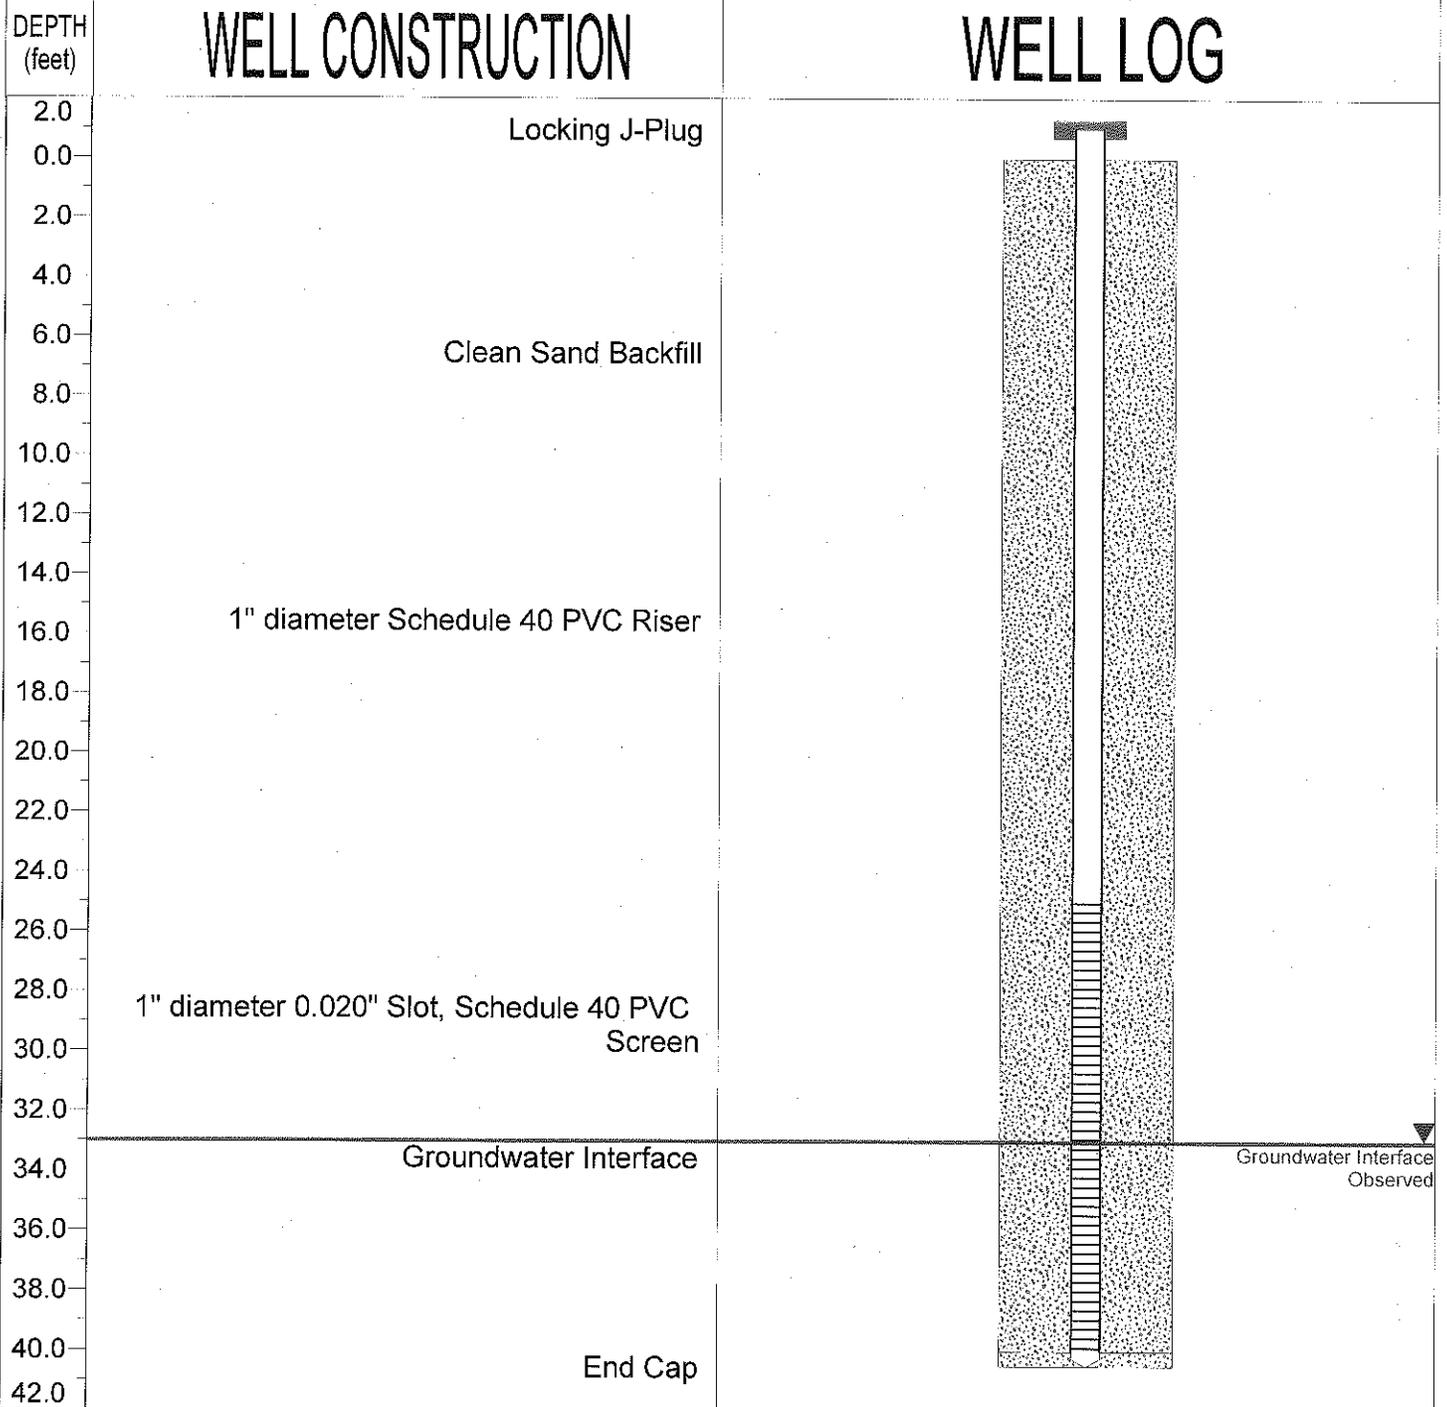
Figure 3 Log and construction details of MW 1

PROJECT NAME: Long Island City		BORING NUMBER: MW-1	
PROJECT ADDRESS: 27-01 41st Avenue Long Island City, NY 11101		BORING LOCATION: North Corner of Subject Property	
DRILLING CONTRACTOR: JC Broderick & Associates, Inc.	DRILLING METHOD: 2.125 inch Direct Push Rods	TOTAL DEPTH: 40 Feet bsg	MEASURING POINT: Ground Surface
DRILLING EQUIPMENT: Geoprobe® 7720DT	SAMPLING METHOD: MC5 Soil Sampling System	GROUND SURFACE ELEVATION: 39 Feet Above Sea Level	DATE COMPLETED: 3/14/13
HAMMER WEIGHT: N/A	DROP: N/A	DEPTH TO GROUNDWATER: 33 Feet bsg	RESponsible Professional: Jeffrey Nannini
		LOGGED BY: Adam Hutchinson

0-1 Soil and plant debris, Dark brown

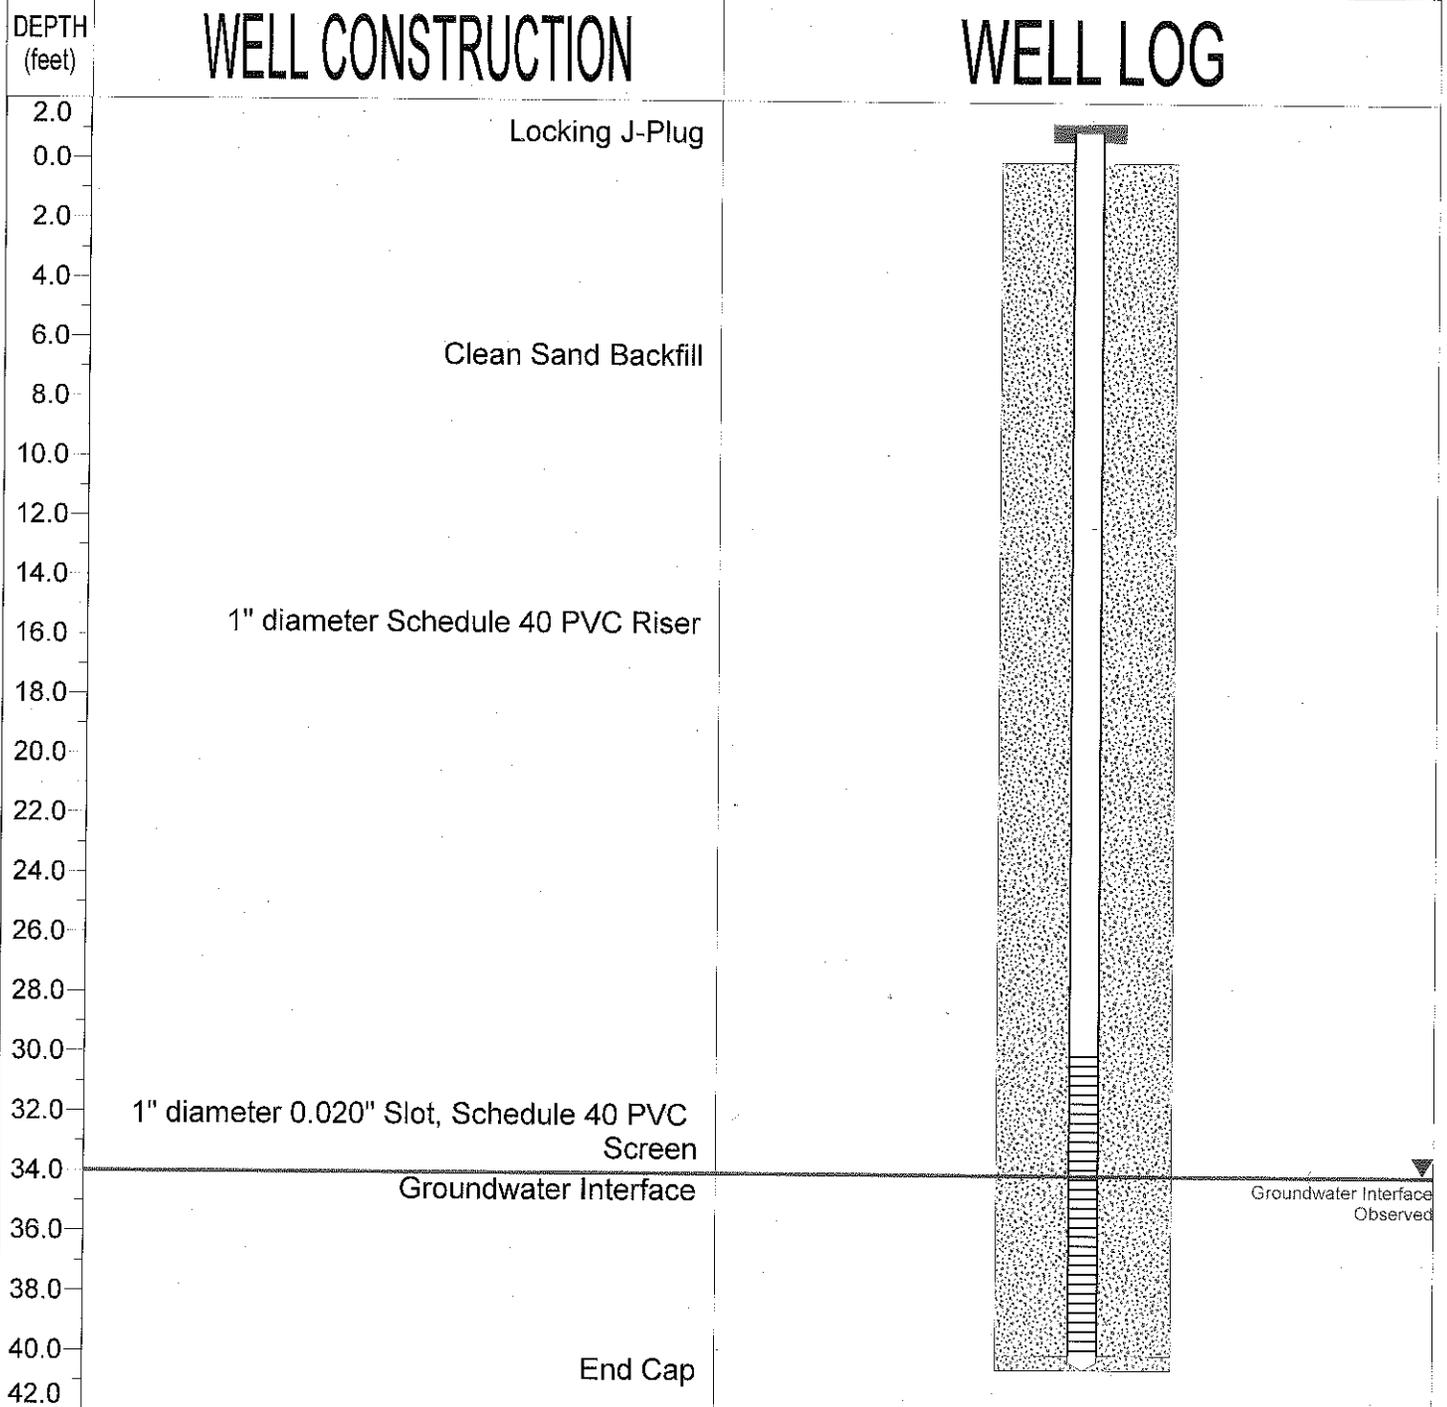
Figure 4 Log and construction details of MW 2

PROJECT NAME: Long Island City		BORING NUMBER: MW-2	
PROJECT ADDRESS: 27-01 41st Avenue Long Island City, NY 11101		BORING LOCATION: East Corner of Subject Property	
DRILLING CONTRACTOR: JC Broderick & Associates, Inc.		TOTAL DEPTH: 40 Feet bsg	MEASURING POINT: Ground Surface
DRILLING METHOD: 2.125 inch Direct Push Rods	DRILLING EQUIPMENT: Geoprobe® 7720DT	GROUND SURFACE ELEVATION: 39 Feet Above Sea Level	DATE COMPLETED: 3/14/13
SAMPLING METHOD: N/A		DEPTH TO GROUNDWATER: 34 Feet bsg	
HAMMER WEIGHT: N/A	DROP: N/A	RESPONSIBLE PROFESSIONAL: Jeffrey Nannini	LOGGED BY: Adam Hutchinson

0-0.5 Dark brown soil, roots and plant debris, Some fill material

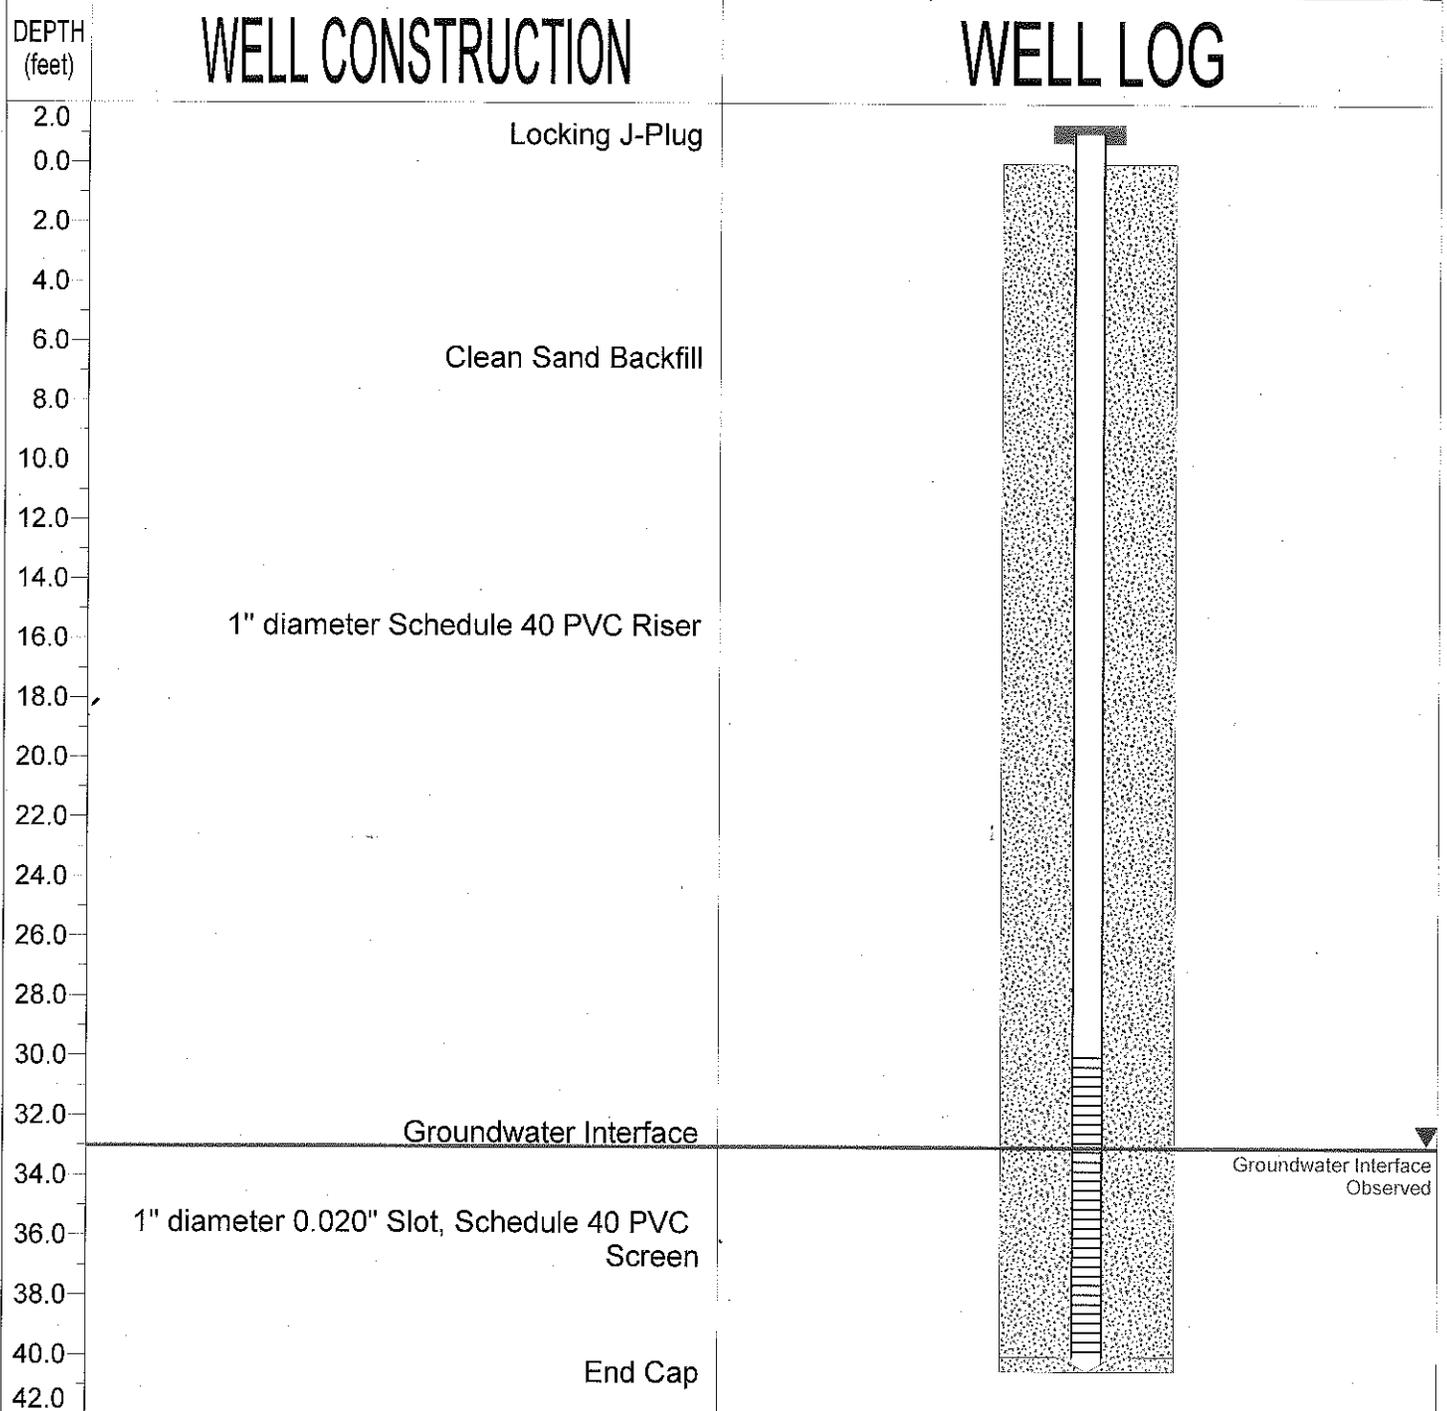
Figure 5 Log and construction details of MW-3

PROJECT NAME: Long Island City		BORING NUMBER: MW-3	
PROJECT ADDRESS: 27-01 41st Avenue Long Island City, NY 11101		BORING LOCATION: Center of Subject Property	
DRILLING CONTRACTOR: JC Broderick & Associates, Inc.		TOTAL DEPTH: 40 Feet bsg	MEASURING POINT: Ground Surface
DRILLING METHOD: 2.125 inch Direct Push Rods		GROUND SURFACE ELEVATION: 39 Feet Above Sea Level	DATE COMPLETED: 3/14/13
DRILLING EQUIPMENT: Geoprobe® 7720DT		DEPTH TO GROUNDWATER: 32 Feet bsg	
SAMPLING METHOD: N/A		RESPONSIBLE PROFESSIONAL: Jeffrey Nannini	LOGGED BY: Adam Hutchinson
HAMMER WEIGHT: N/A	DROP: N/A

0-0.5 Dark brown soil with roots and plant debris. Some trash and construction debris

30-40 Sand fine to medium light brown, Becomes lighter in color with depth

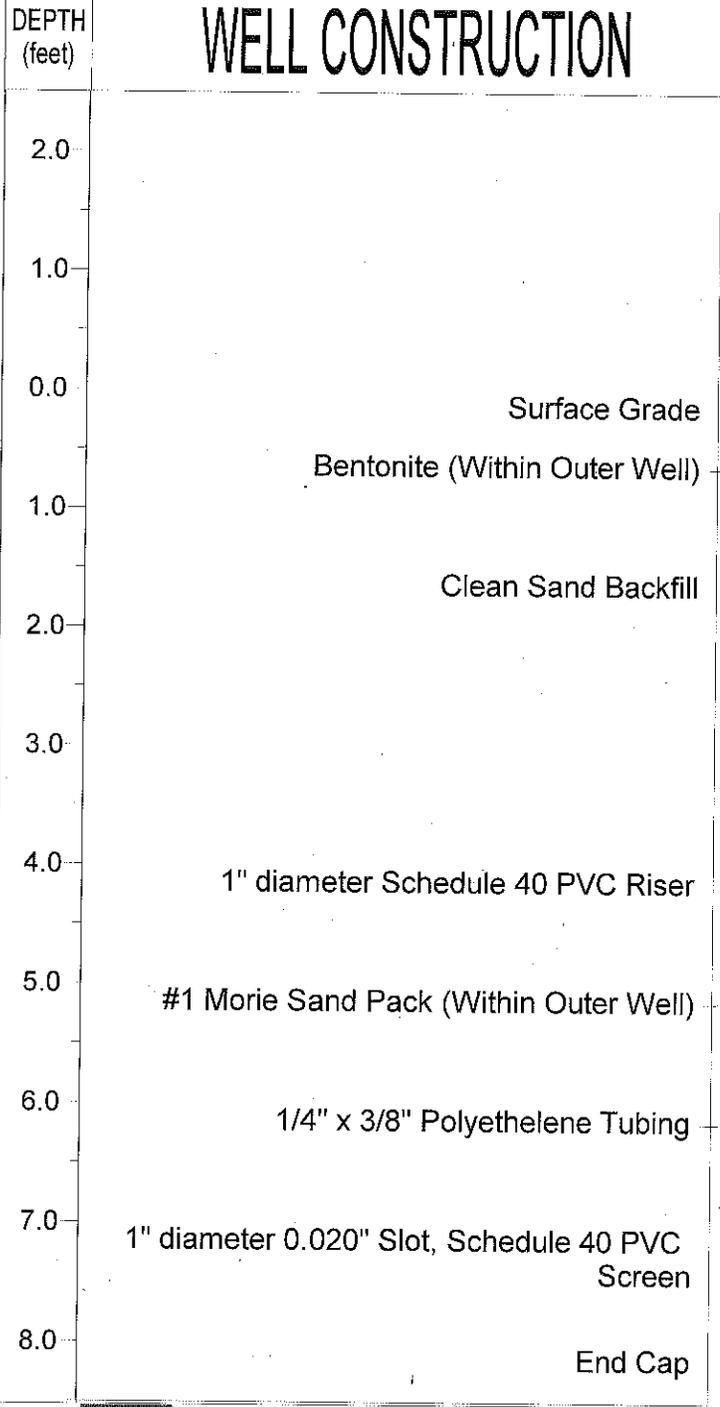
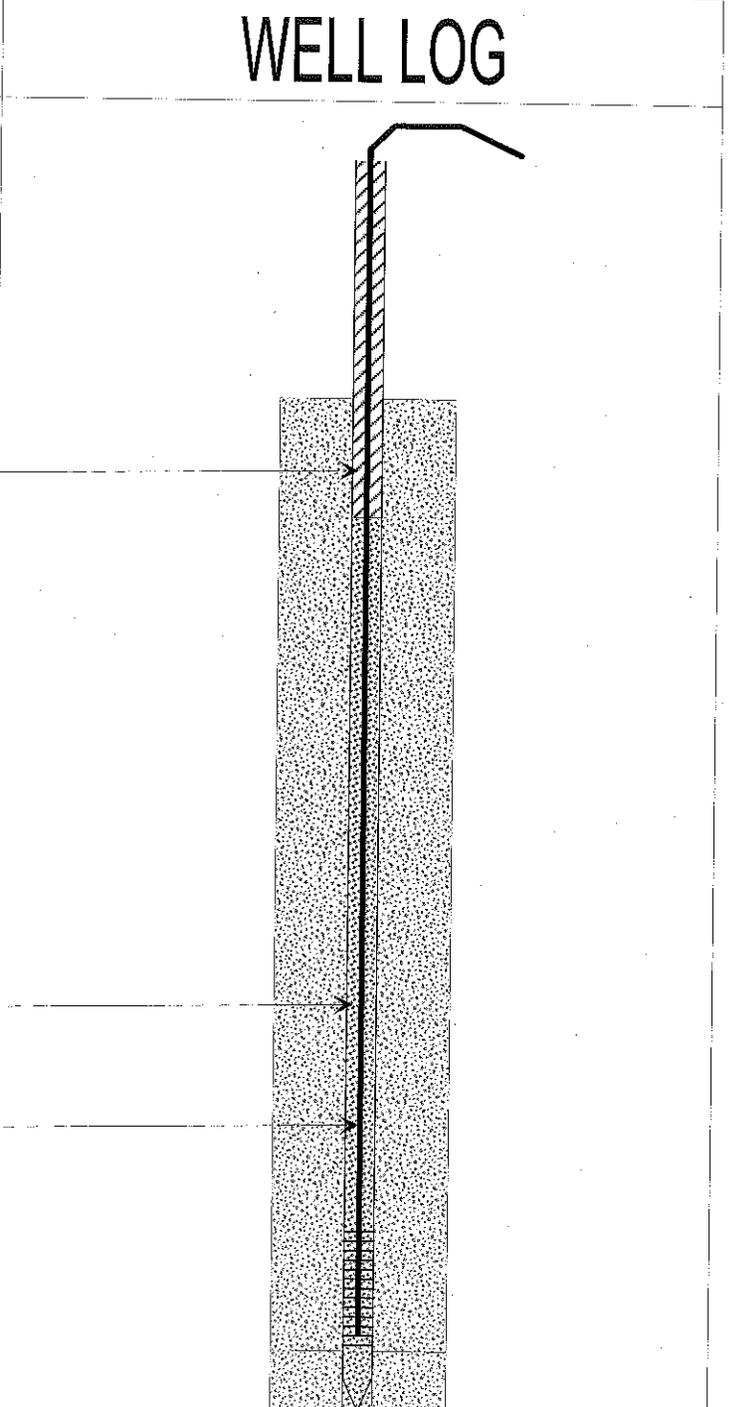
PROJECT NAME: Long Island City		BORING NUMBER: VP-1	
PROJECT ADDRESS: 27-01 41st Avenue Long Island City, NY 11101		BORING LOCATION: North Center of Subject Property	
DRILLING CONTRACTOR: JC Broderick & Associates, Inc.		TOTAL DEPTH: 8 Feet bsg	MEASURING POINT: Ground Surface
DRILLING METHOD: 2.125 inch Direct Push Rods		GROUND SURFACE ELEVATION: 39 Feet Above Sea Level	DATE COMPLETED: 3/14/13
DRILLING EQUIPMENT: Geoprobe® 7720DT		DEPTH TO GROUNDWATER: Not Encountered	
SAMPLING METHOD: N/A		RESPONSIBLE PROFESSIONAL: Jeffrey Nannini	LOGGED BY: Adam Hutchinson
HAMMER WEIGHT: N/A	DROP: N/A

The soil gas probes were installed in accordance with NYSDOH Guidance for Evaluating Soil Vapor Intrusion. Each sampling probe consisted of a stainless steel screen or implant fitted with plastic tubing. Each of the implants is 1.5 inches in diameter. The insert was sealed with bentonite to prevent leakage. The plastic tubing was connected to a Summa Canister and gas was extracted. Following this, the entire canister was removed to laboratory for analysis.

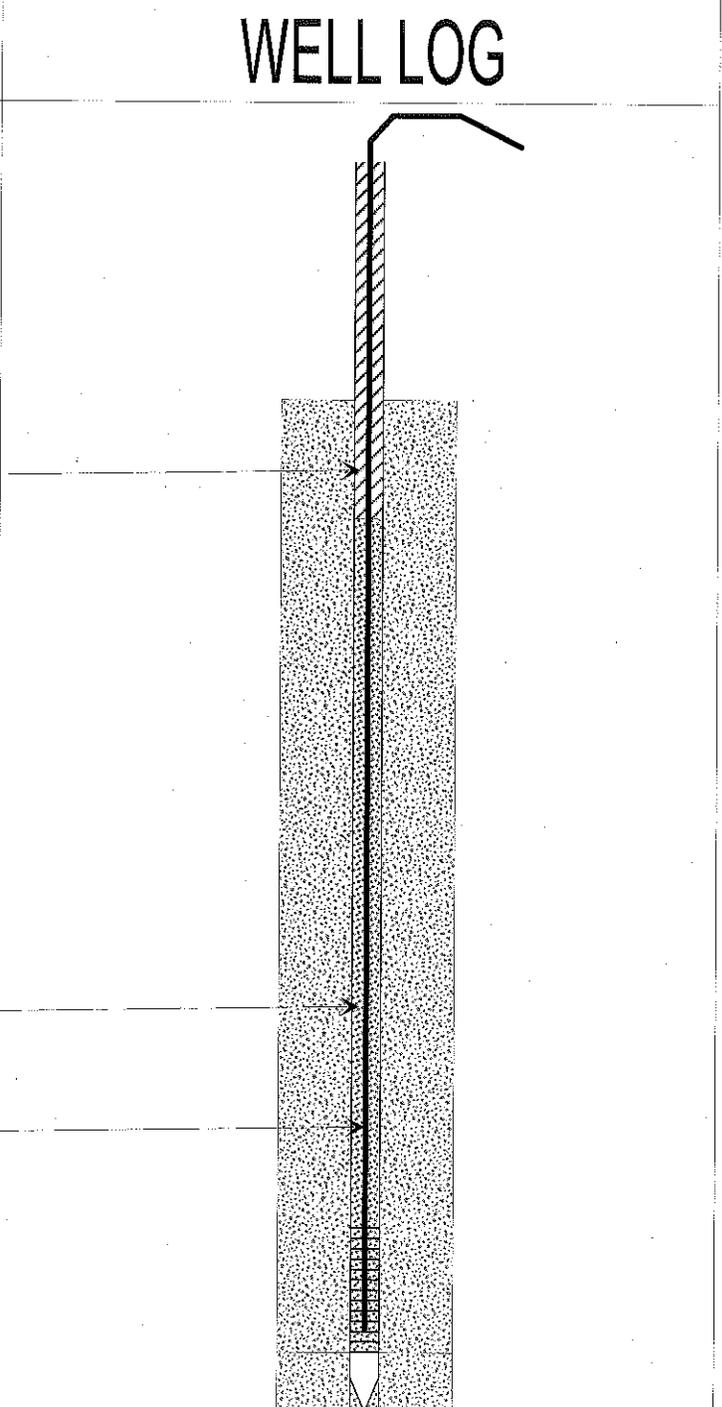
PROJECT NAME: Long Island City	BORING NUMBER: VP-2	
PROJECT ADDRESS: 27-01 41st Avenue Long Island City, NY 11101		
DRILLING CONTRACTOR: JC Broderick & Associates, Inc.	BORING LOCATION: North Corner of Subject Property	
DRILLING METHOD: 2.125 inch Direct Push Rods	TOTAL DEPTH: 8 Feet bsg	MEASURING POINT: Ground Surface
DRILLING EQUIPMENT: Geoprobe® 7720DT	GROUND SURFACE ELEVATION: 39 Feet Above Sea Level	DATE COMPLETED: 3/14/13
SAMPLING METHOD: N/A	DEPTH TO GROUNDWATER: Not Encountered	
HAMMER WEIGHT: N/A	DROP: N/A	RESPONSIBLE PROFESSIONAL: Jeffrey Nannini
		LOGGED BY: Adam Hutchinson

DEPTH (feet)	WELL CONSTRUCTION
2.0	
1.0	
0.0	Surface Grade
1.0	Bentonite (Within Outer Well)
2.0	Clean Sand Backfill
3.0	
4.0	1" diameter Schedule 40 PVC Riser
5.0	#1 Morie Sand Pack (Within Outer Well)
6.0	1/4" x 3/8" Polyethelene Tubing
7.0	1" diameter 0.020" Slot, Schedule 40 PVC Screen
8.0	End Cap

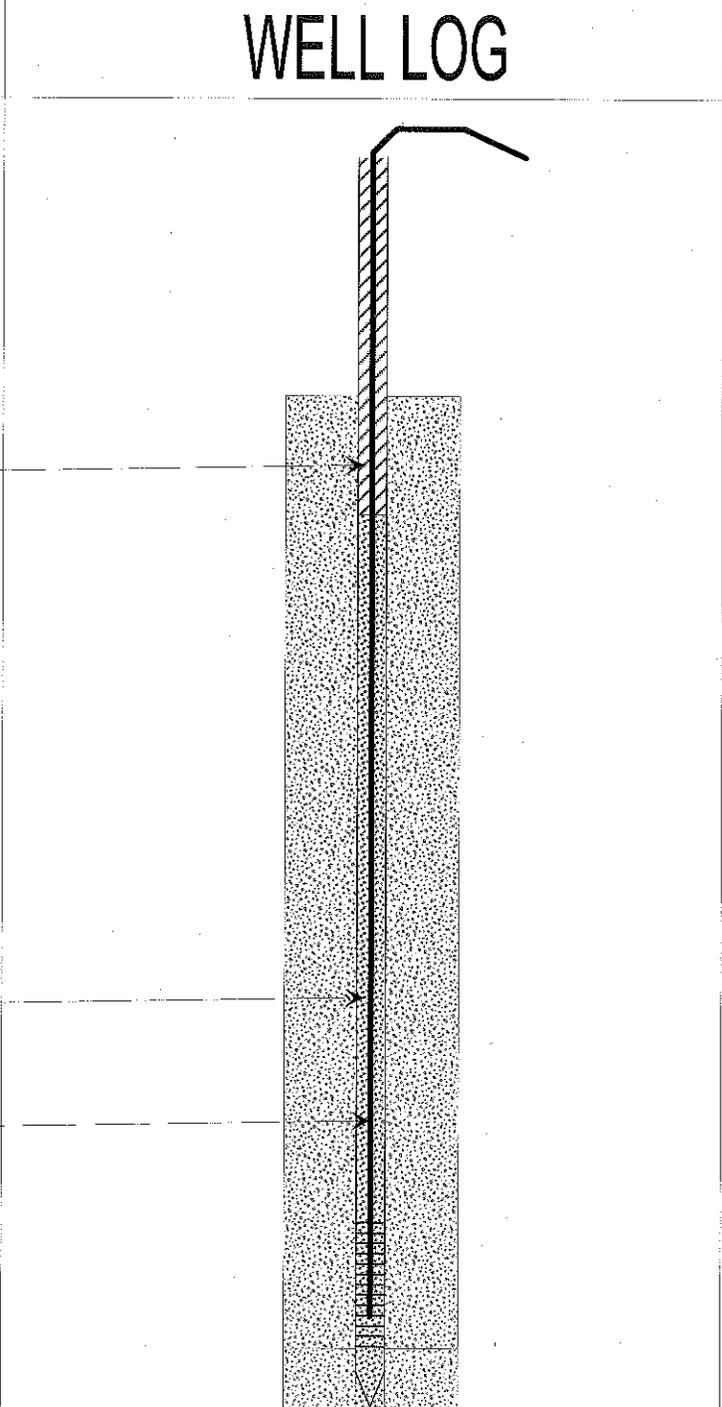
PROJECT NAME: Long Island City		BORING NUMBER: VP-3	
PROJECT ADDRESS: 27-01 41st Avenue Long Island City, NY 11101			
DRILLING CONTRACTOR: JC Broderick & Associates, Inc.		BORING LOCATION: South Corner of Subject Property	
DRILLING METHOD: 2.125 inch Direct Push Rods	TOTAL DEPTH: 8 Feet bsg	MEASURING POINT: Ground Surface	
DRILLING EQUIPMENT: Geoprobe® 7720DT	GROUND SURFACE ELEVATION: 39 Feet Above Sea Level	DATE COMPLETED: 3/14/13	
SAMPLING METHOD: N/A	DEPTH TO GROUNDWATER: Not Encountered		
HAMMER WEIGHT: N/A	DROP: N/A	RESPONSIBLE PROFESSIONAL: Jeffrey Nannini	LOGGED BY: Adam Hutchinson

DEPTH (feet)	WELL CONSTRUCTION
2.0	
1.0	
0.0	Surface Grade
1.0	Bentonite (Within Outer Well)
2.0	Clean Sand Backfill
3.0	
4.0	1" diameter Schedule 40 PVC Riser
5.0	#1 Morie Sand Pack (Within Outer Well)
6.0	1/4" x 3/8" Polyethylene Tubing
7.0	1" diameter 0.020" Slot, Schedule 40 PVC Screen
8.0	End Cap

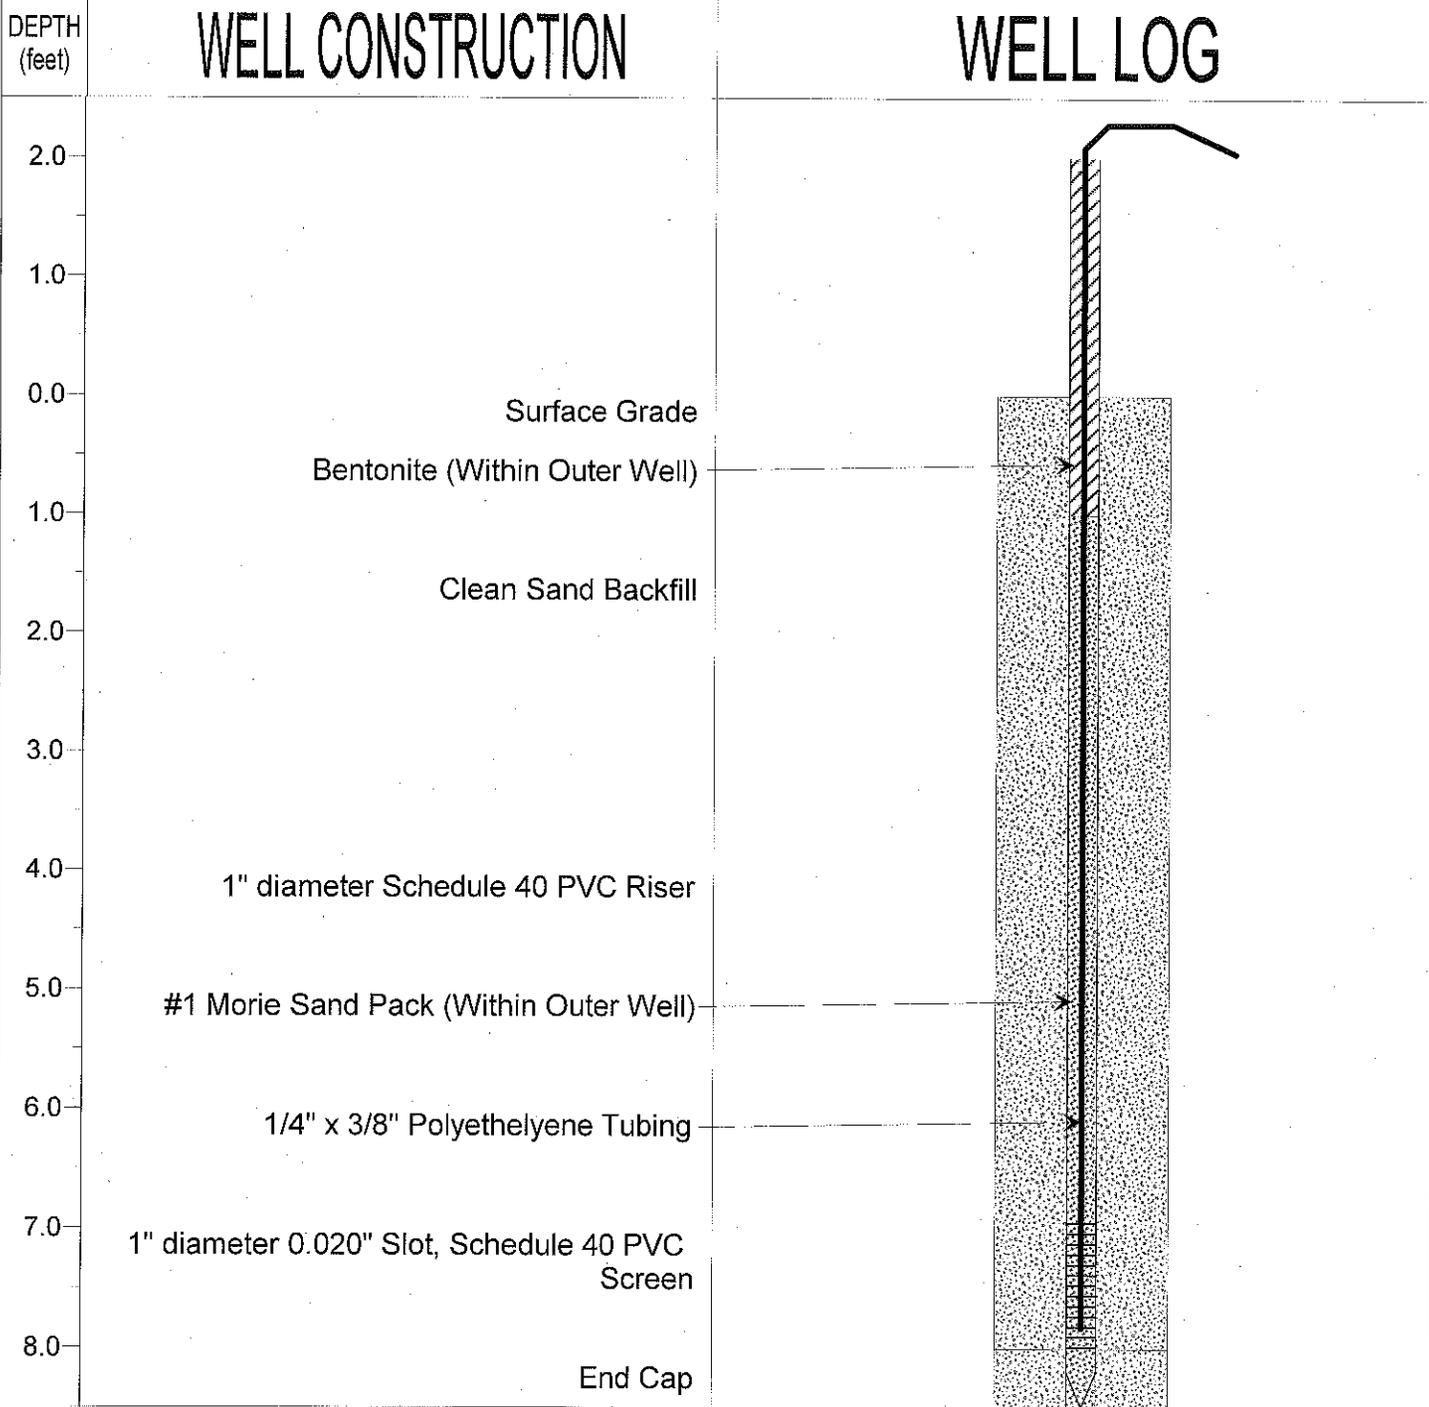
PROJECT NAME: Long Island City		BORING NUMBER: VP-4	
PROJECT ADDRESS: 27-01 41st Avenue Long Island City, NY 11101			
DRILLING CONTRACTOR: JC Broderick & Associates, Inc.		BORING LOCATION: South Center of Subject Property	
DRILLING METHOD: 2.125 inch Direct Push Rods	TOTAL DEPTH: 8 Feet bsg	MEASURING POINT: Ground Surface	
DRILLING EQUIPMENT: Geoprobe® 7720DT	GROUND SURFACE ELEVATION: 39 Feet Above Sea Level	DATE COMPLETED: 3/14/13	
SAMPLING METHOD: N/A		DEPTH TO GROUNDWATER: Not Encountered	
HAMMER WEIGHT: N/A	DROP: N/A	RESPONSIBLE PROFESSIONAL: Jeffrey Nannini	LOGGED BY: Adam Hutchinson

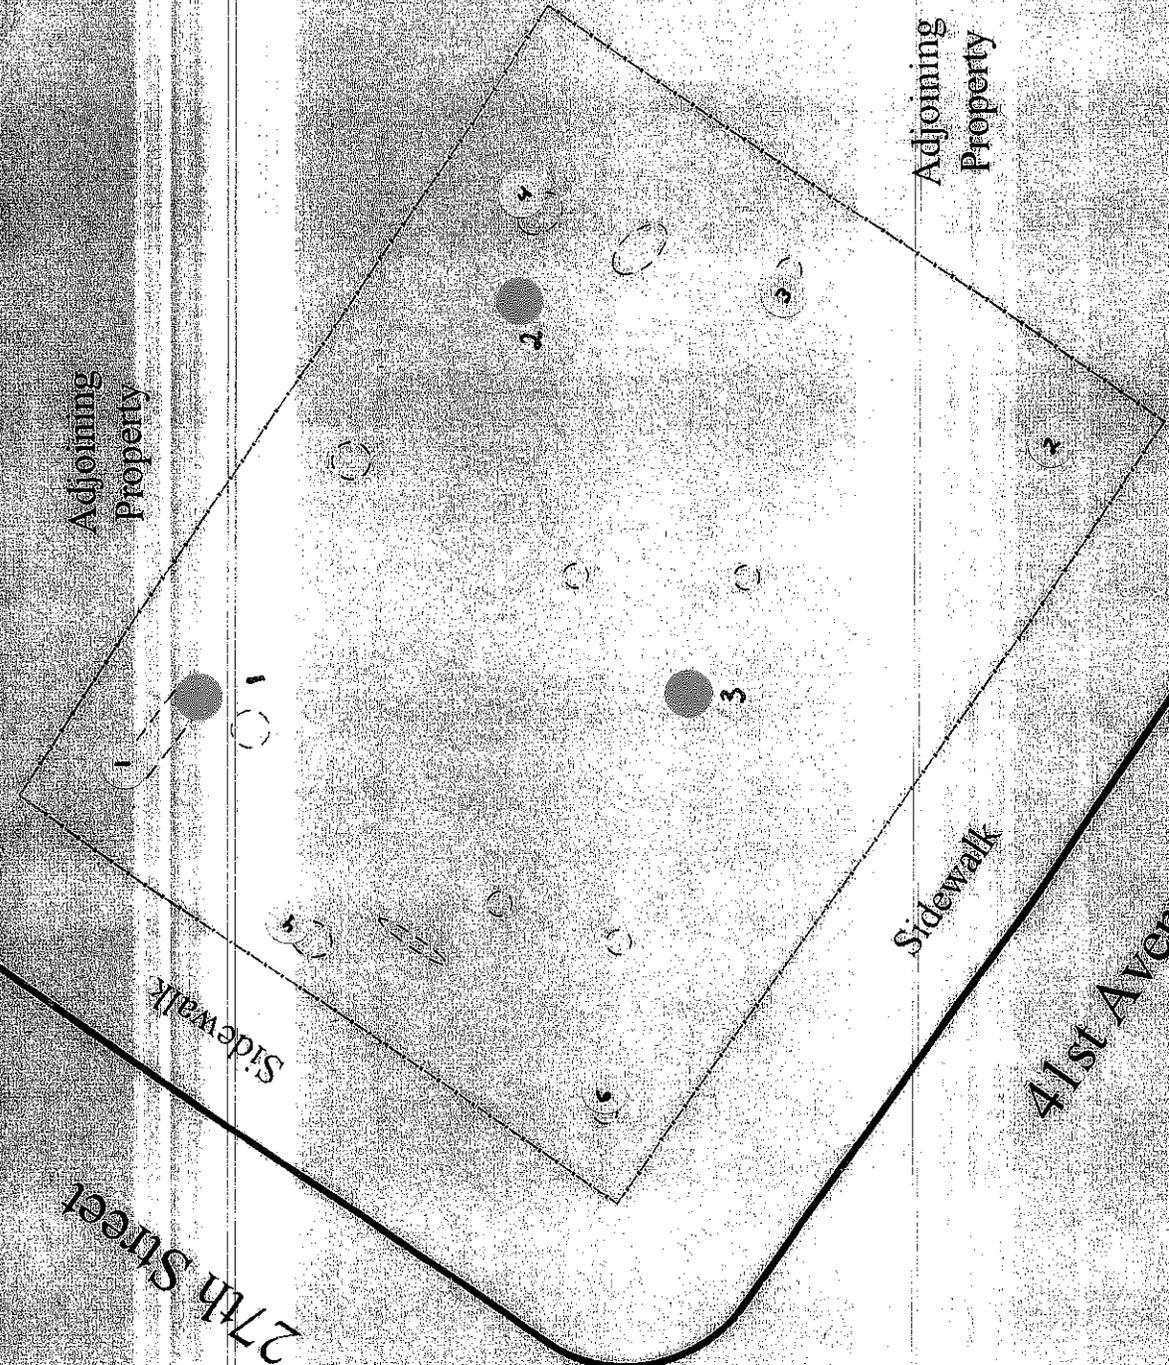
Figure 10 site map showing the location of the three groundwater monitoring wells

Three ground water sampling wells were drilled at the locations shown in Figure 10. The locations were selected on the basis of anomalies noted by the GPR survey. No correspondence was determined. As previously described they were drilled to a depth of 40 feet and to a diameter of two inches. A 10 foot length of screen was set between 30 and 40 feet. The screen slot was 0.10 inches The water levels were below 30 feet below grade and too deep to develop or sample by pumping. The wells were developed by bailing to the point where water was clear and to the point where clarity was no longer improving. The wells were bailed anywhere from 20 to 40 times.

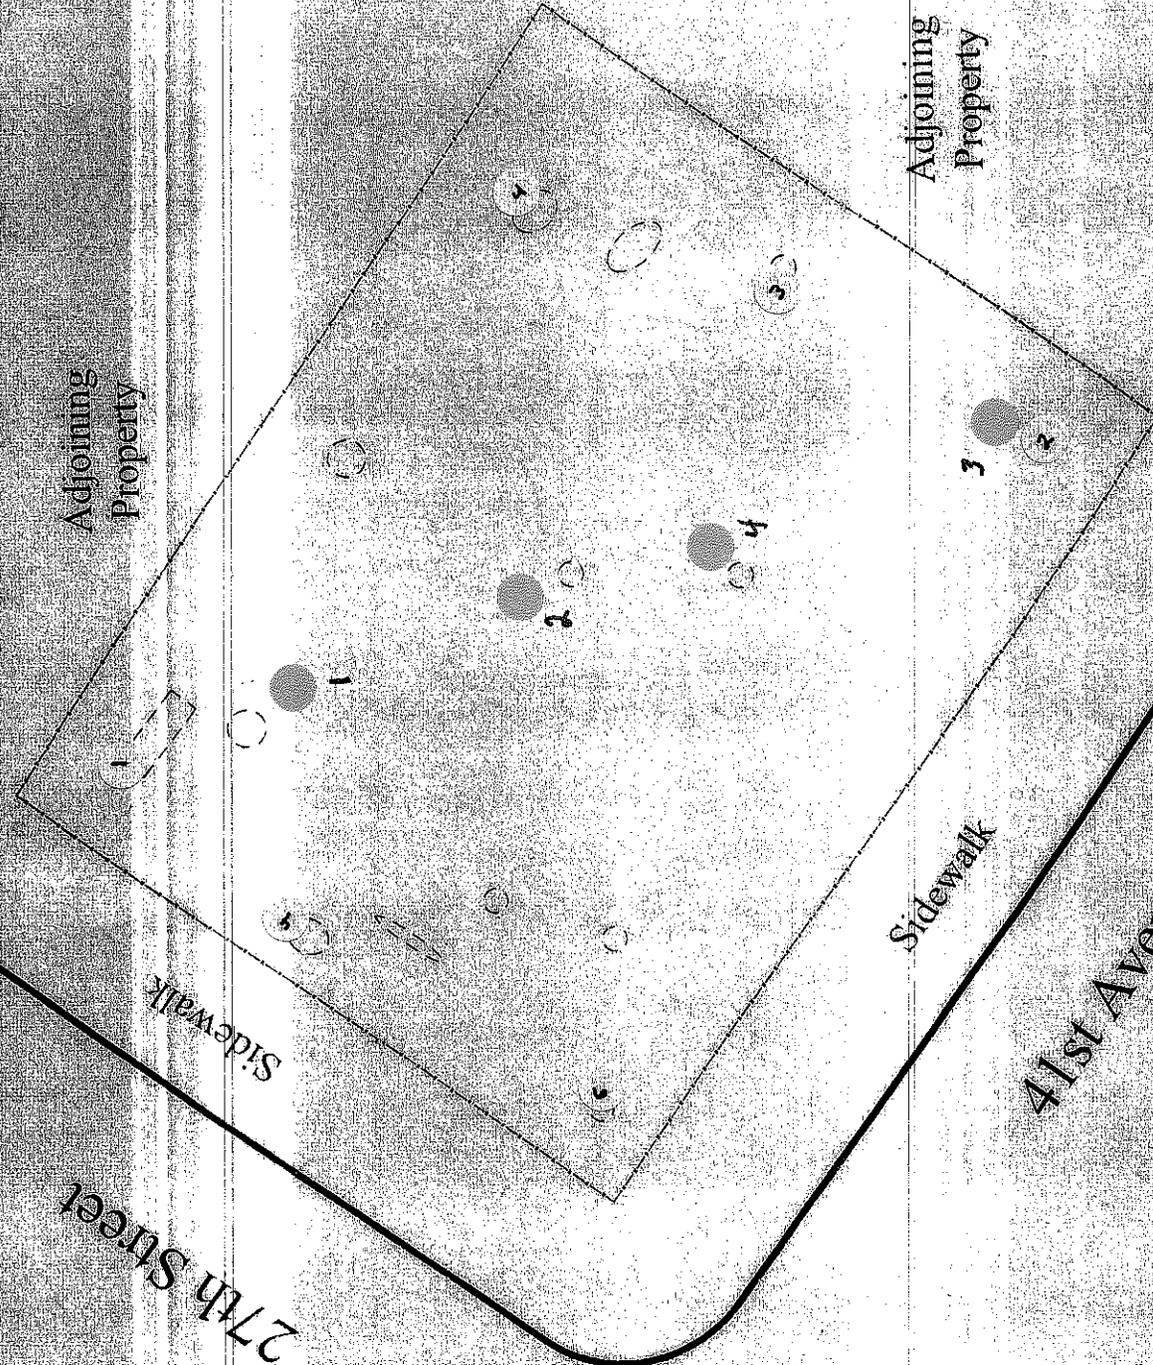
Figure 1.1 Site map showing the locations of the four soil vapor sampling points

Four soil vapor probes were installed, and four soil vapor samples were collected for 2 hours for chemical analysis during this RI. Soil vapor sampling locations are shown in Figure 11. Soil vapor sample collection data are found in the Phoenix Lab results, which were submitted under separate cover. Methodologies used for soil vapor assessment conform to the *NYS DOH Final Guidance on Soil Vapor Intrusion, October 2006*.
